**APPENDIX A**  
**HISTORIC RESOURCE EVALUATION AND**  
**ASSESSMENT REPORT**

# Historic Resources of Memorial Park

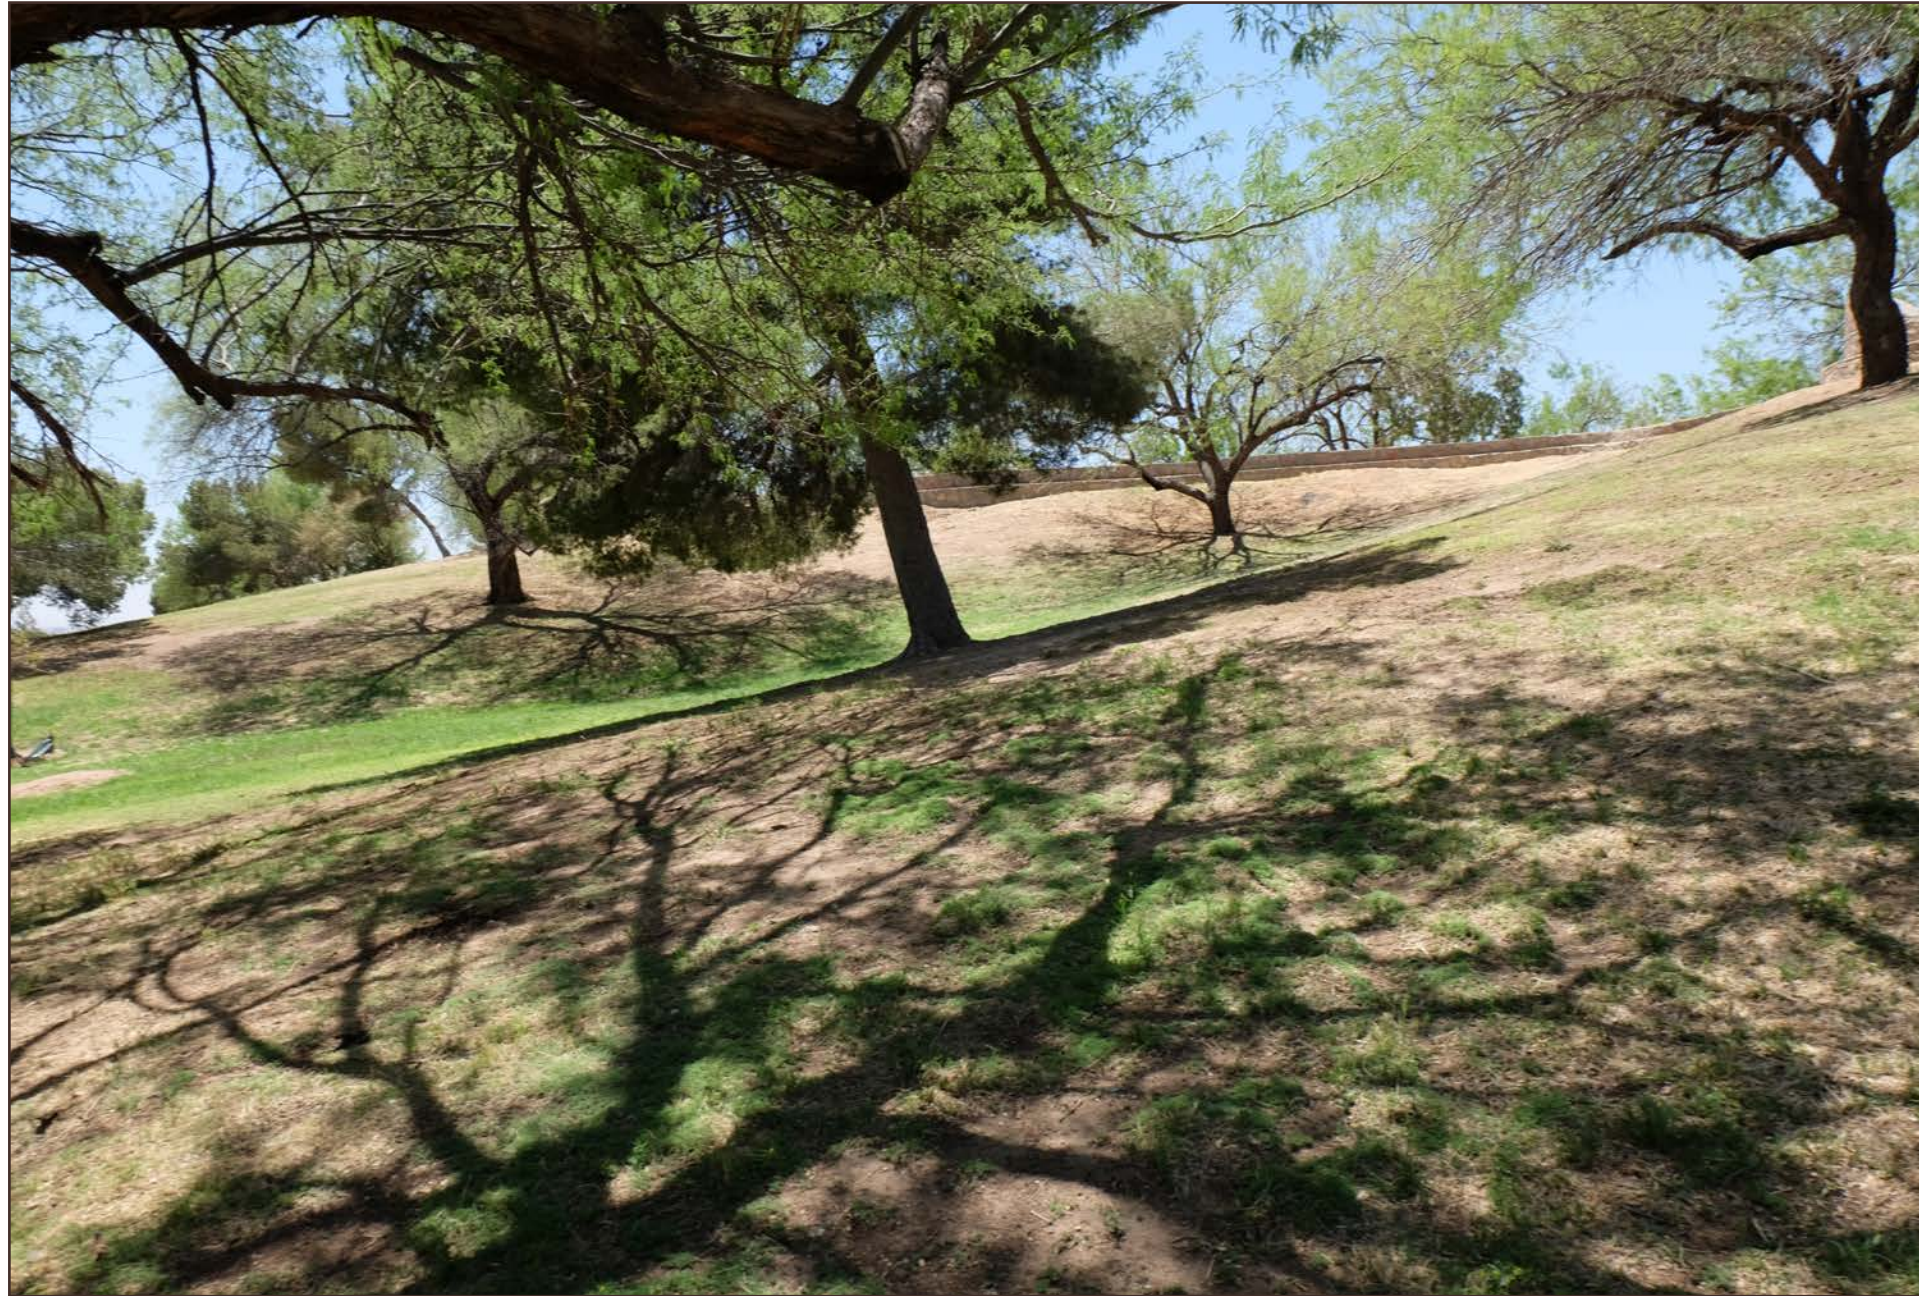
Memorial Park, south of the historic Manhattan Heights neighborhood in El Paso, Texas, is a neighborhood park with features dating from the 1920s to present. Remnants of park development campaigns are visible in a 1920s bridge, masonry walls constructed by the Works Progress Administration during the 1930s and 1940s, and mid-century features like the rose garden and garden center building. A rolling, hilly topography characterizes the site and is a relic of a historic industrial operation that took place at the site during the early twentieth century.

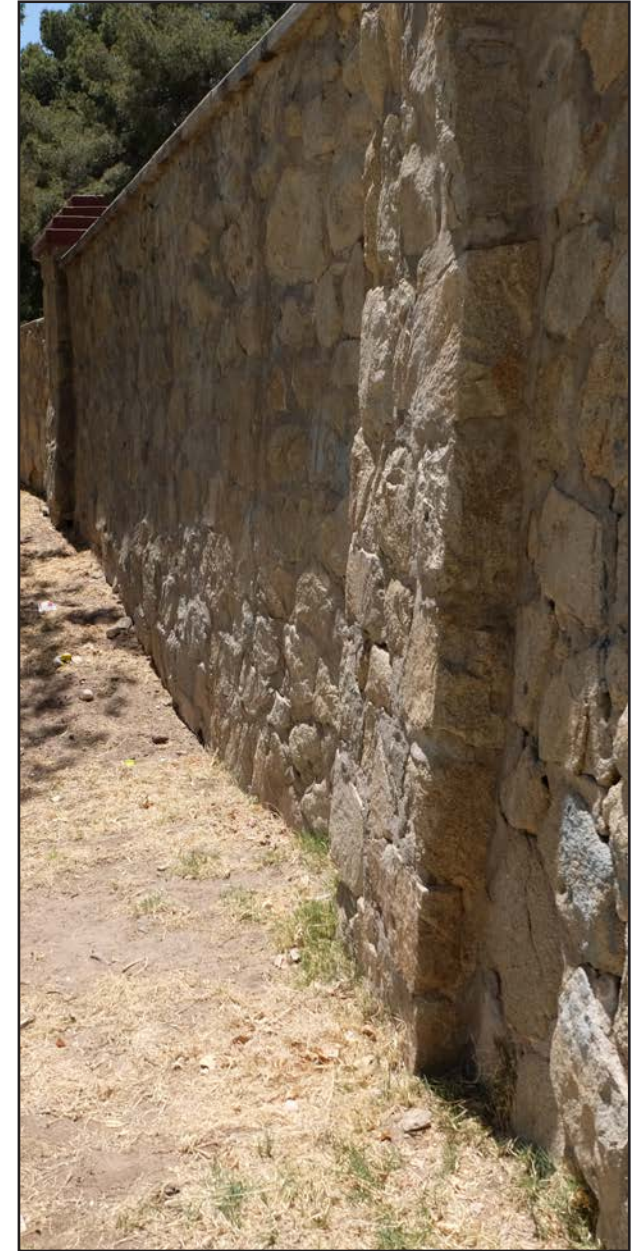
Masonry Walls at the Estrella Street Bridge

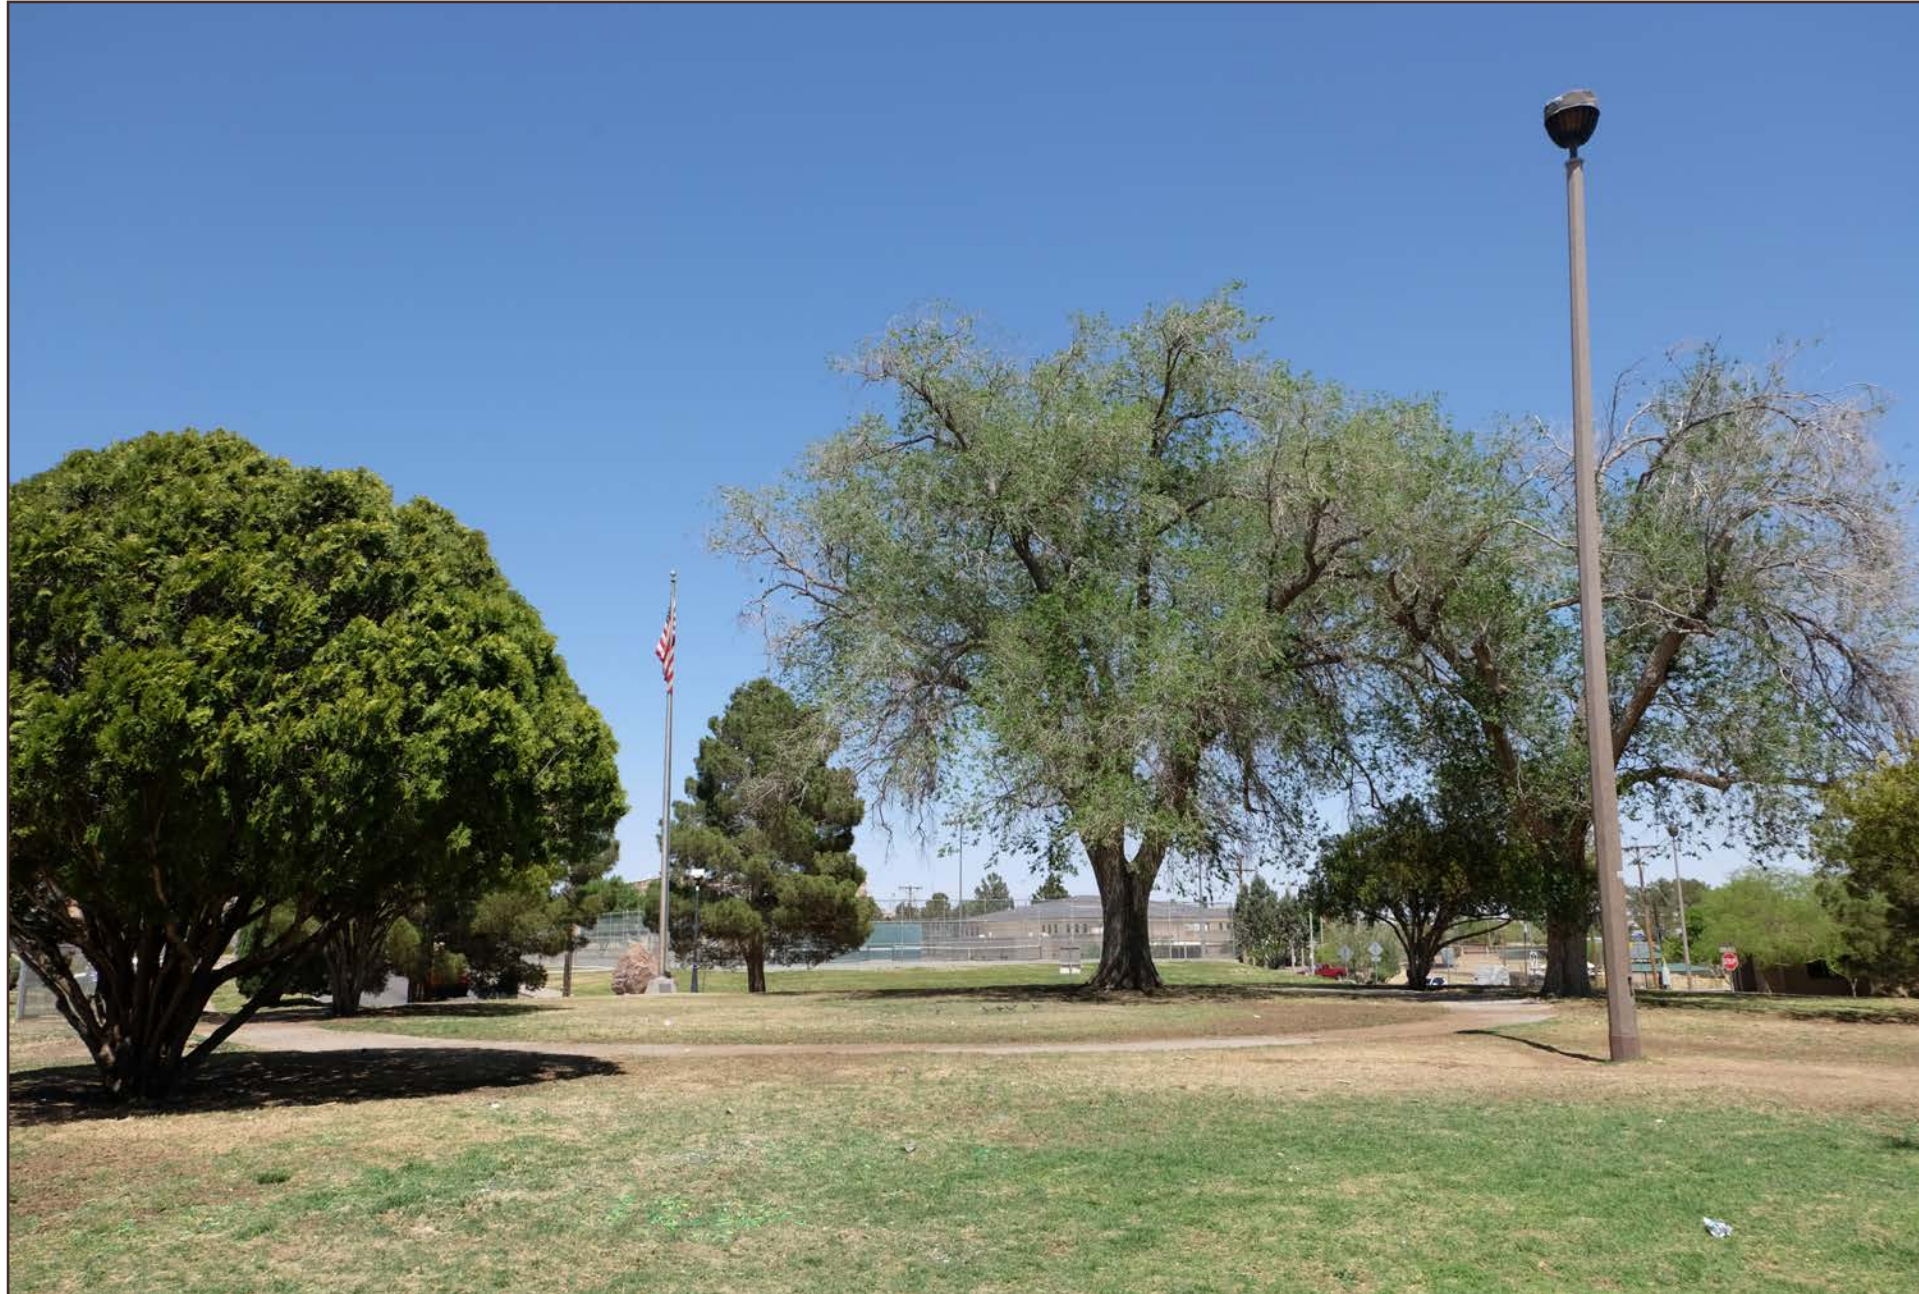
**CHAPTER 1: HISTORIC CONTEXT AND INTEGRITY ..... 7**

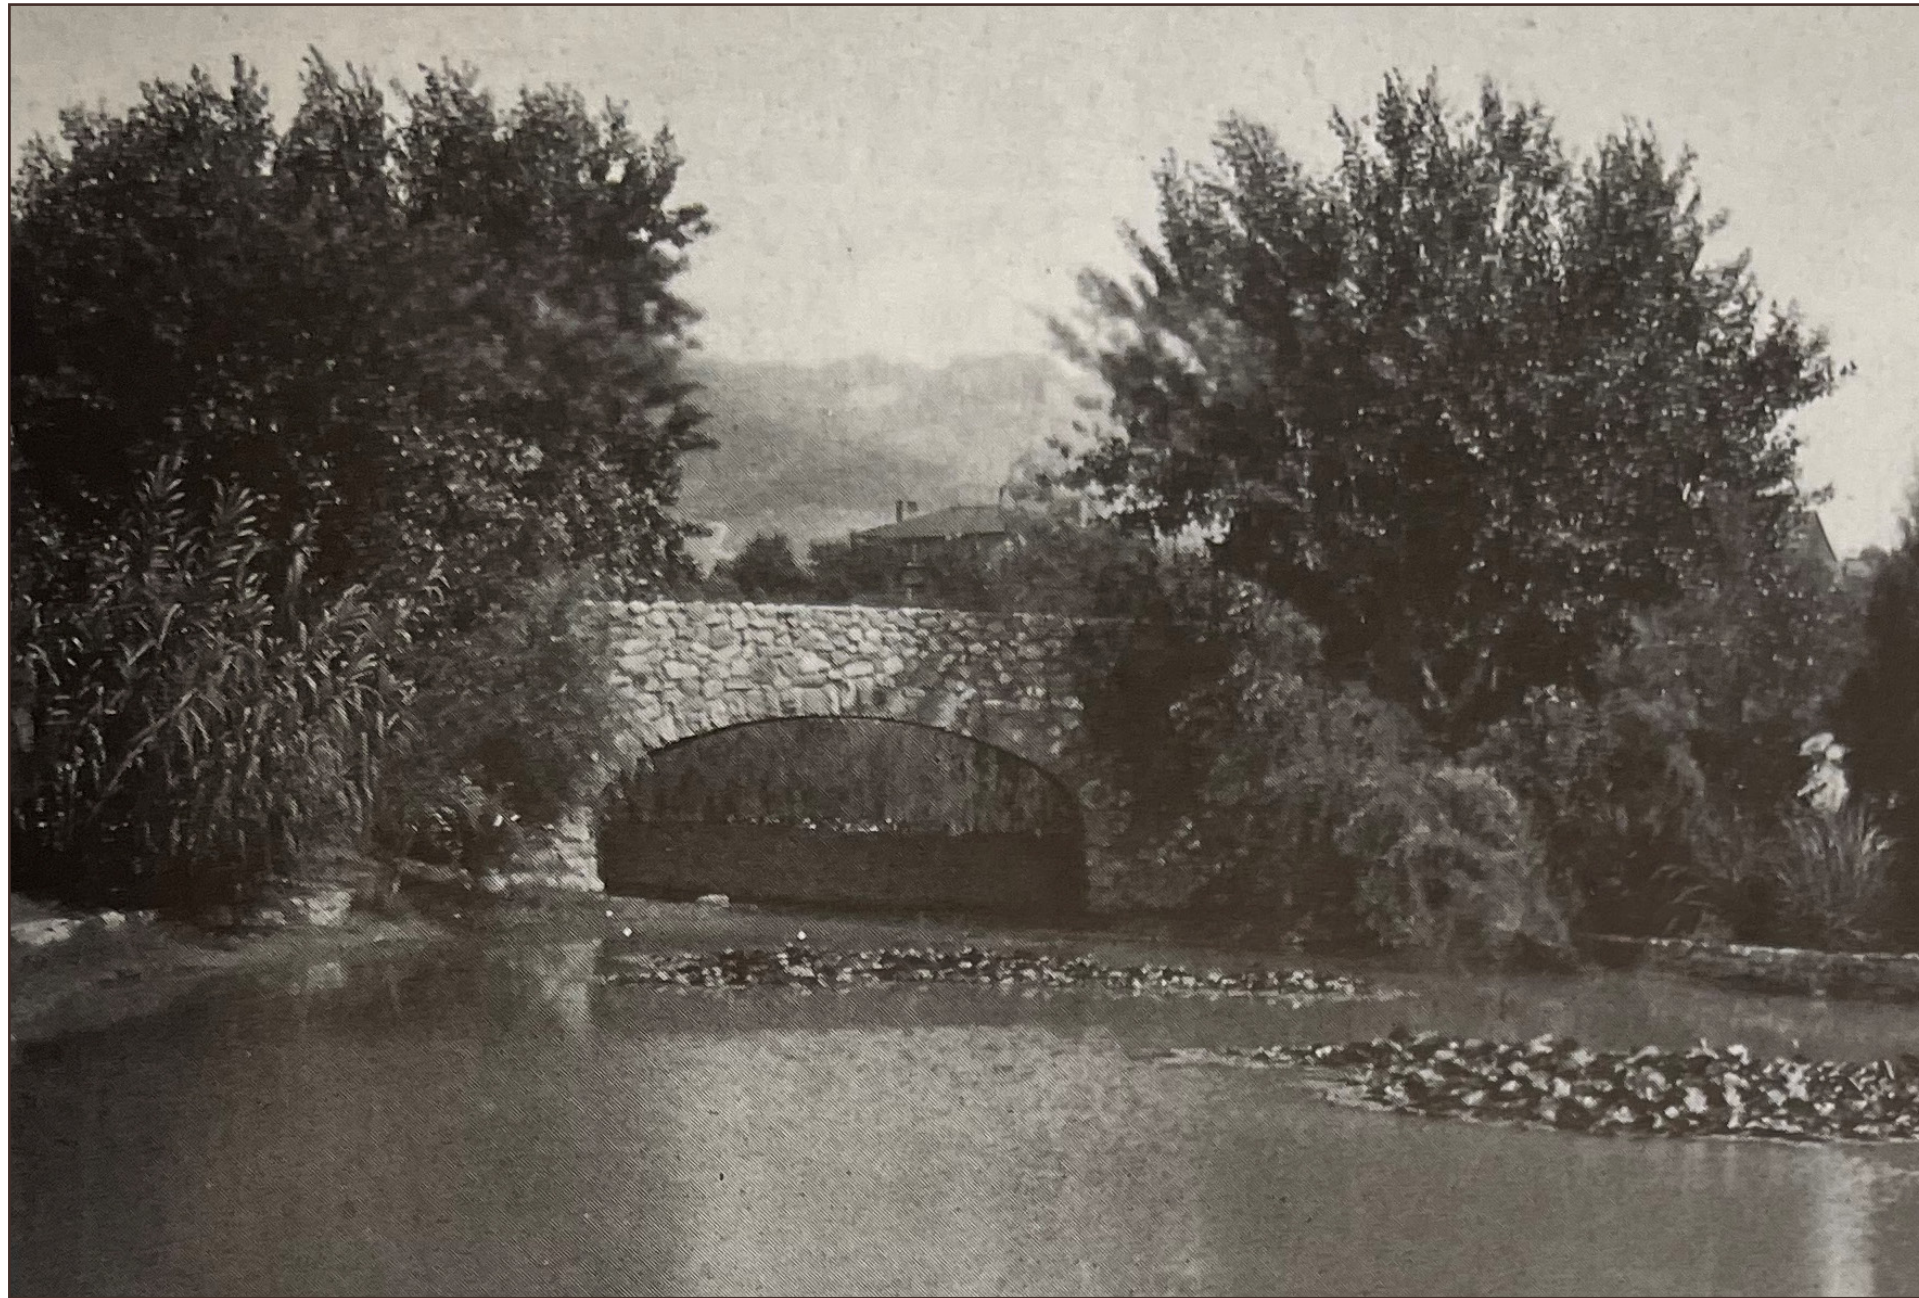
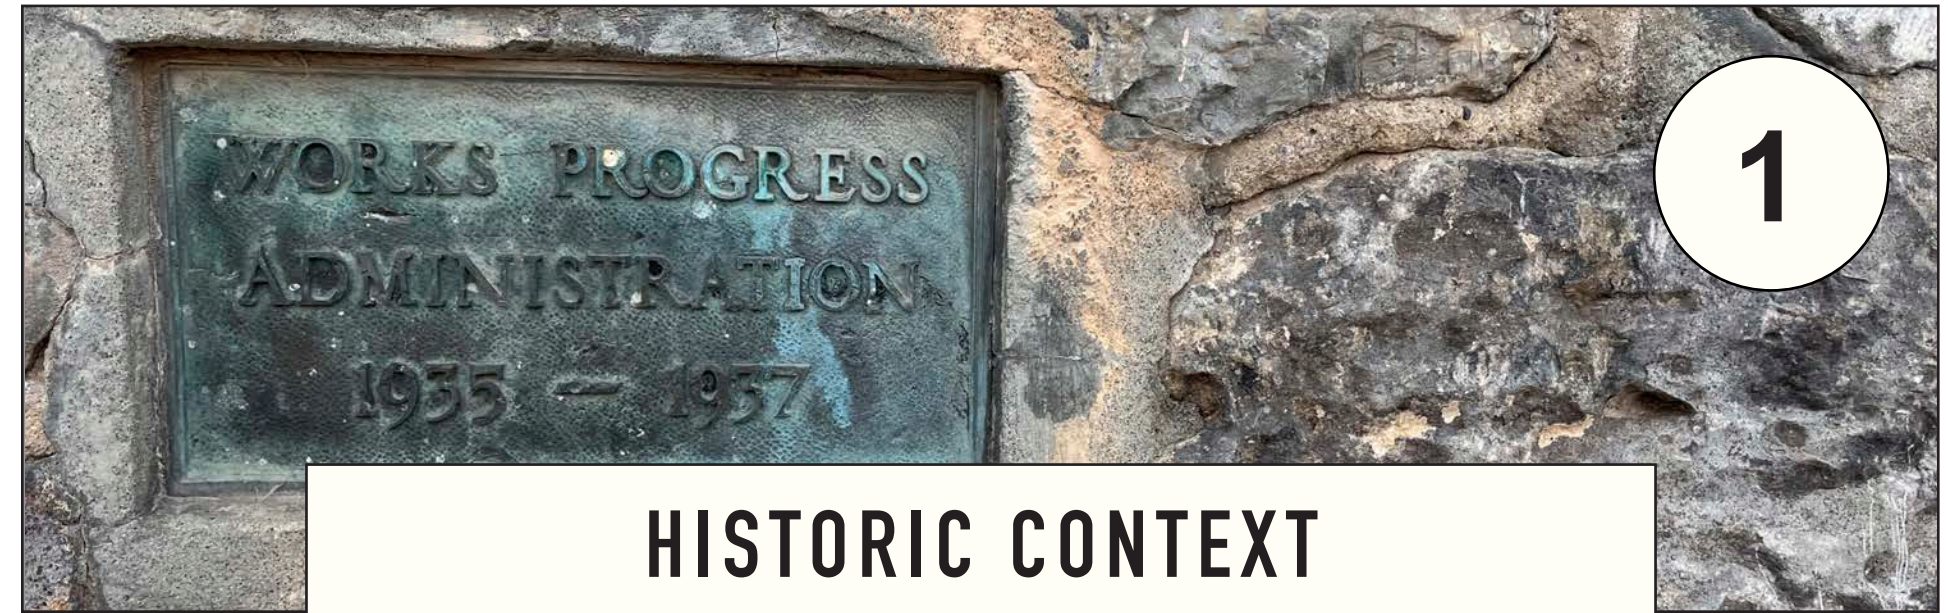
## HISTORIC CONTEXT AND INTEGRITY

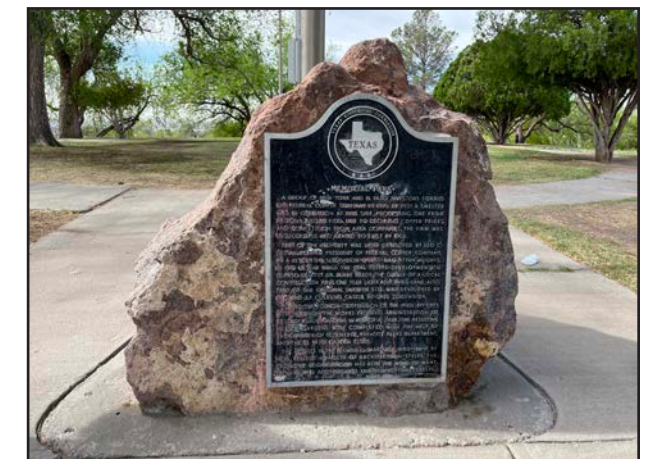
Chapter 1: Historic Context and Integrity provides a history of Memorial Park within the context of El Paso, a timeline of major events relating to the park's development, an explanation of historic evaluation methodology, recommended areas and periods of significance, character-defining features of the park, and a discussion of historic integrity. Integrity for this chapter was assessed based on seven criteria defined by the National Park Service for evaluating historic resources.

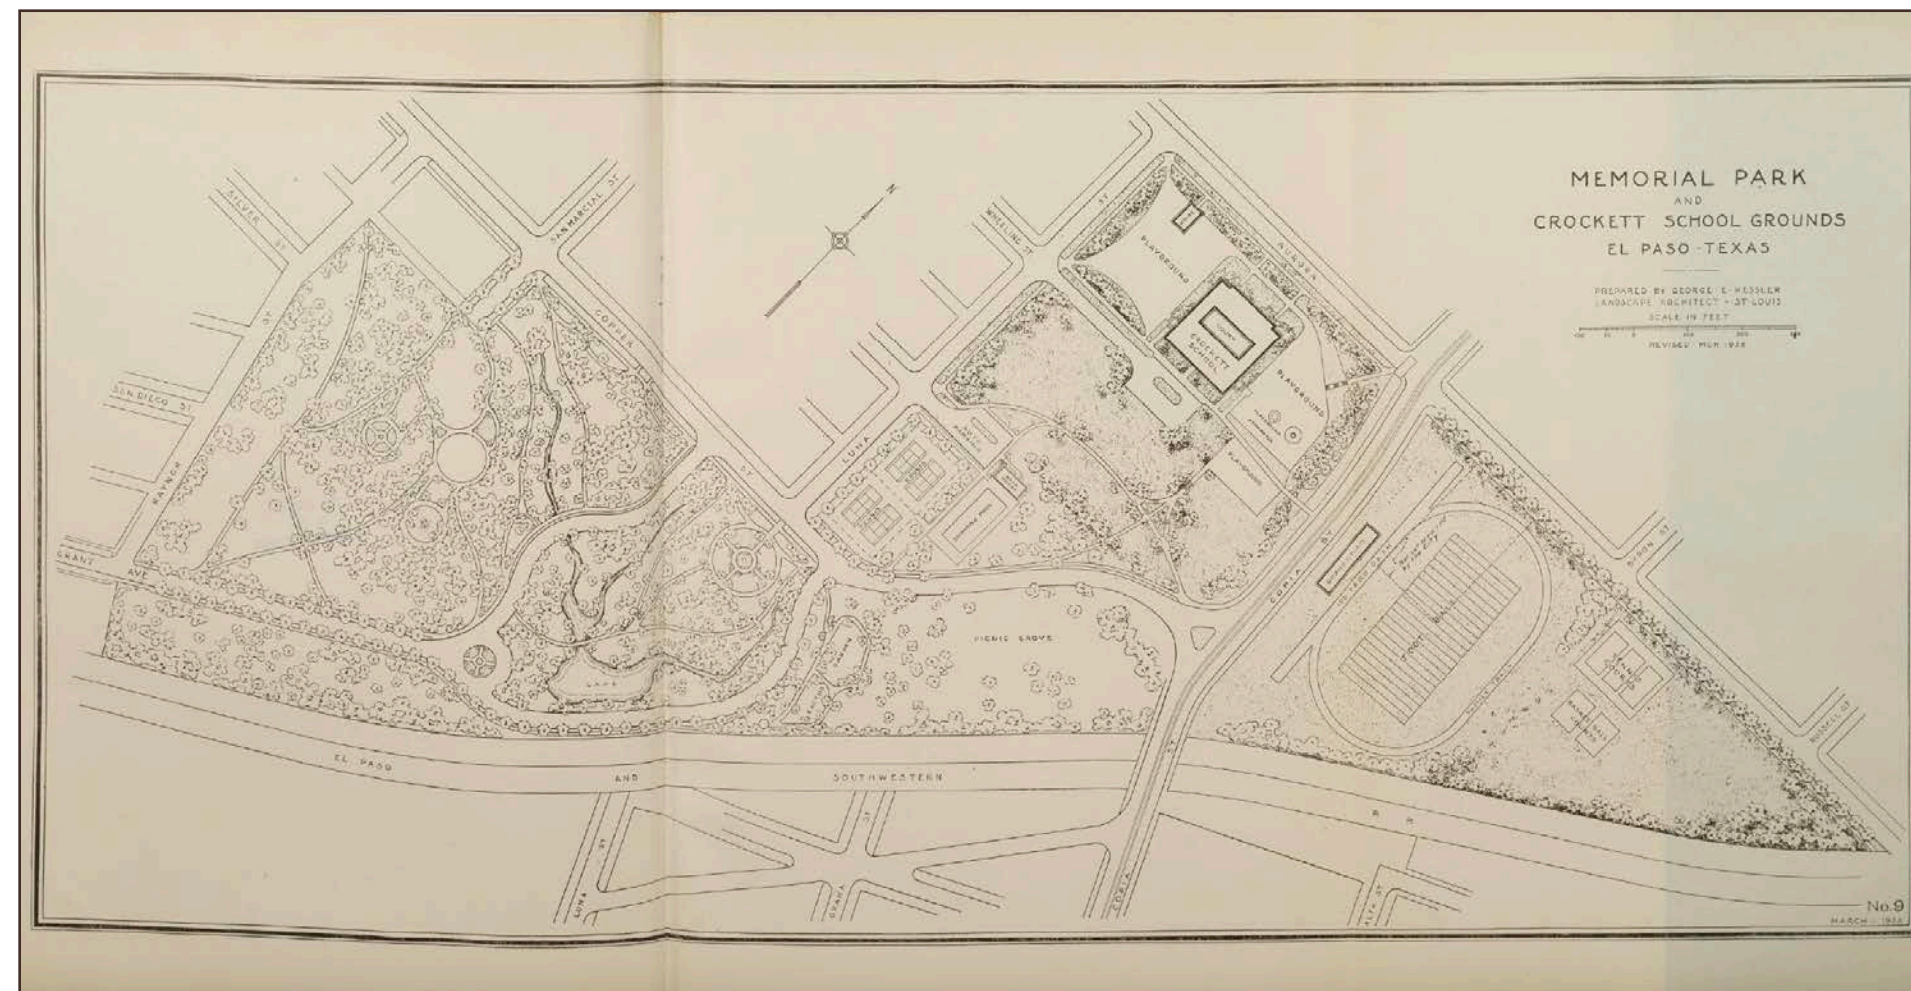
Memorial Park Map from the 1925 City Plan for El Paso Texas. It is likely that some of the features on this plan were realized prior to 1925. For example, the south bridge (HR1) has the date "1922" engraved in the stone, suggesting that it pre-dates City Plan publication.

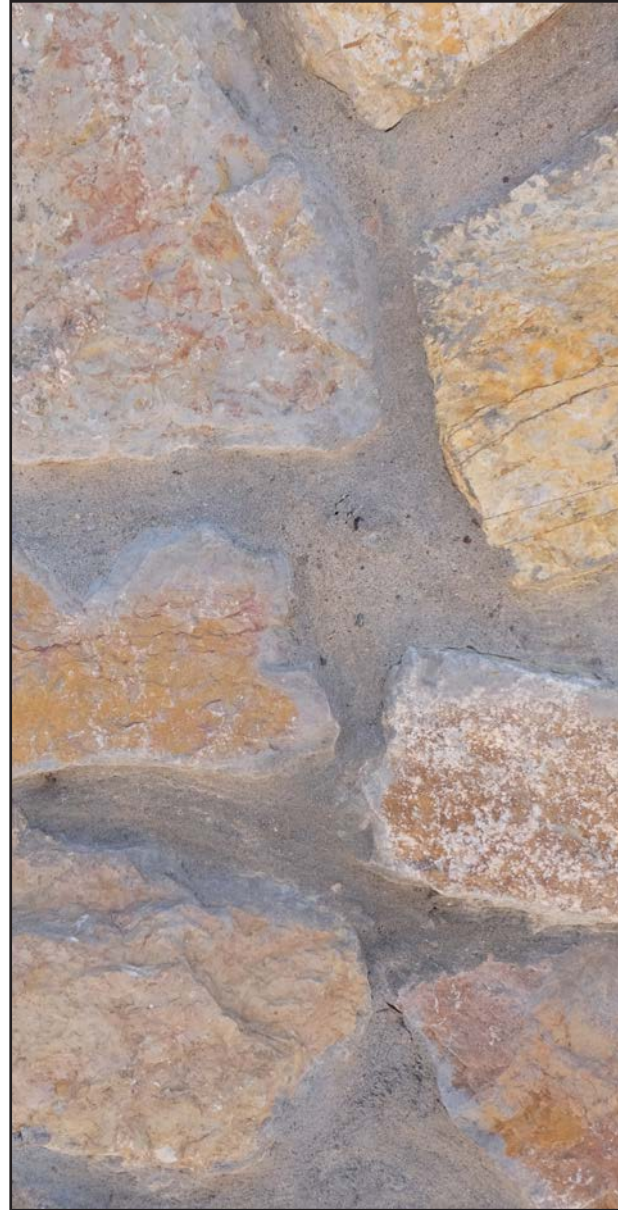
MEMORIAL PARK HISTORY AND DEVELOPMENT

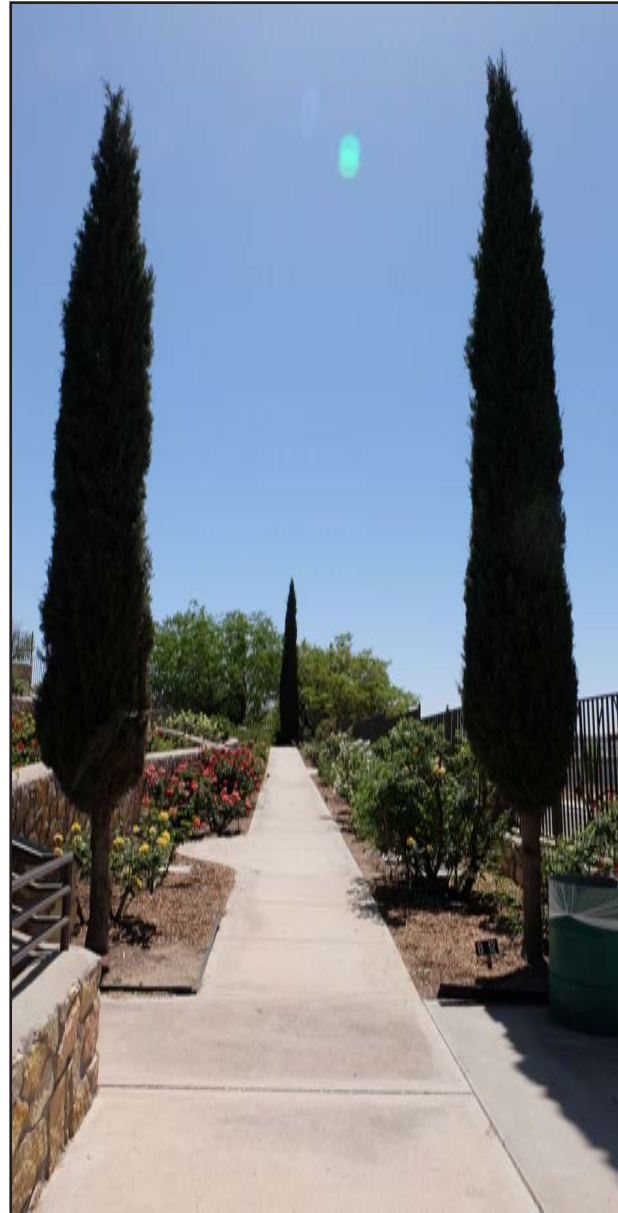
HISTORIC EVALUATION METHODOLOGY

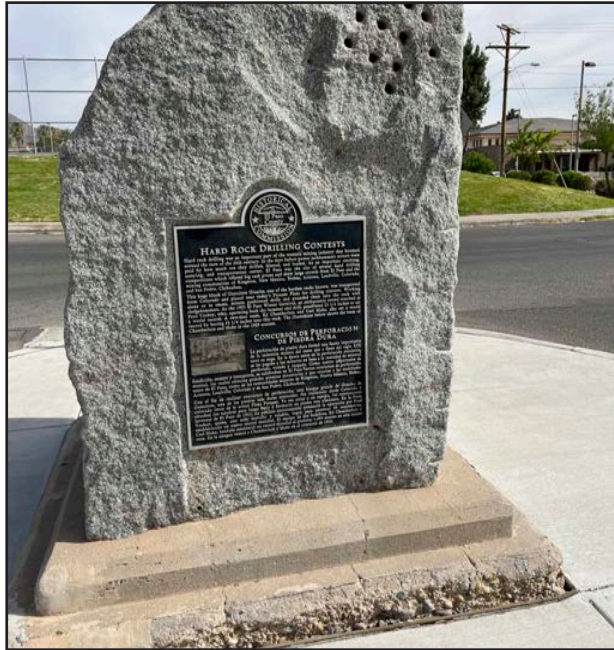
El Paso Historical Commission Marker for the Hard Rock Drilling Contest

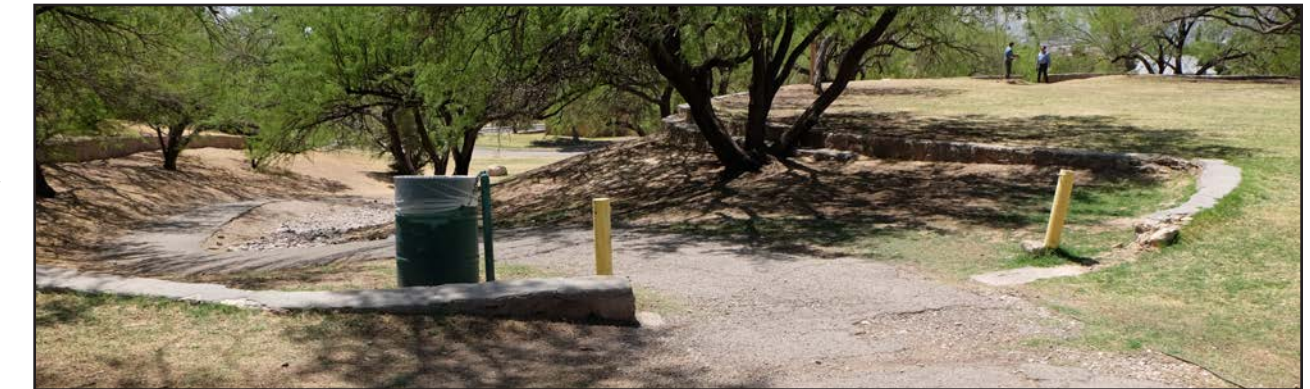
Memorial Park's hilly topography is one of its character-defining features.

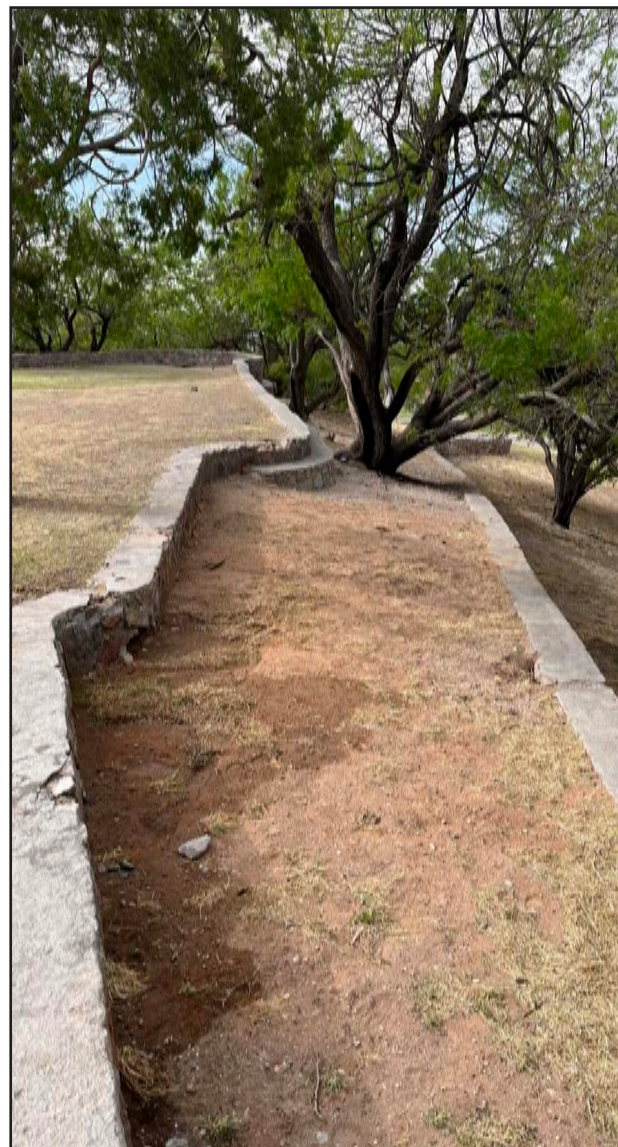
Memorial Park was first established over 100 years ago, and since then has undergone periods of development, deterioration, alteration, expansion, upgrade, and neglect. Some alterations to the park are minimal, and do not impact the overall historic integrity of the park to such a degree that they interfere with the park’s ability to convey its historical significance. These include cracked or missing stones in the masonry, cracked mortar, and the use of incompatible Portland cement mortar. Some alterations, including demolition of the Hilltop Garden and lover’s benches, were done during the park’s period of significance, and thus are part of the park’s history. Later, mid-century additions to the park, including the 1950s Garden Center and Rose Garden, have achieved historical significance in their own right, and contribute to the park’s overall historic significance.

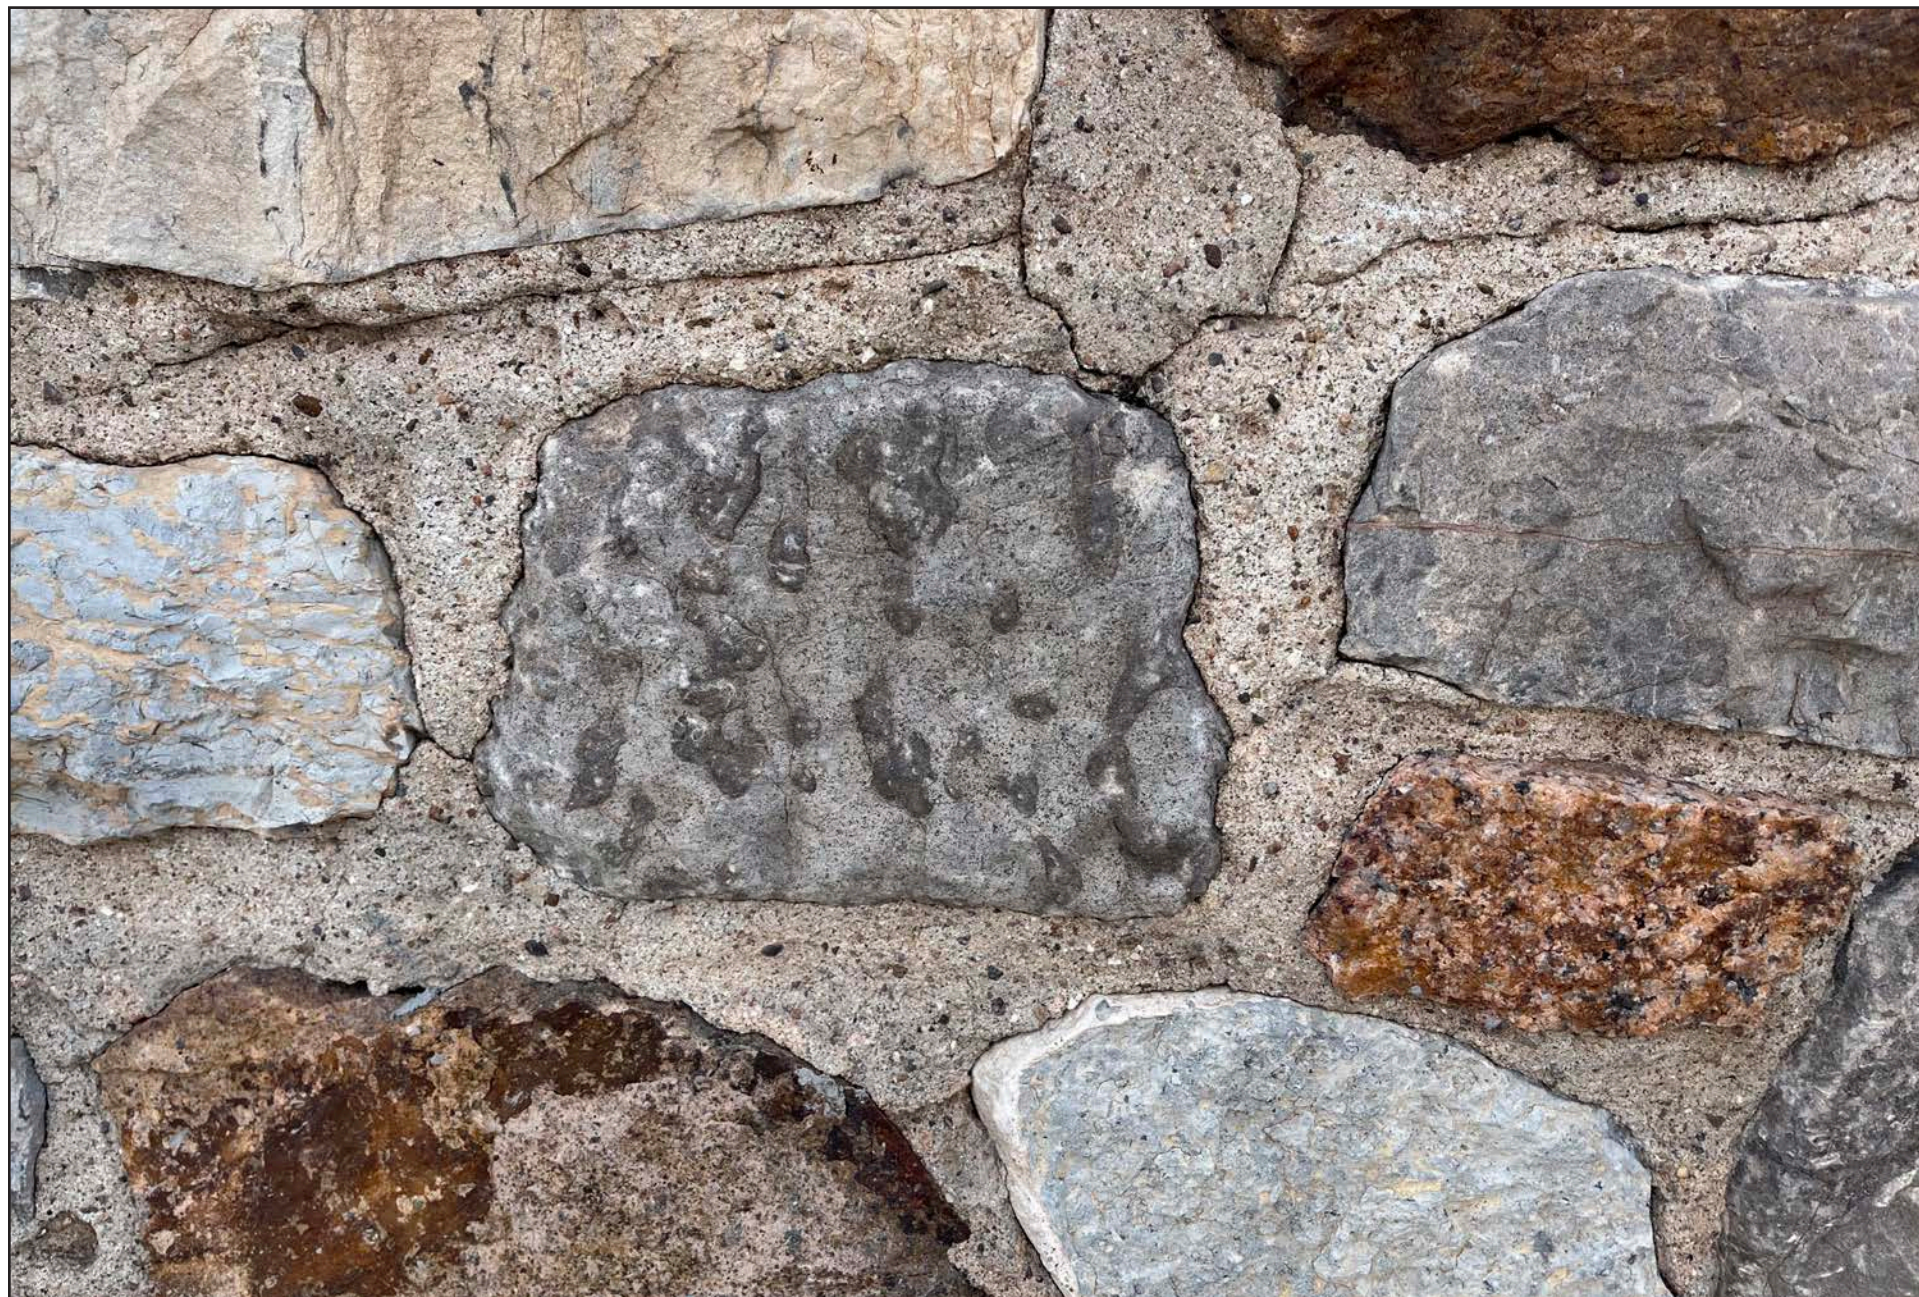
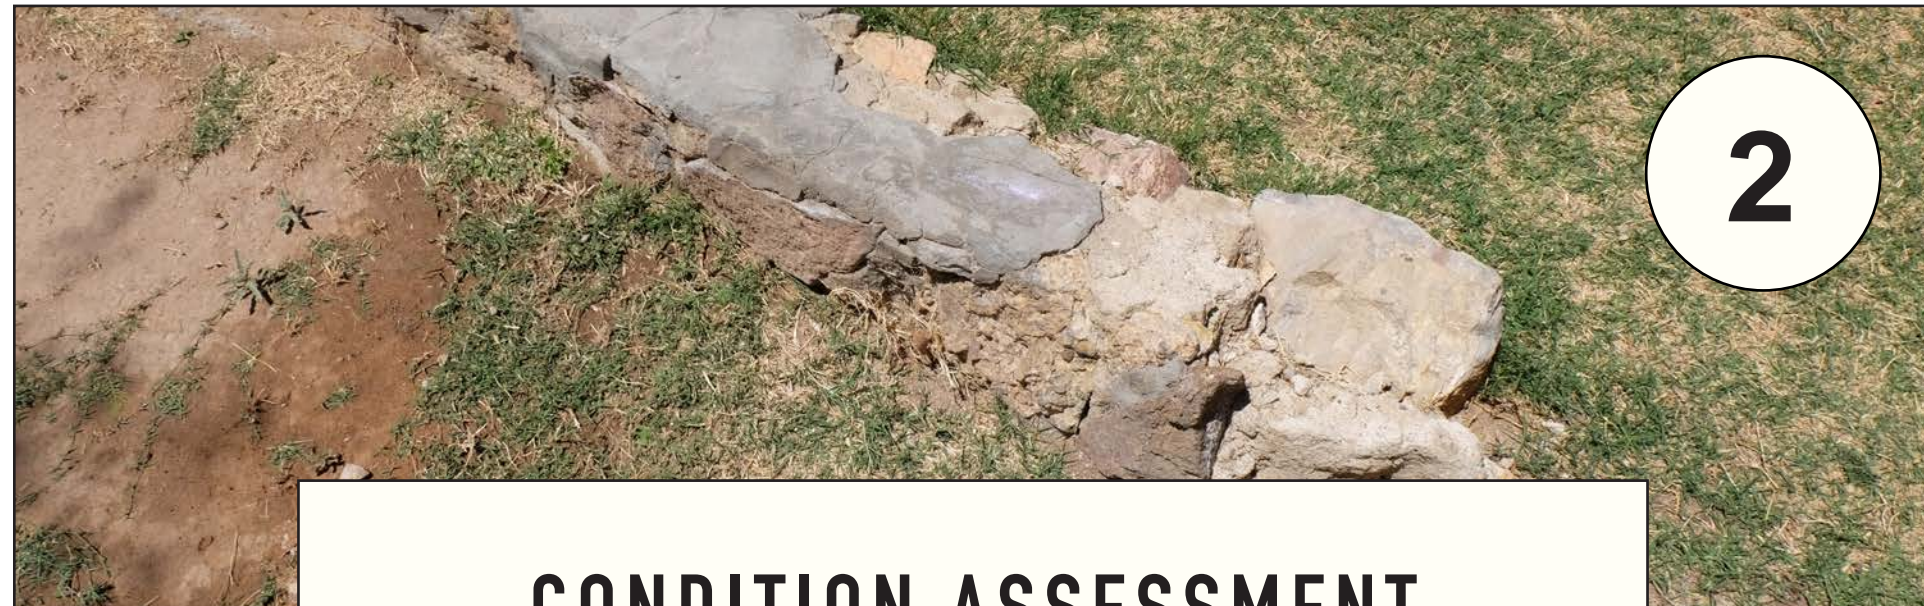
## CONDITION ASSESSMENT

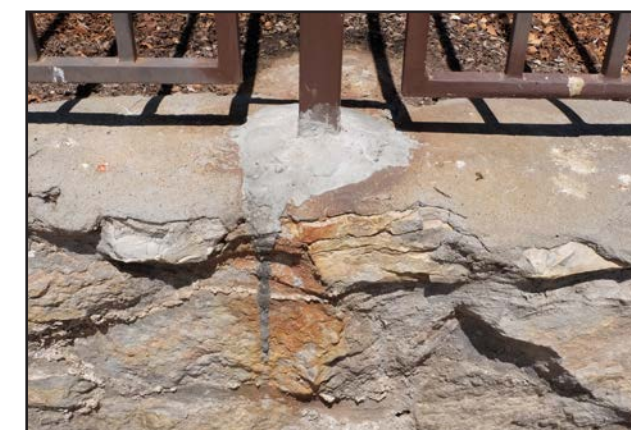
*Incompatible repair patch, corrosion, and staining at the Rose Garden.*

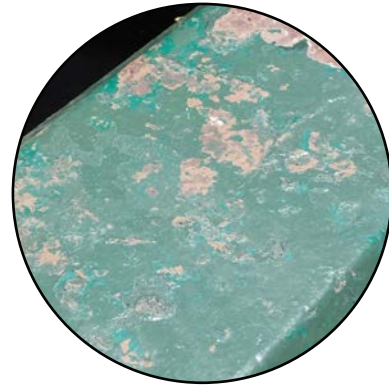
Native stone, limestone, and granite were used through the masonry structures in the park. The masonry structures appear to date from the early 1920s, the WPA-era, midcentury, and more recent times. The masonry materials are irregularly shaped and vary in color, texture, and size.

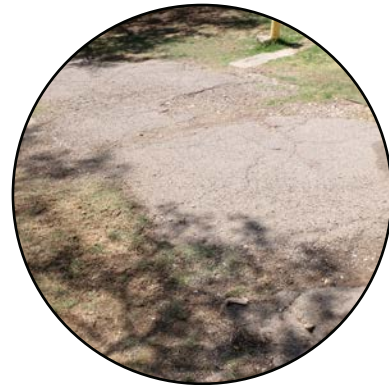
Exterior paint finishes are applied to most buildings throughout the park. It is both an aesthetic and protective layer over the substrate. In general, it is not recommended to apply paint to masonry walls that were historically unpainted. Non-historic paint coatings were noted on the brick exterior walls of the garden center (HR15), the 1920s bridge (HR1), on various elements of the hilltop masonry walls (HR3), and the masonry accessory building (HR18). Paint was likely historically used on the picnic tables (HR20) and exterior elements of the concession building (HR17) and garden center (HR15).

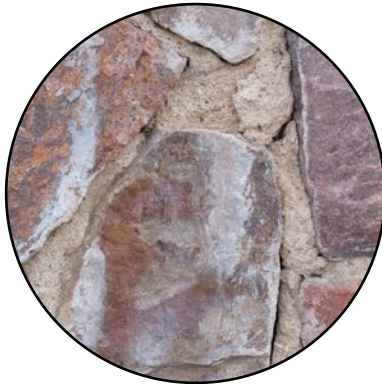
The garden center (HR15) has brick exterior walls..

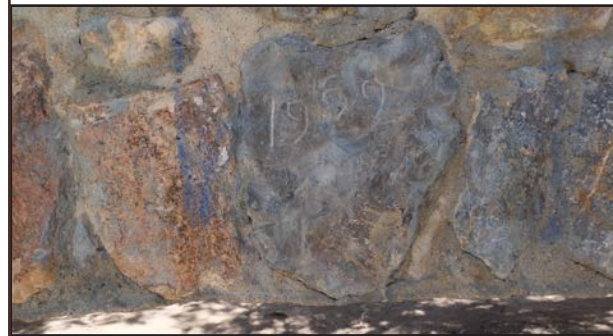
Keystone with "1922" inscription.

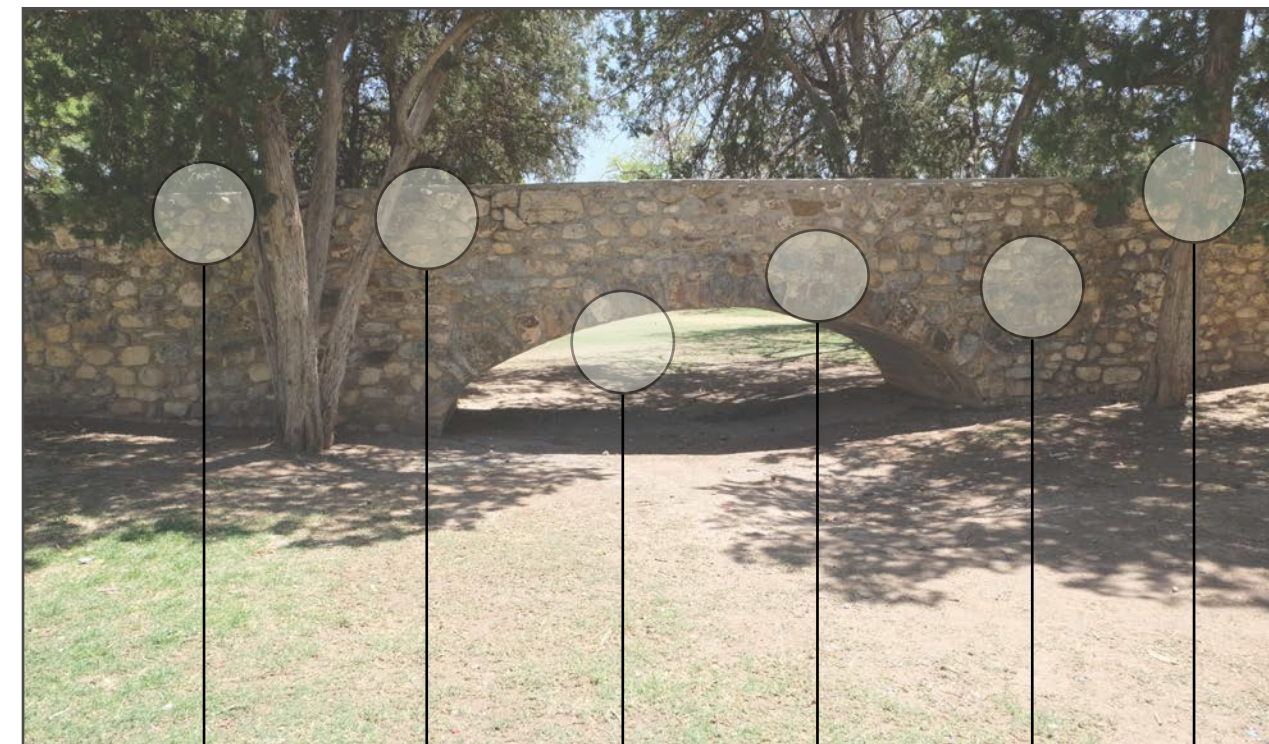
TYPICAL CONDITIONS: 1920S BRIDGE (HR1)

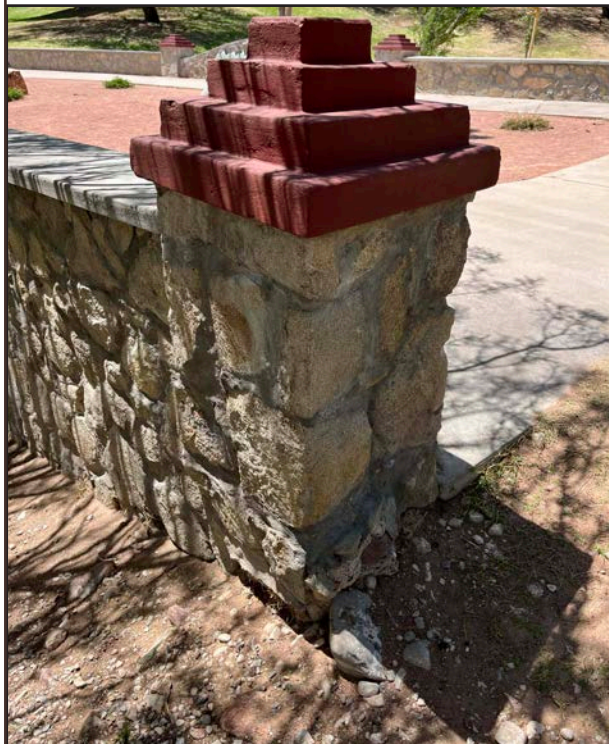
Tiered posts at Estrella Street Bridge

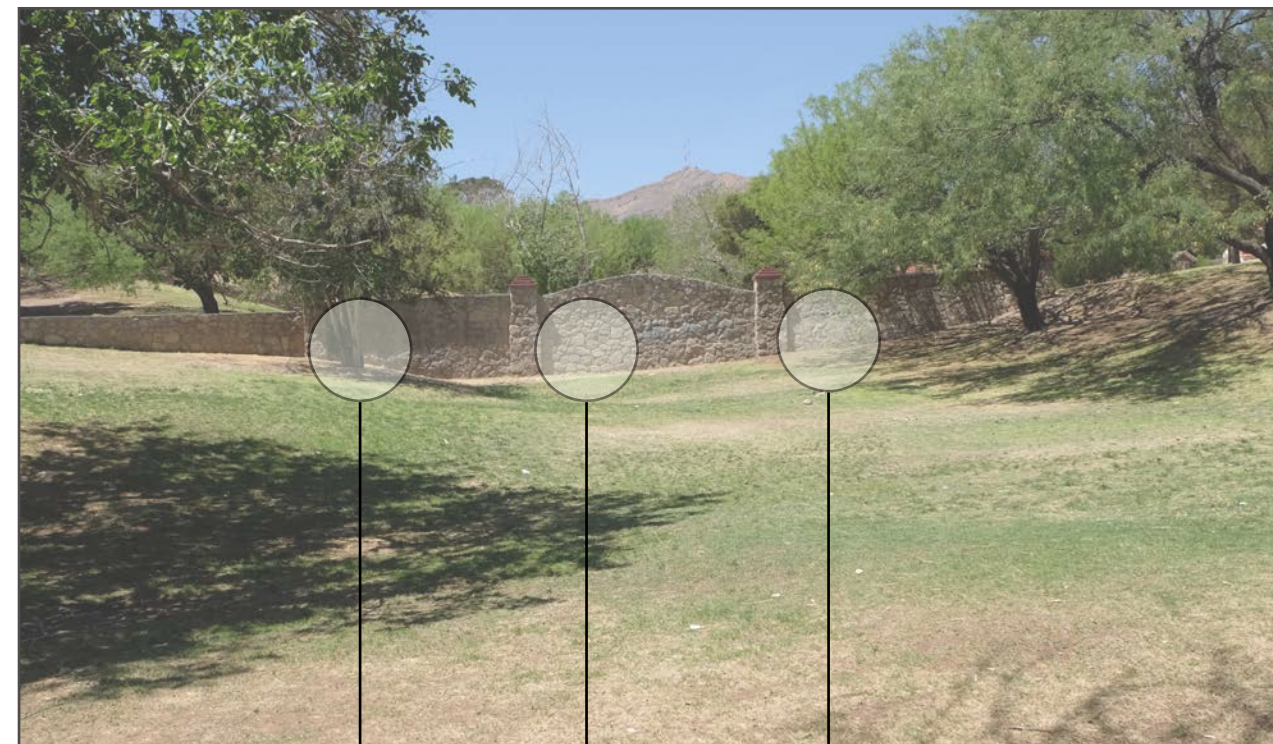
ESTRELLA STREET BRIDGE (HR2)

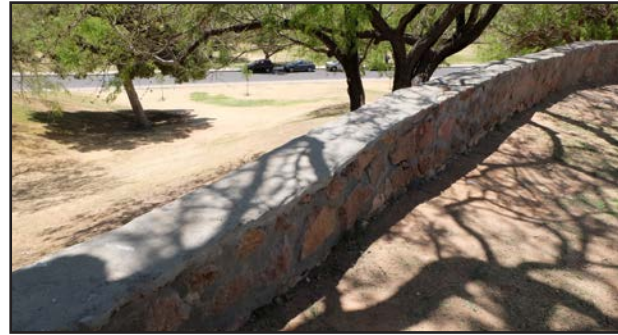
Masonry walls follow the topography of the landscape.

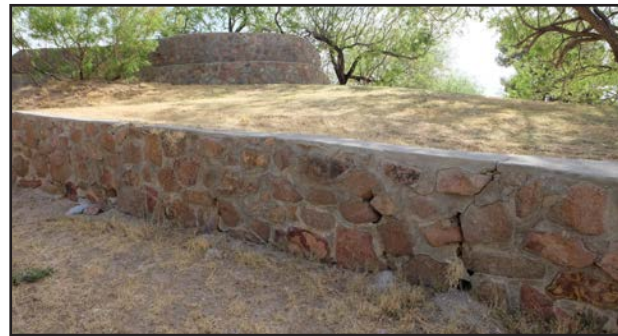
Step cracks from differential settlement
