**APPENDIX A**  
**HISTORIC RESOURCE EVALUATION AND**  
**ASSESSMENT REPORT**

# Historic Resources of Memorial Park

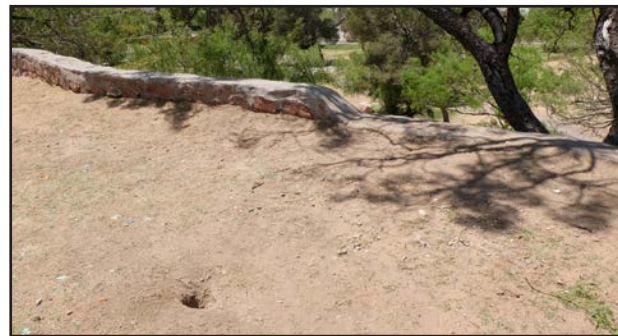
Varying features in the hilltop walls

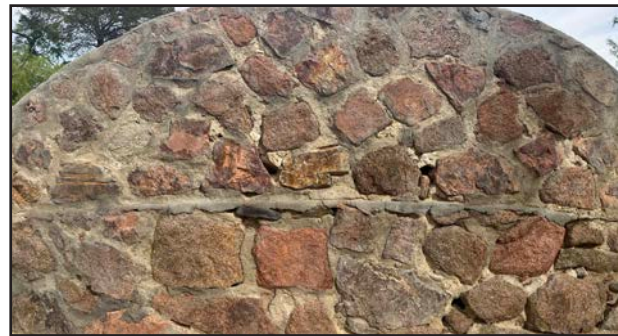
Missing mortar on rear of bench

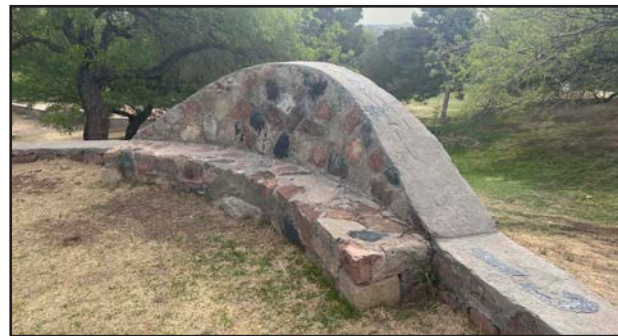
The bench follows the contour of the hilltop walls

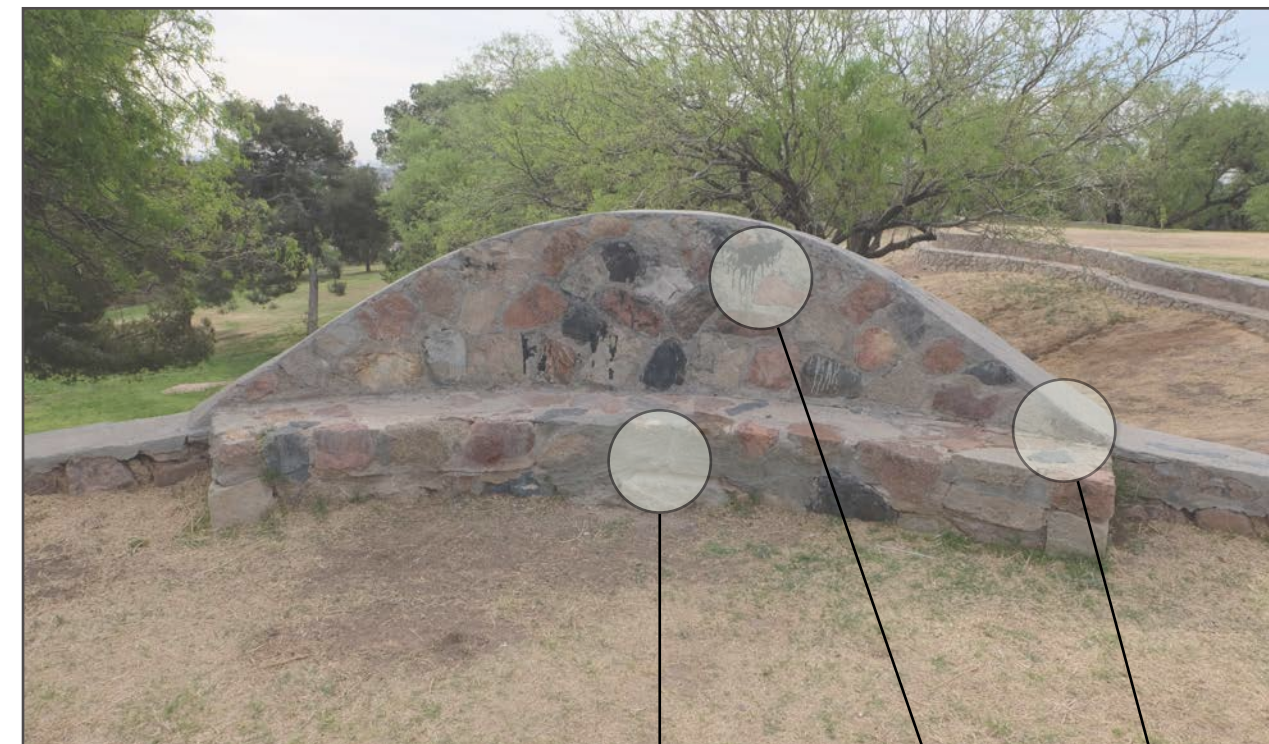
incompatible repair (concrete patch on stone)

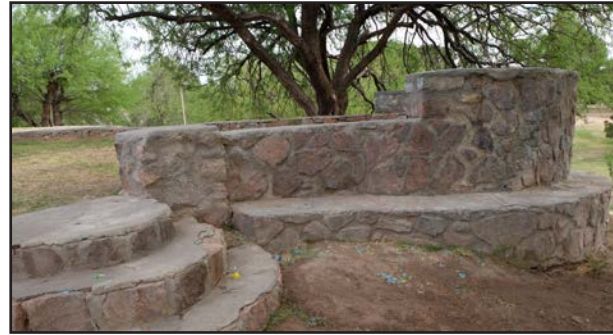
Erosion at rear of bench structure

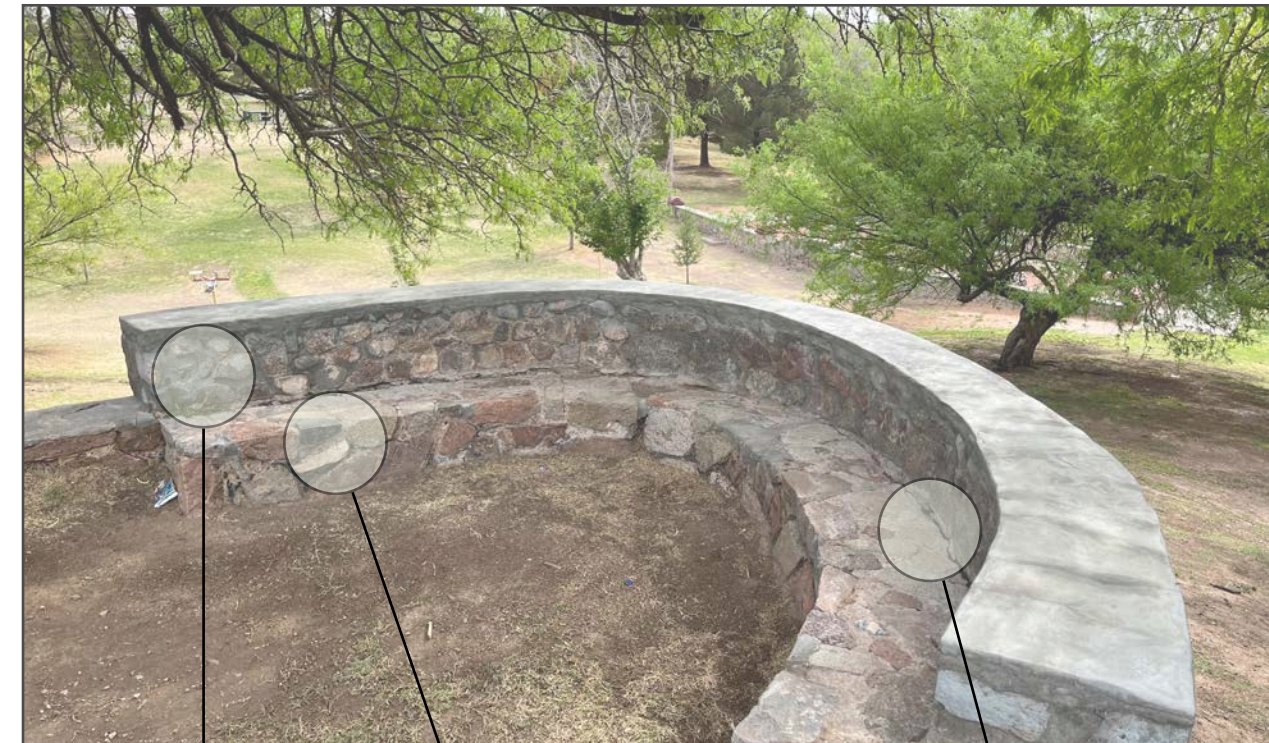
*incompatible repair (concrete patch on stone)*

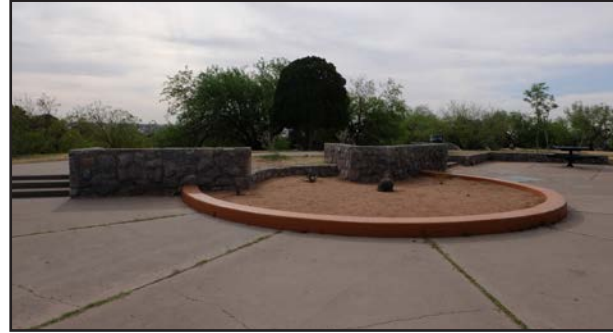
Concrete curbed-garden

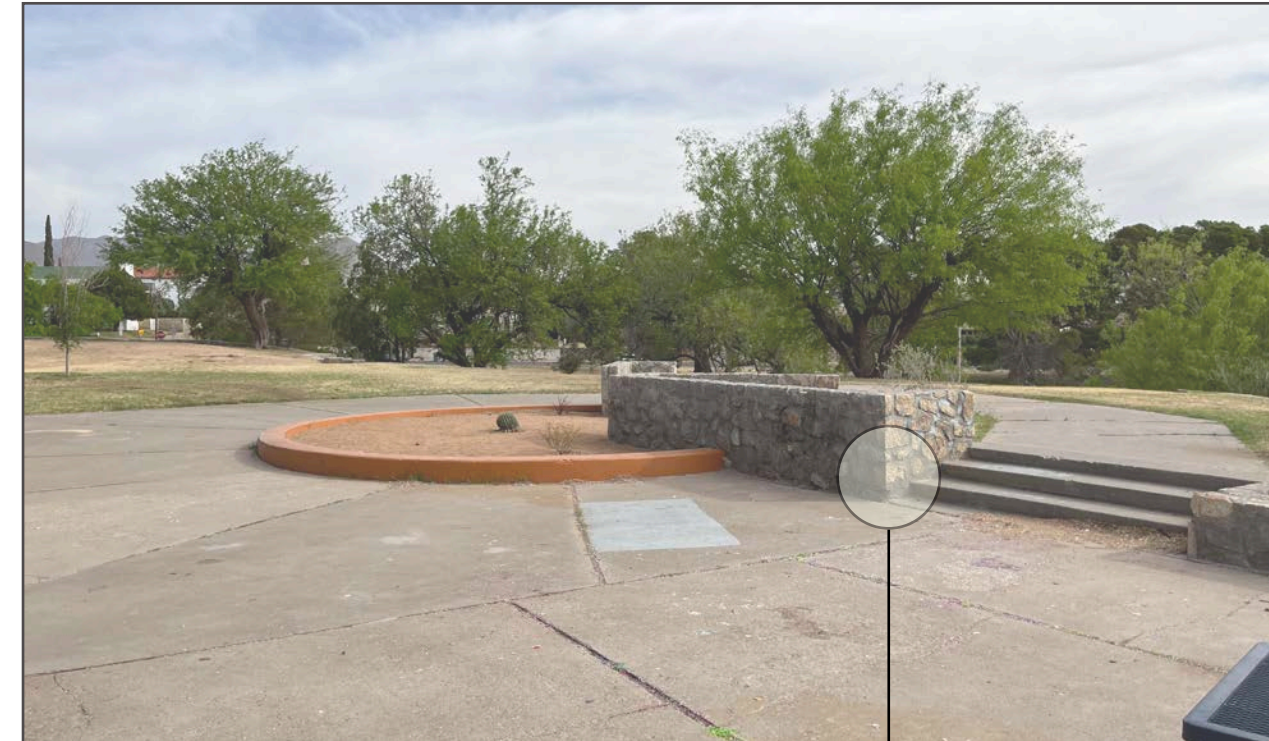
incompatible repair (mortar)

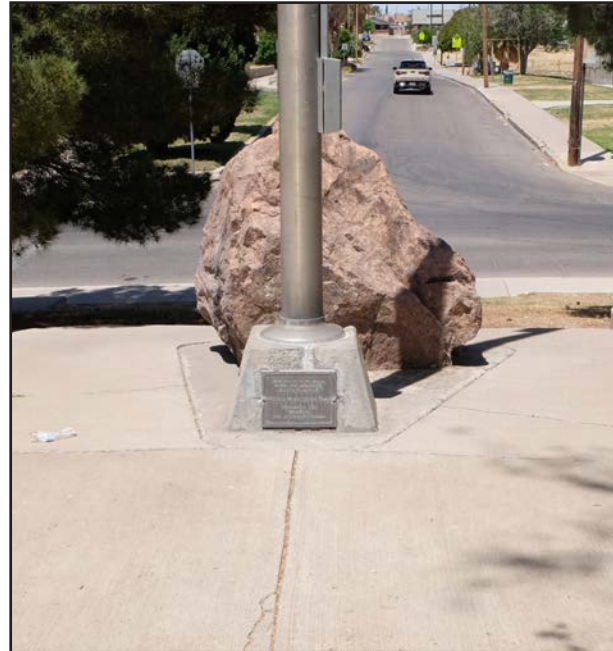
Flagpole with commemorative plaque

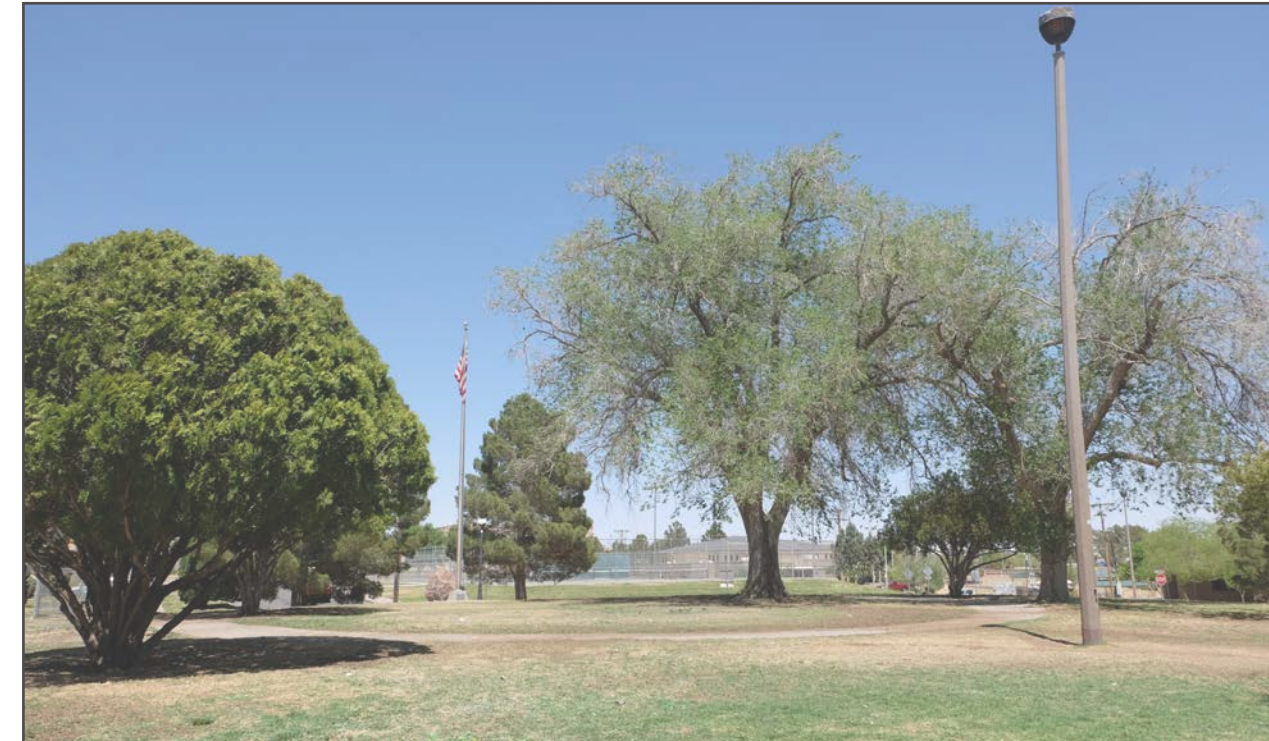
NORTHWEST, SOUTH, & NORTH COPIA STREET MASONRY WALLS (HR8-10)

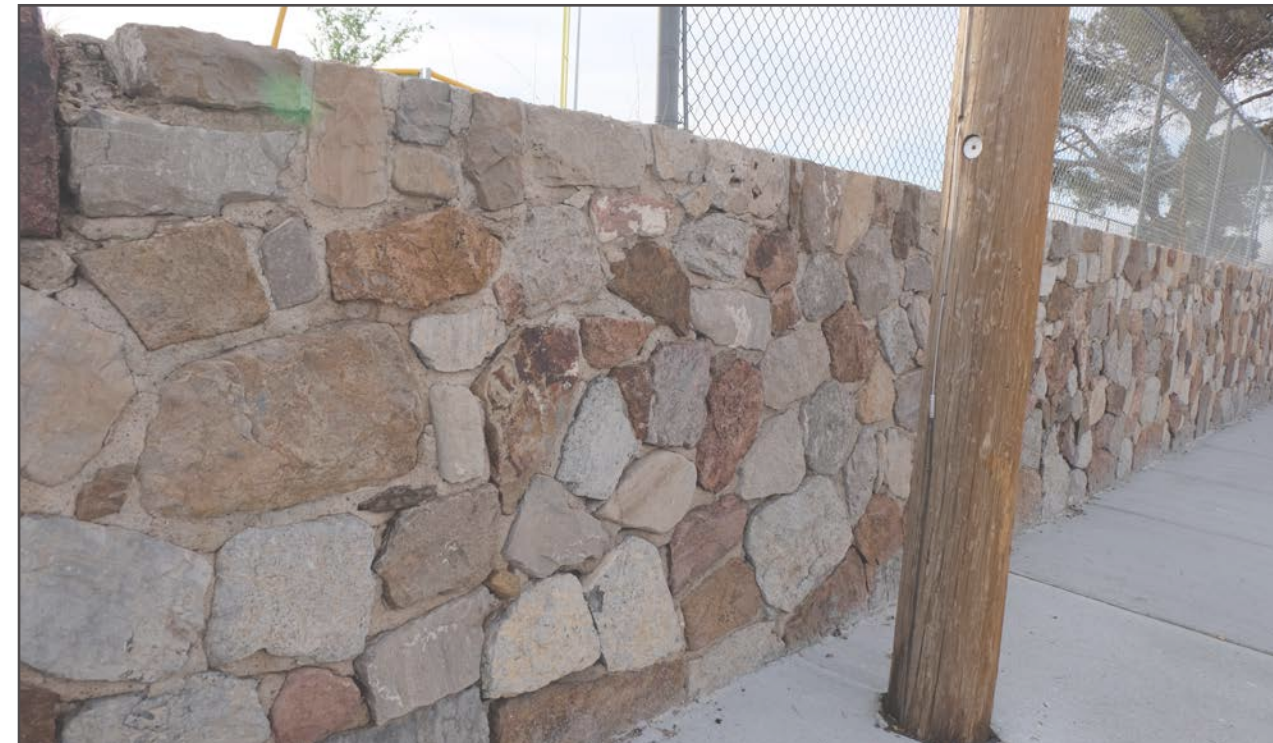
TREATMENT RECOMMENDATIONS

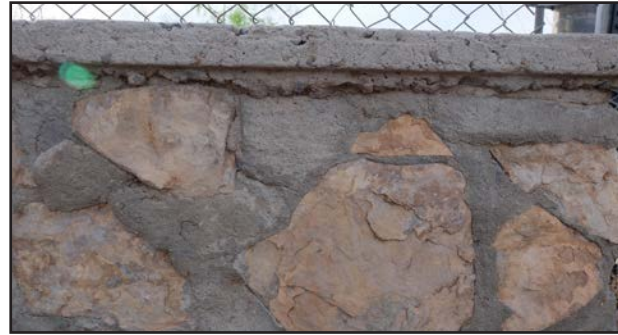
Keystone with "1922" inscription.

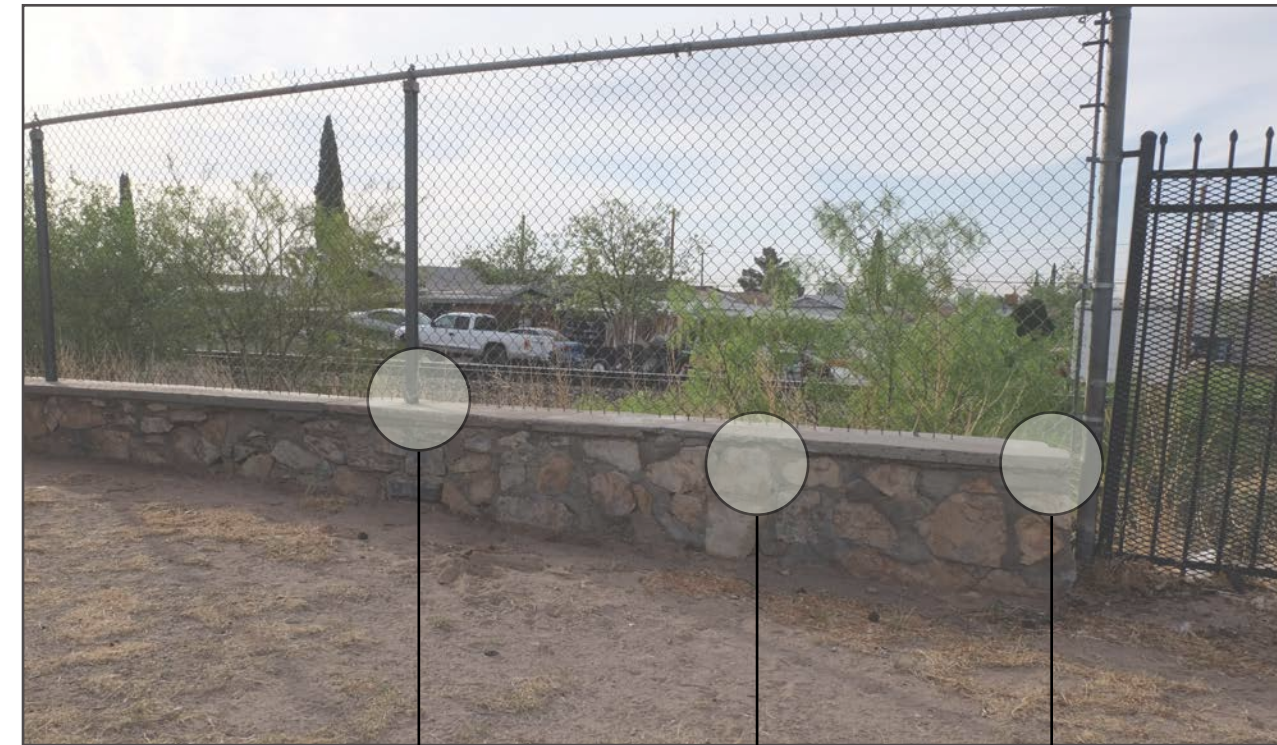
cracks in coping, especially where fence is attached (concrete)

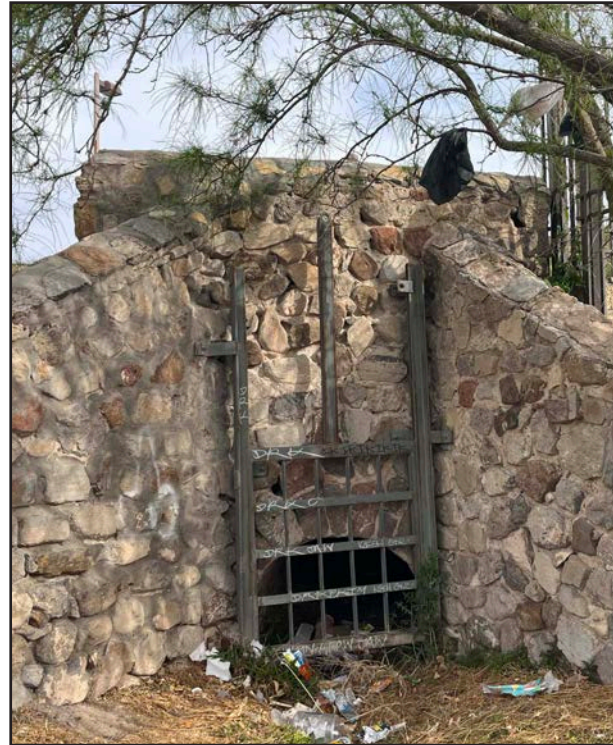
Overall Condition: Fair

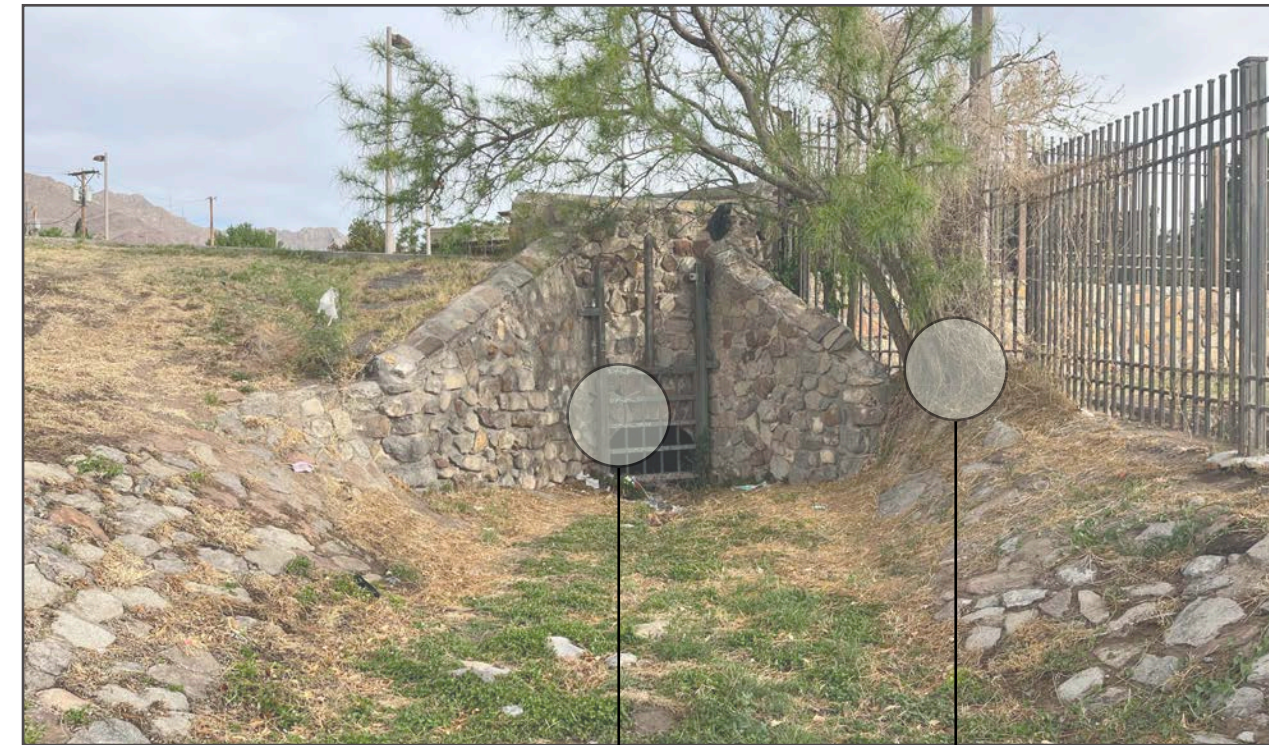
applied graffiti (metal)

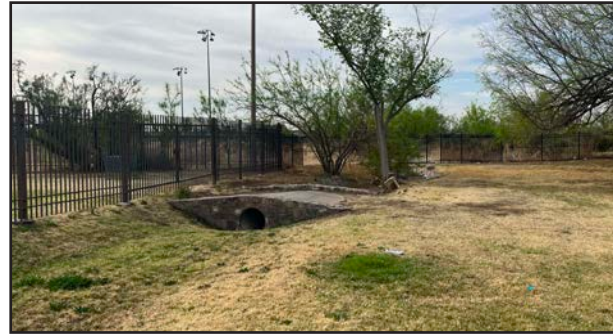
Overall Condition: Fair

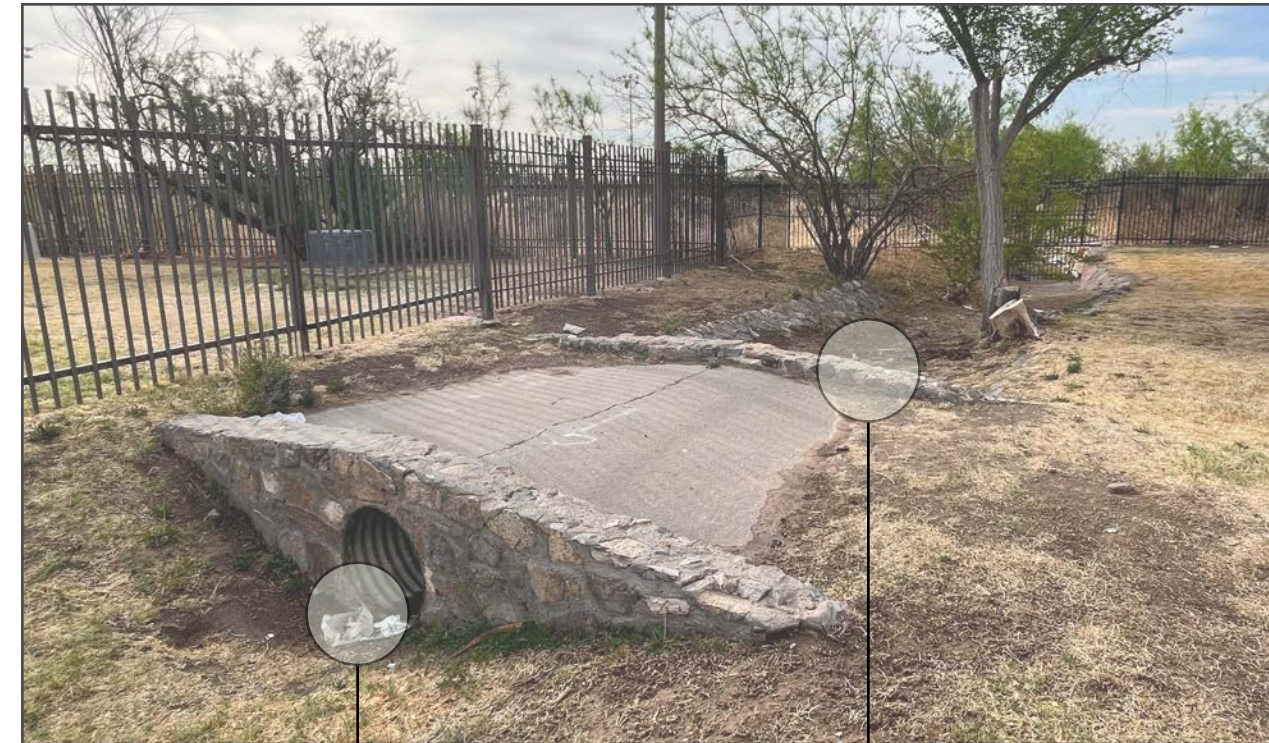
- Vegetation adjacent to historic masonry should be maintained. It can cause conditions of excess moisture, attract insects or vermin, and grow into the masonry walls causing destabilization and damage.

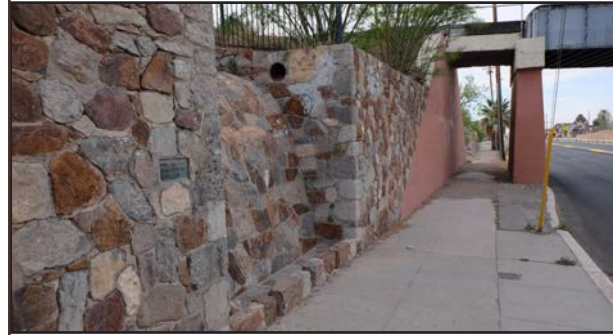
Drainage feature at North Copia Street and the railroad tracks

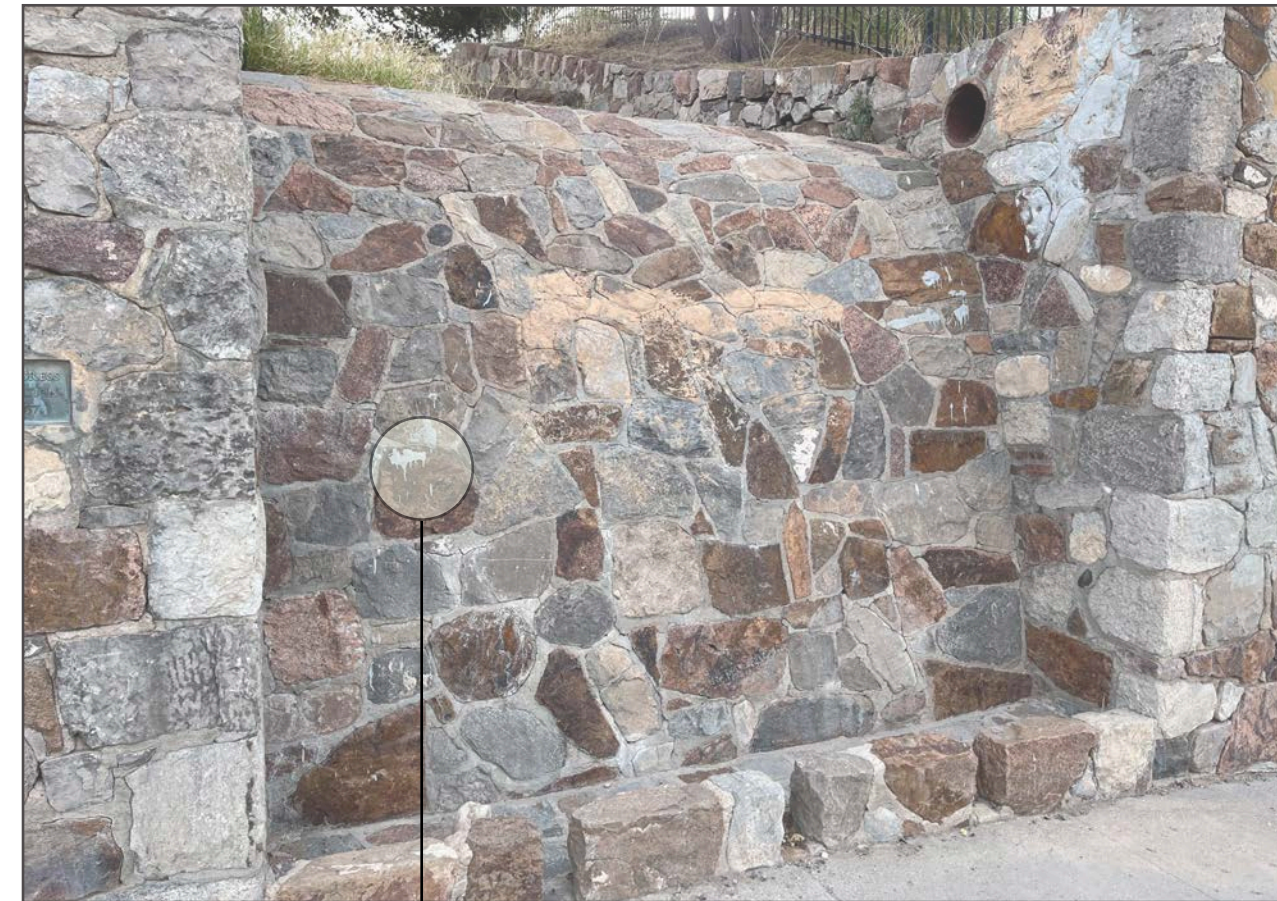
applied paint (masonry)

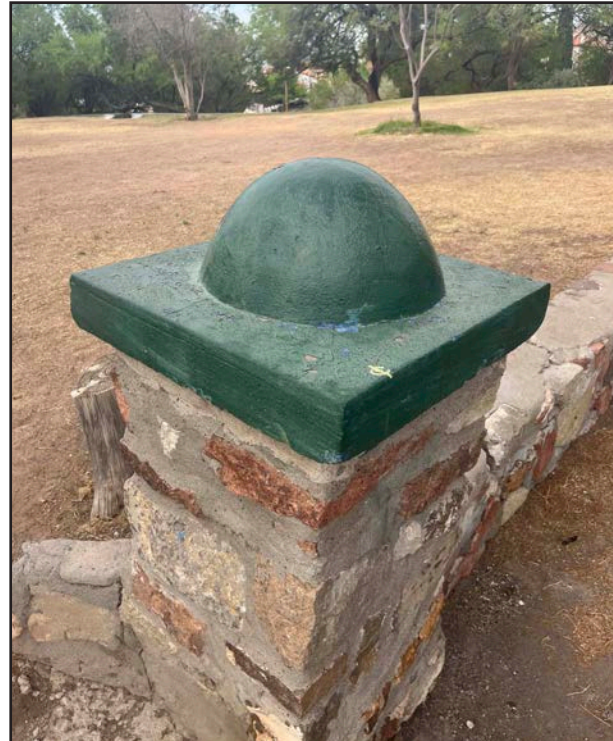
Overall Condition: Fair

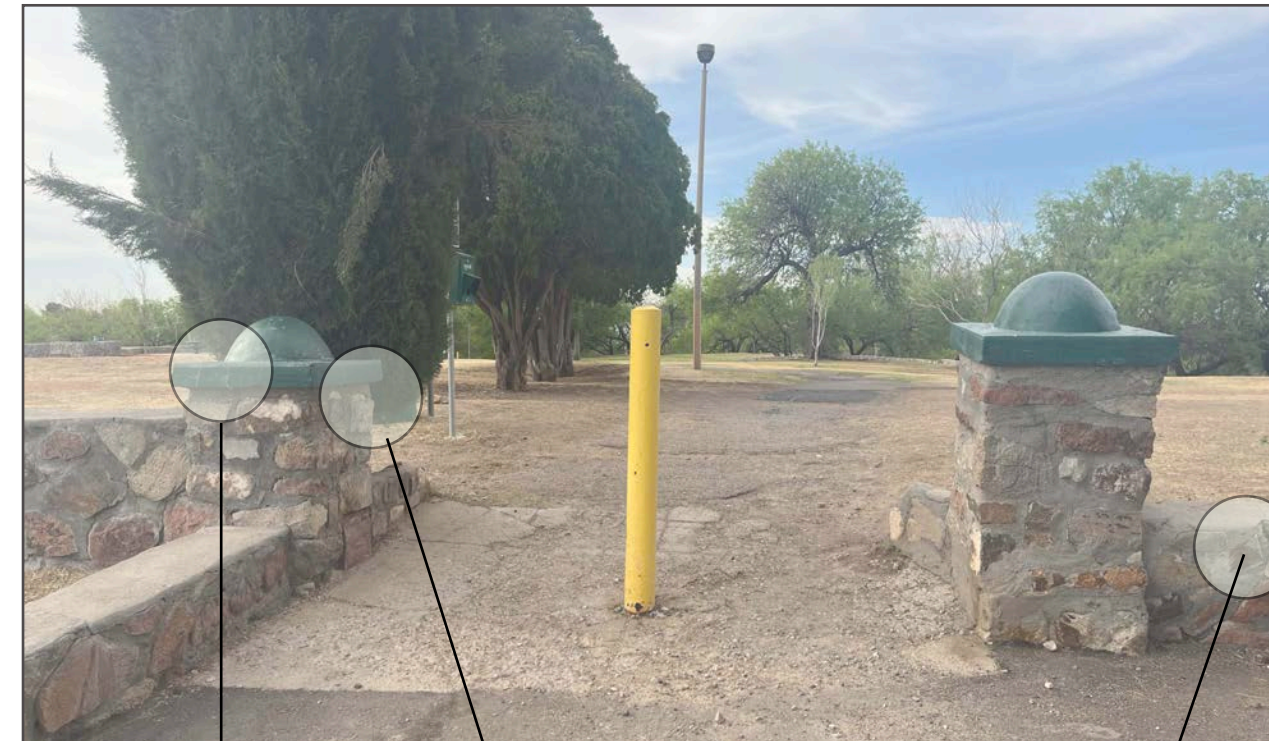
failing paint coating (concrete)

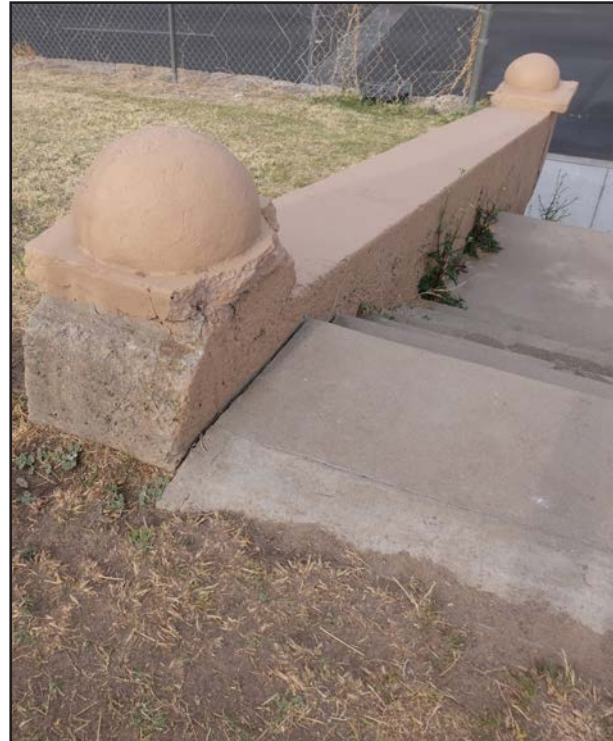
Overall Condition: Poor

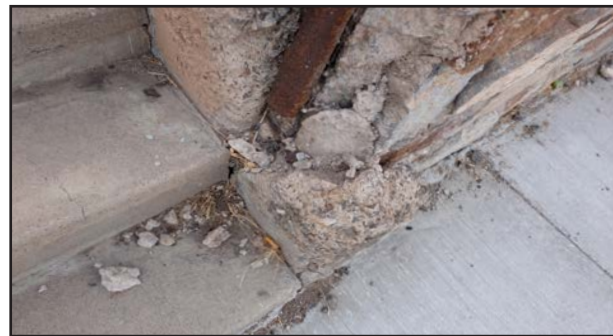
Typical interior structural failure

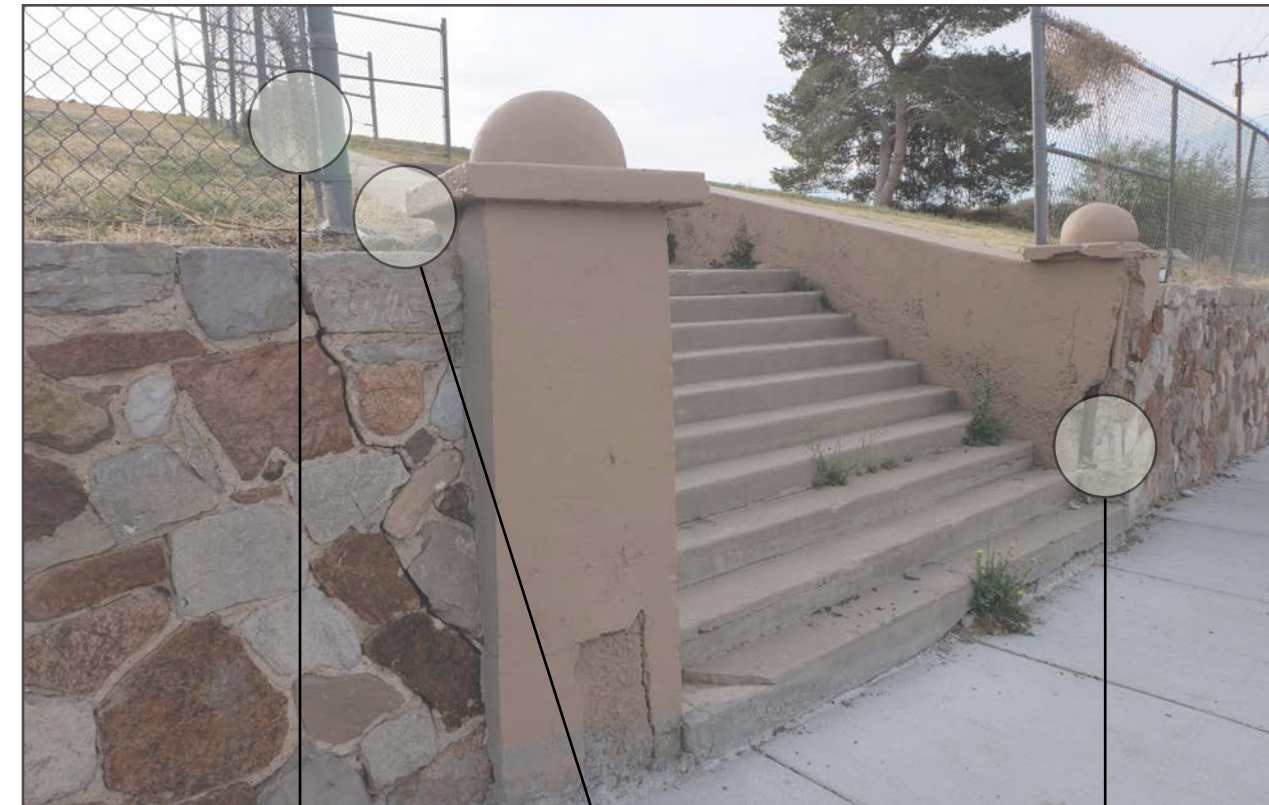
spalling due to corroded rebar

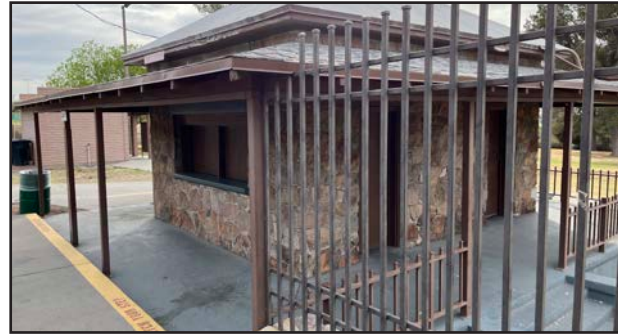
CONCESSION BUILDING (HR17)

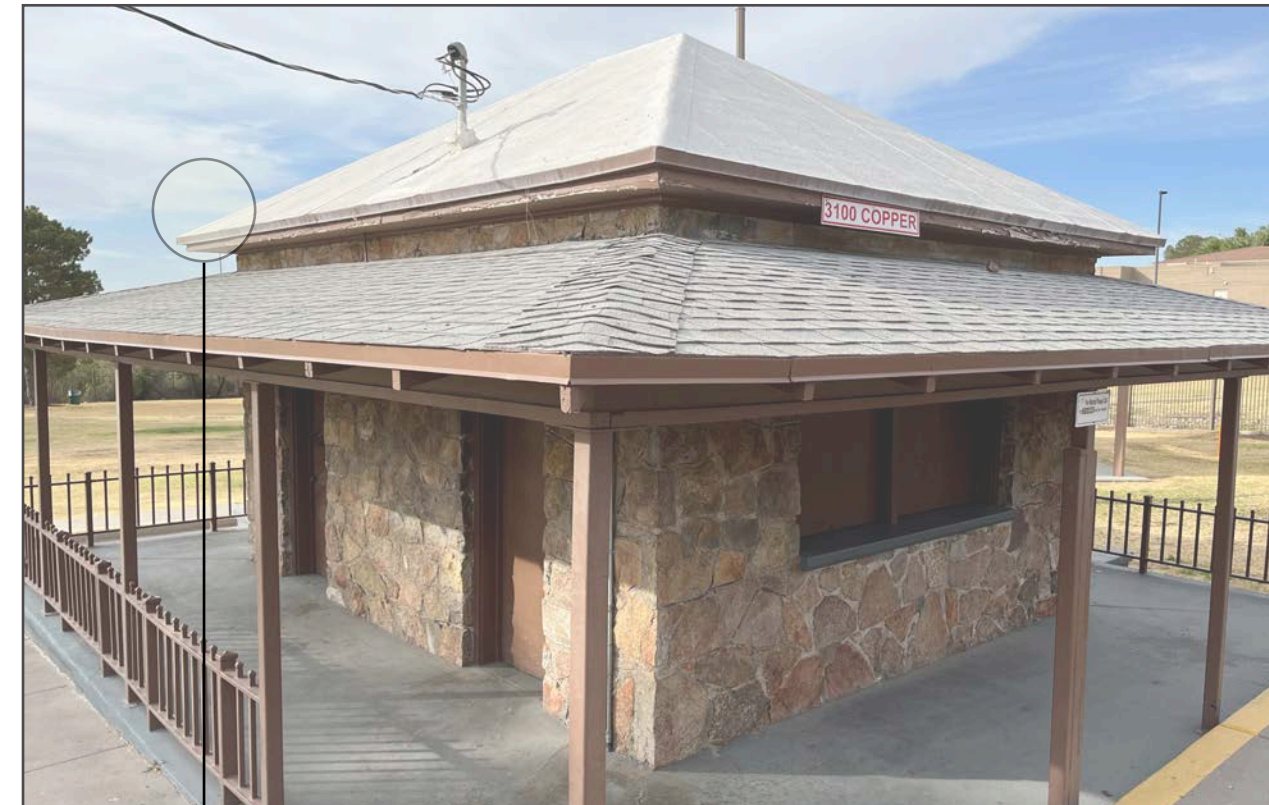
CONCESSION BUILDING (HR17)

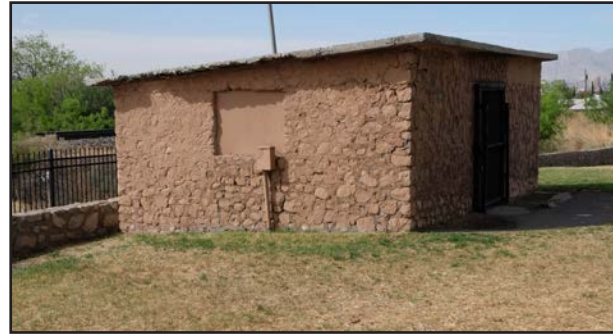
Accessory building exterior with enclosed window

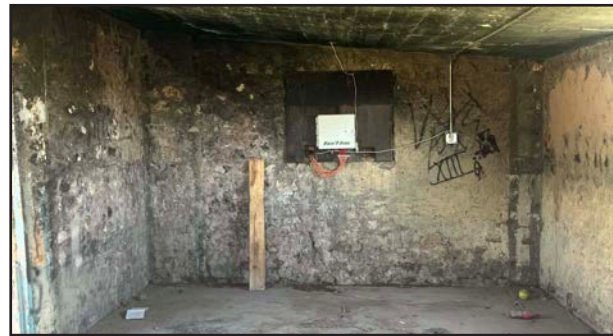
Accessory building interior with applied graffiti and deterioration

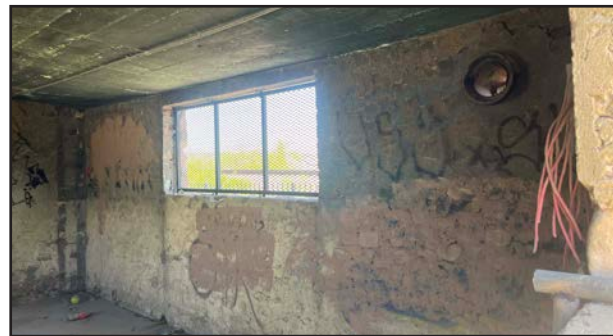
Accessory building interior with applied graffiti and deterioration

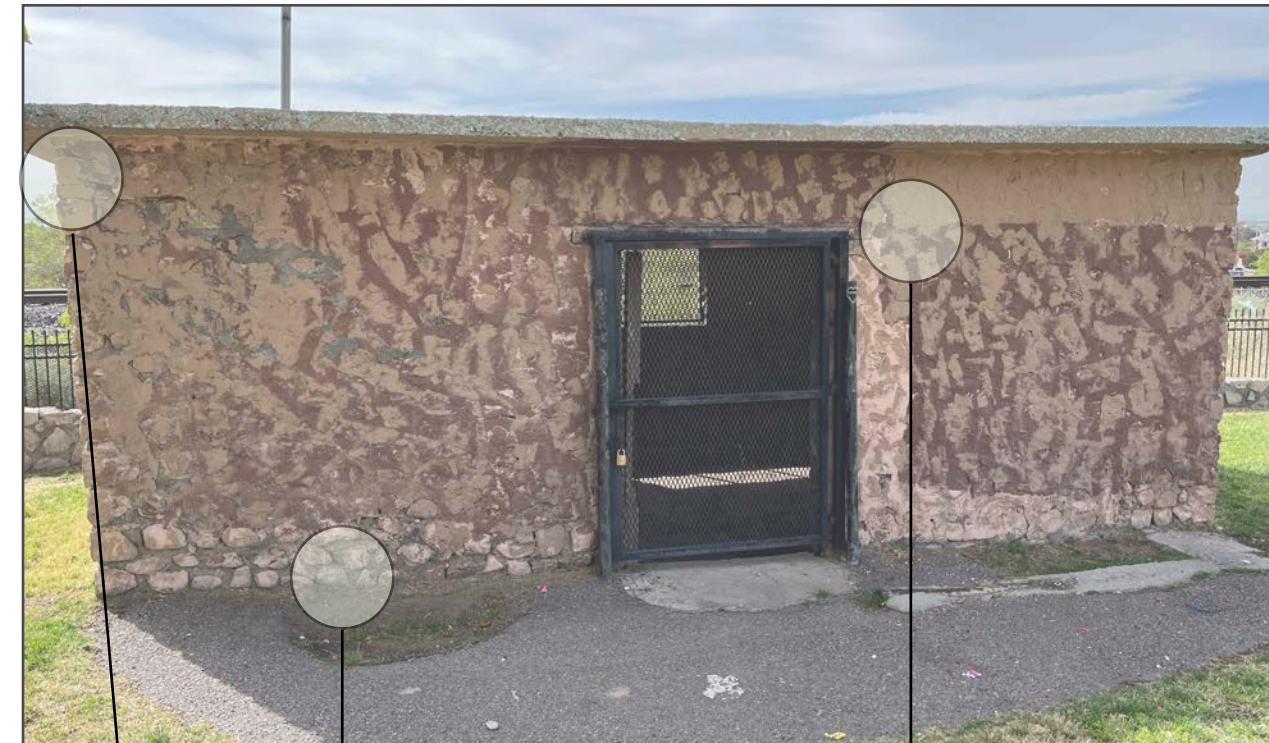
corrosion (structural metal)

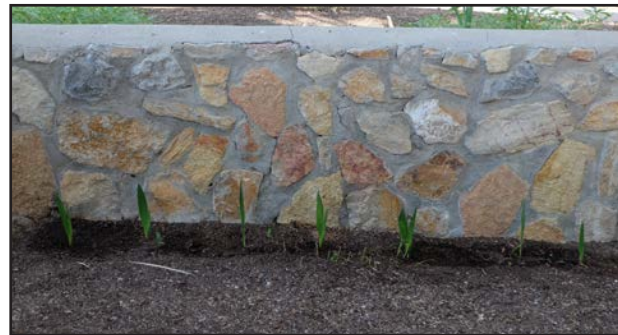
The interior rose garden walls are in good condition with some cracks in the concrete coping.

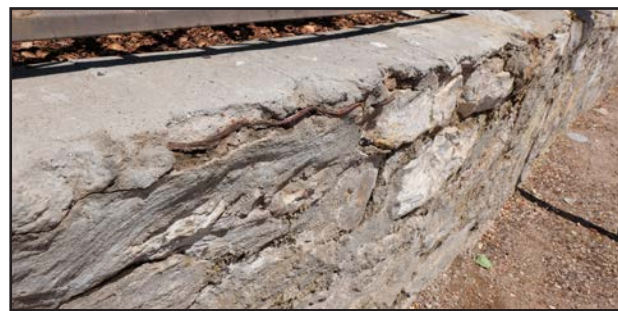
Typical mortar and masonry

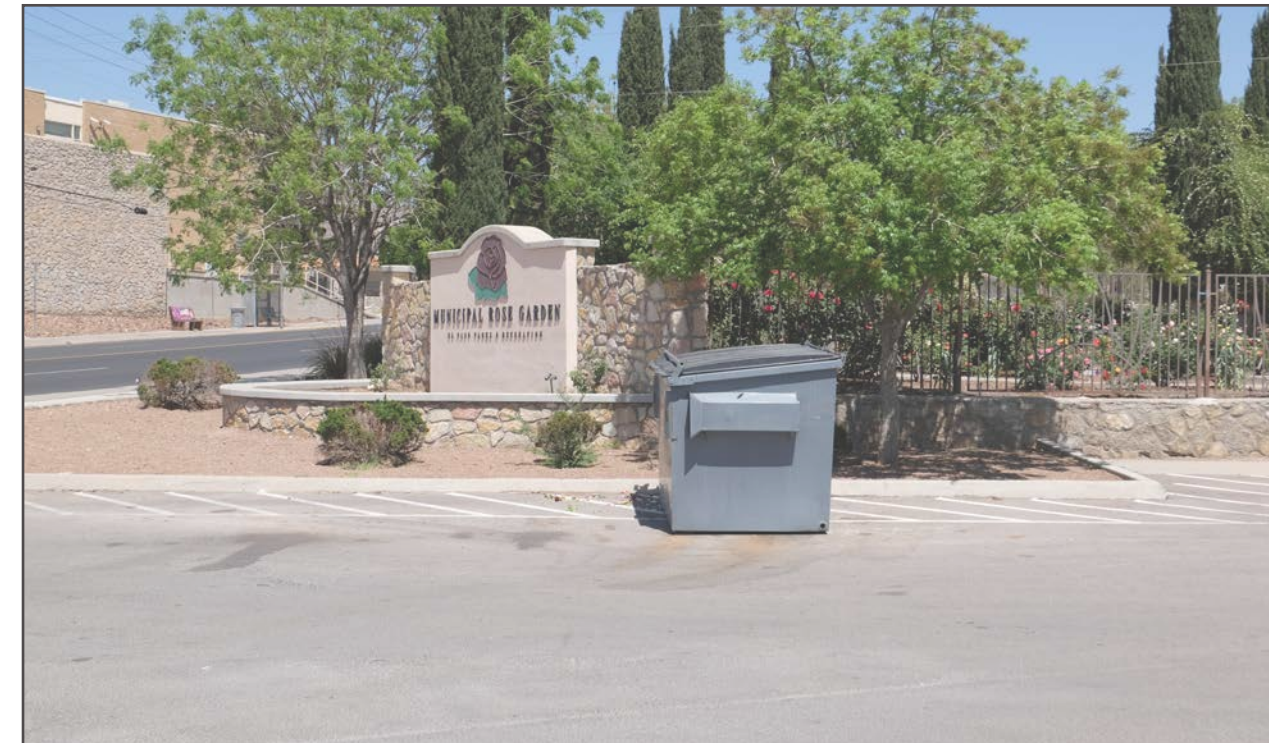
TREATMENT RECOMMENDATIONS

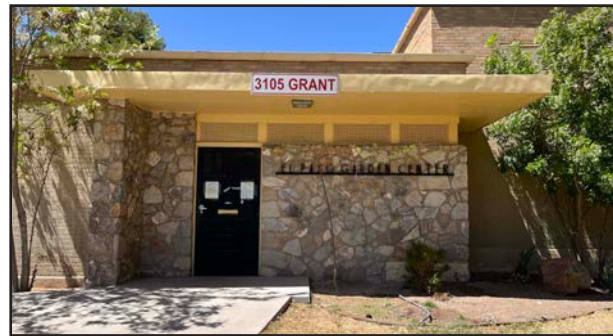
Garden Center entrance

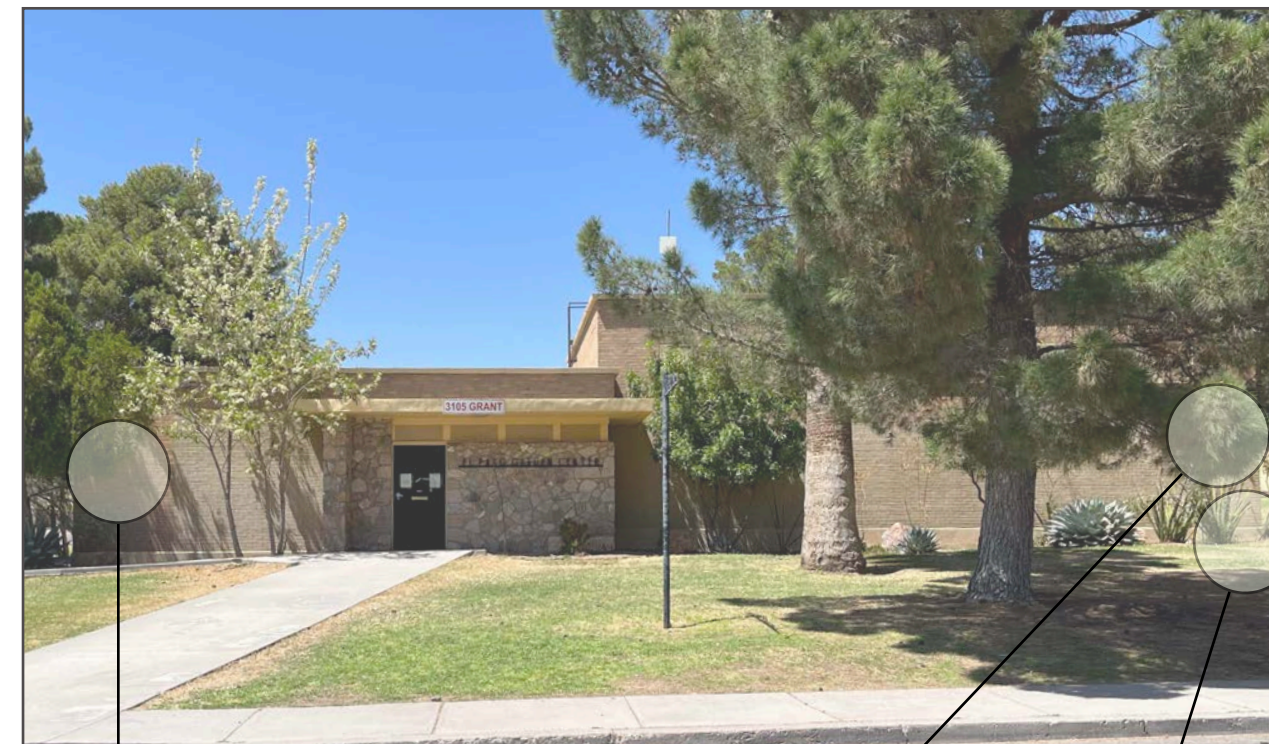
corrosion staining and peeling paint (concrete)

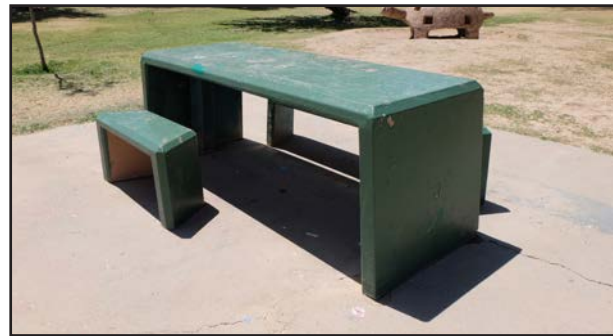
PICNIC TABLES (HR21)

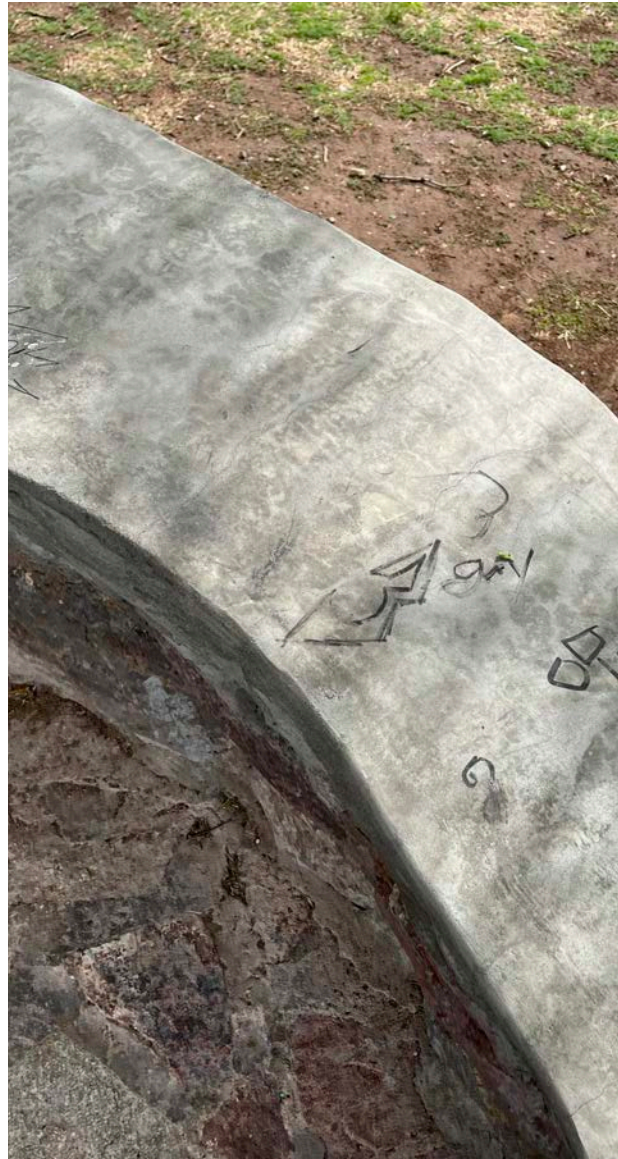
ILLUSTRATED GLOSSARY
