# Historic Resources of Memorial Park

CITY OF EL PASO

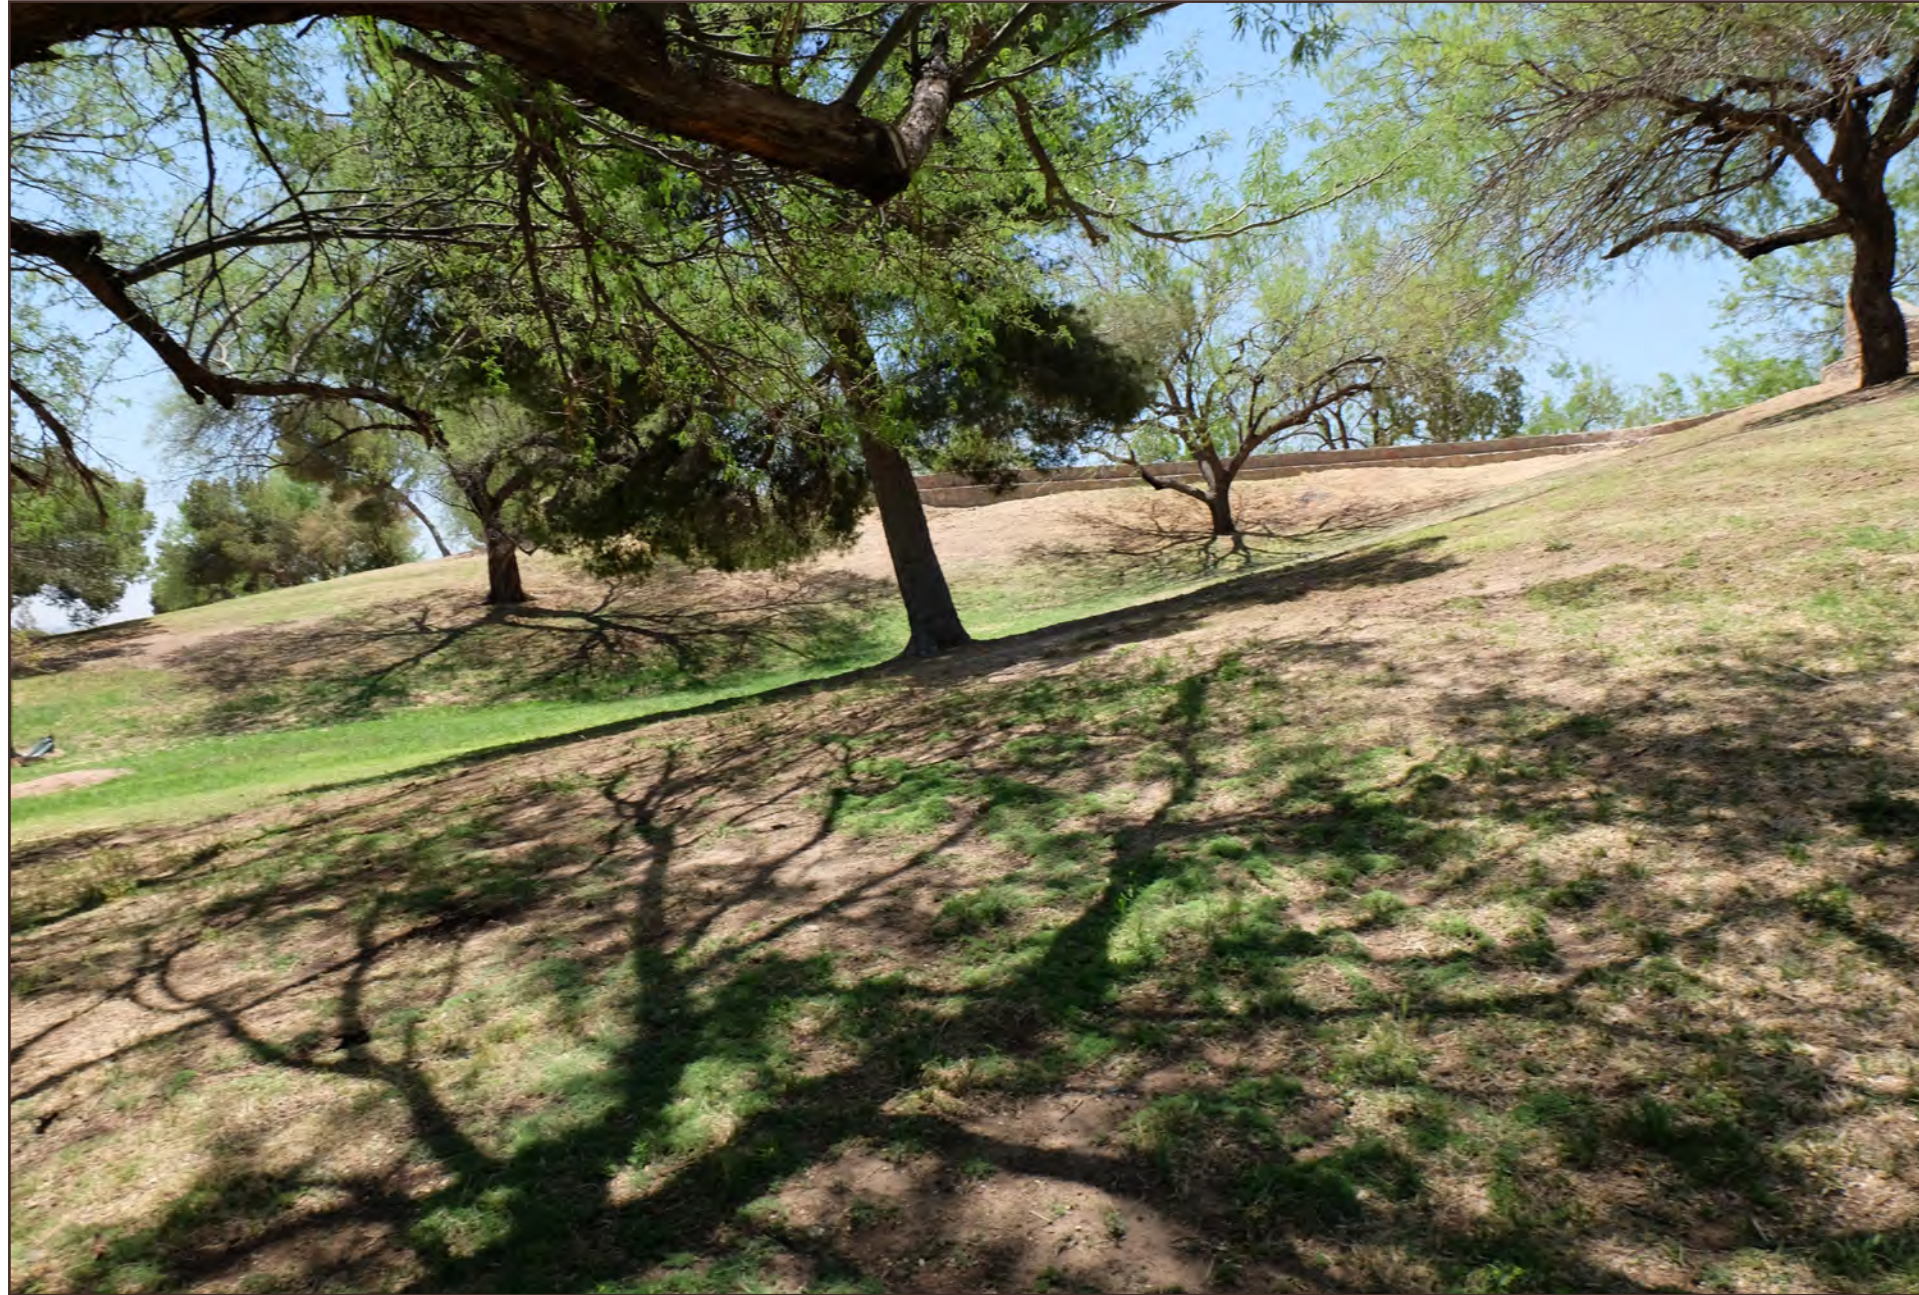
Memorial Park, south of the historic Manhattan Heights neighborhood in El Paso, Texas, is a neighborhood park with features dating from the 1920s to present. Remnants of park development campaigns are visible in a 1920s bridge, masonry walls constructed by the Works Progress Administration during the 1930s and 1940s, and mid-century features like the rose garden and garden center building. A rolling, hilly topography characterizes the site and is a relic of a historic industrial operation that took place at the site during the early twentieth century.

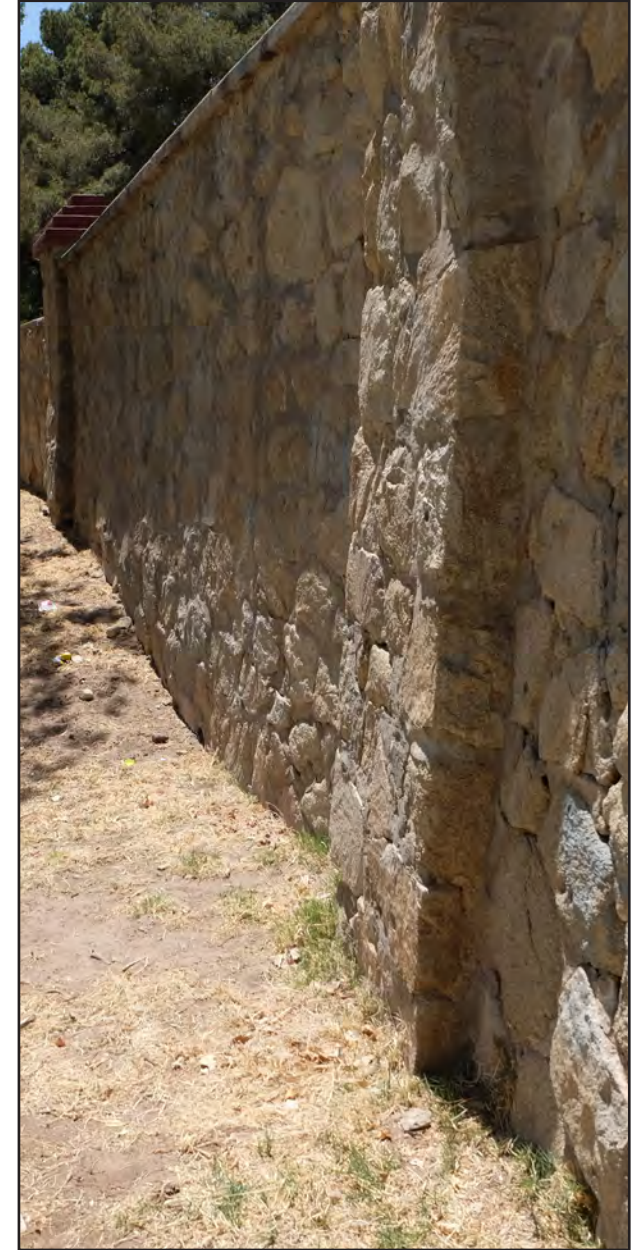
Masonry Walls at the Estrella Street Bridge

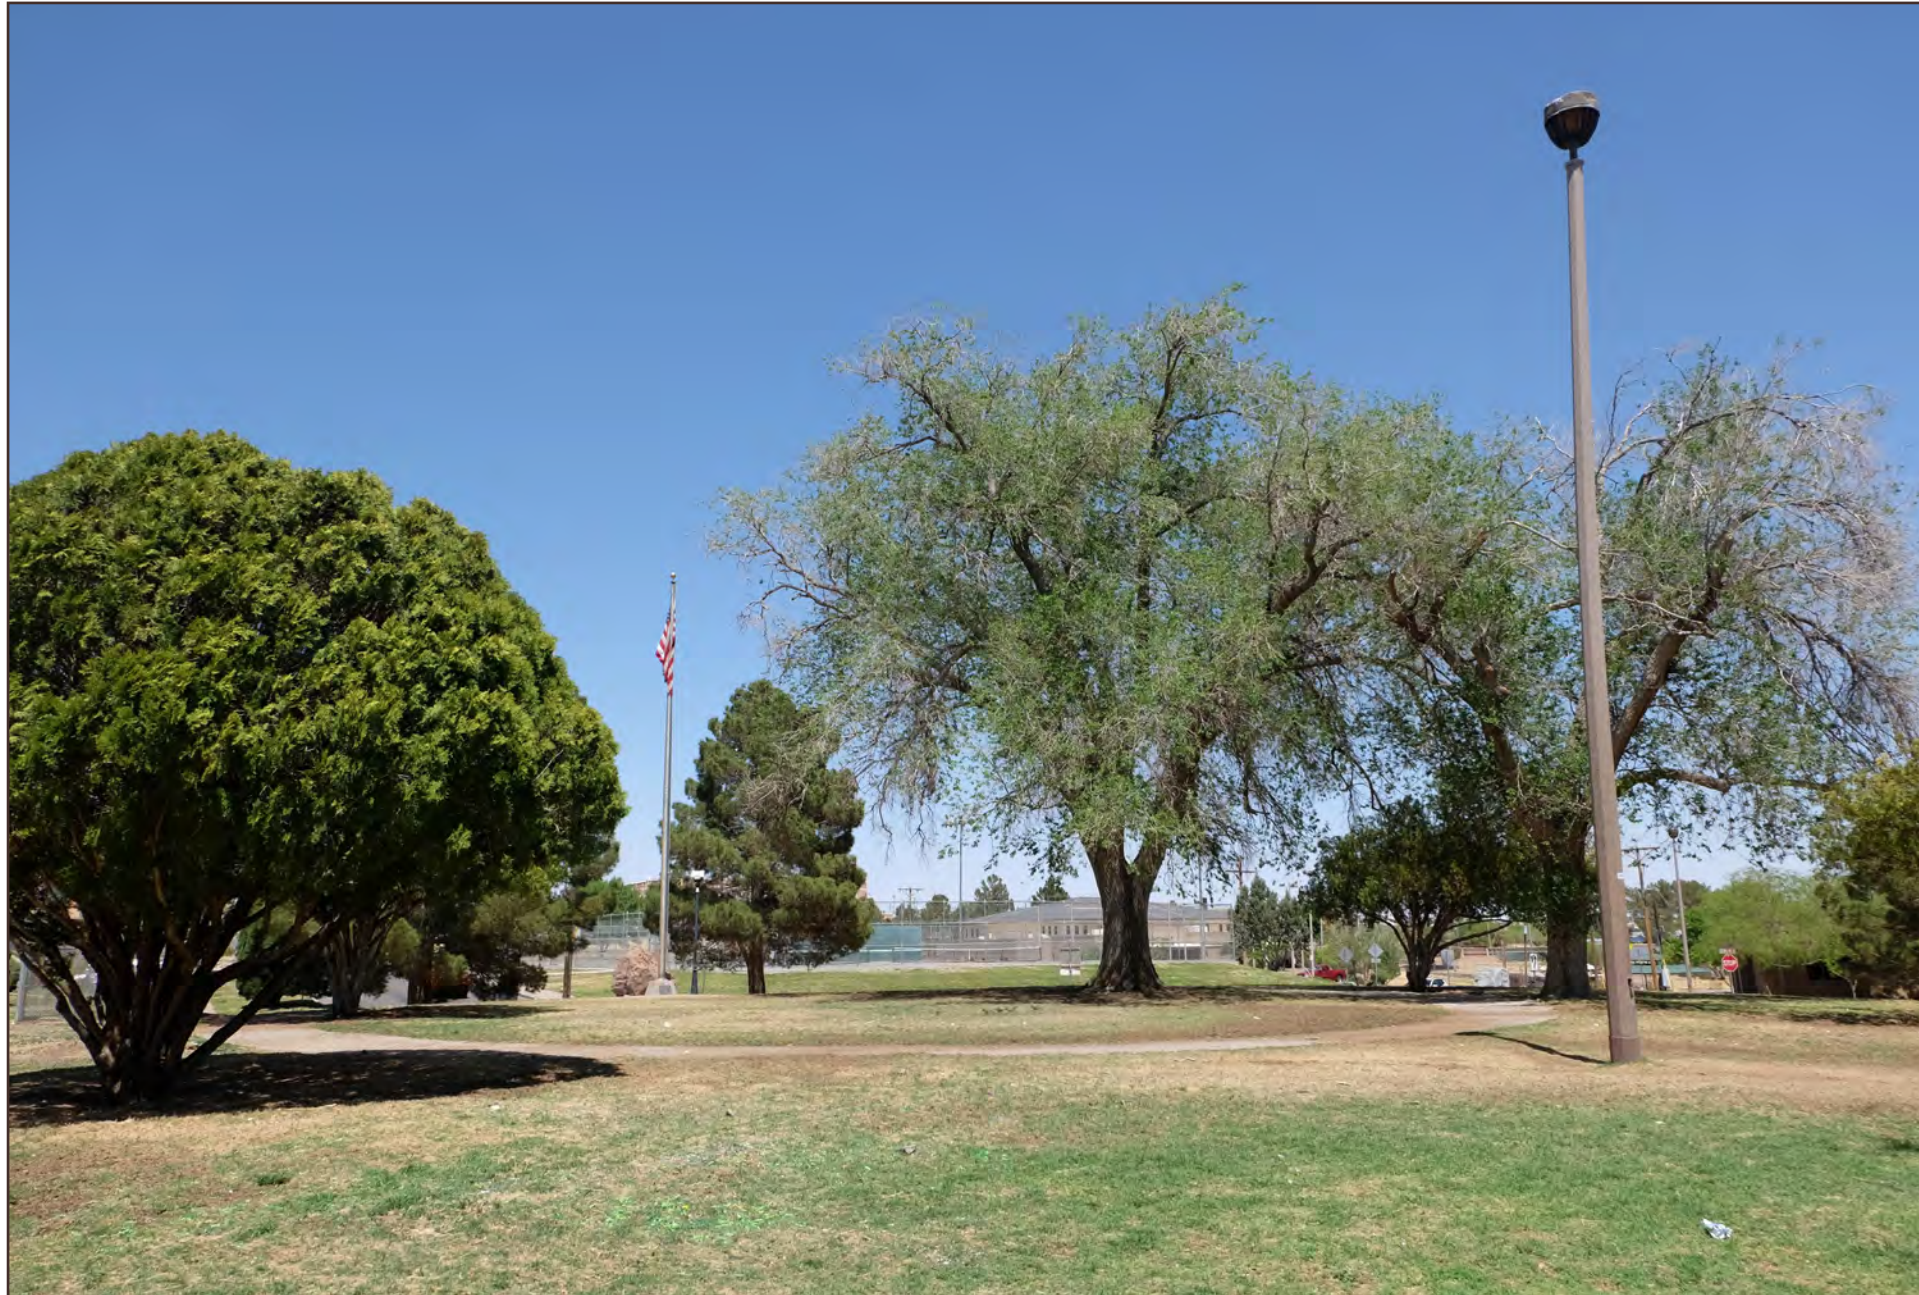
**CHAPTER 1: HISTORIC CONTEXT AND INTEGRITY ..... 7**

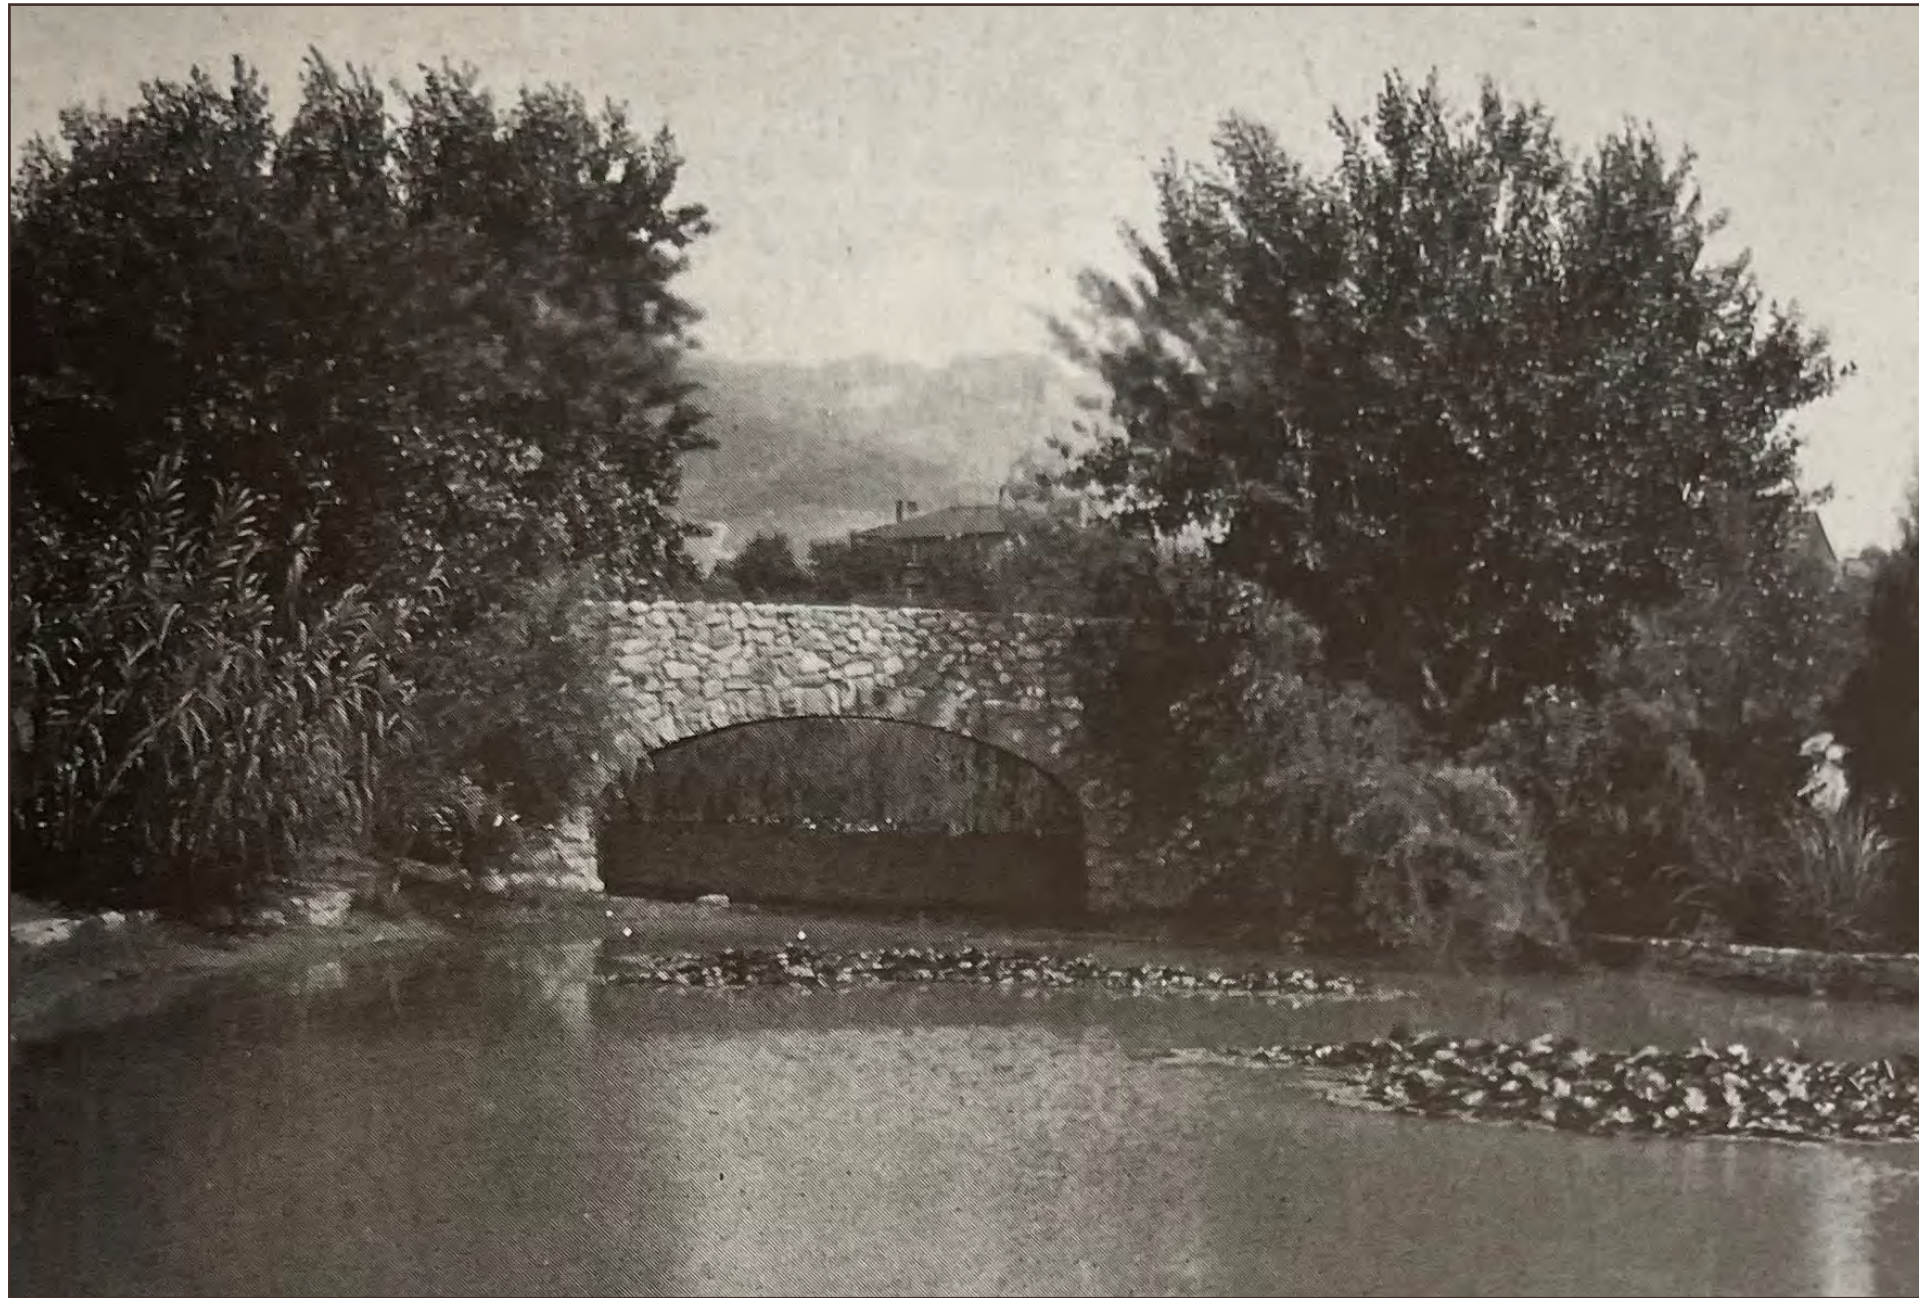
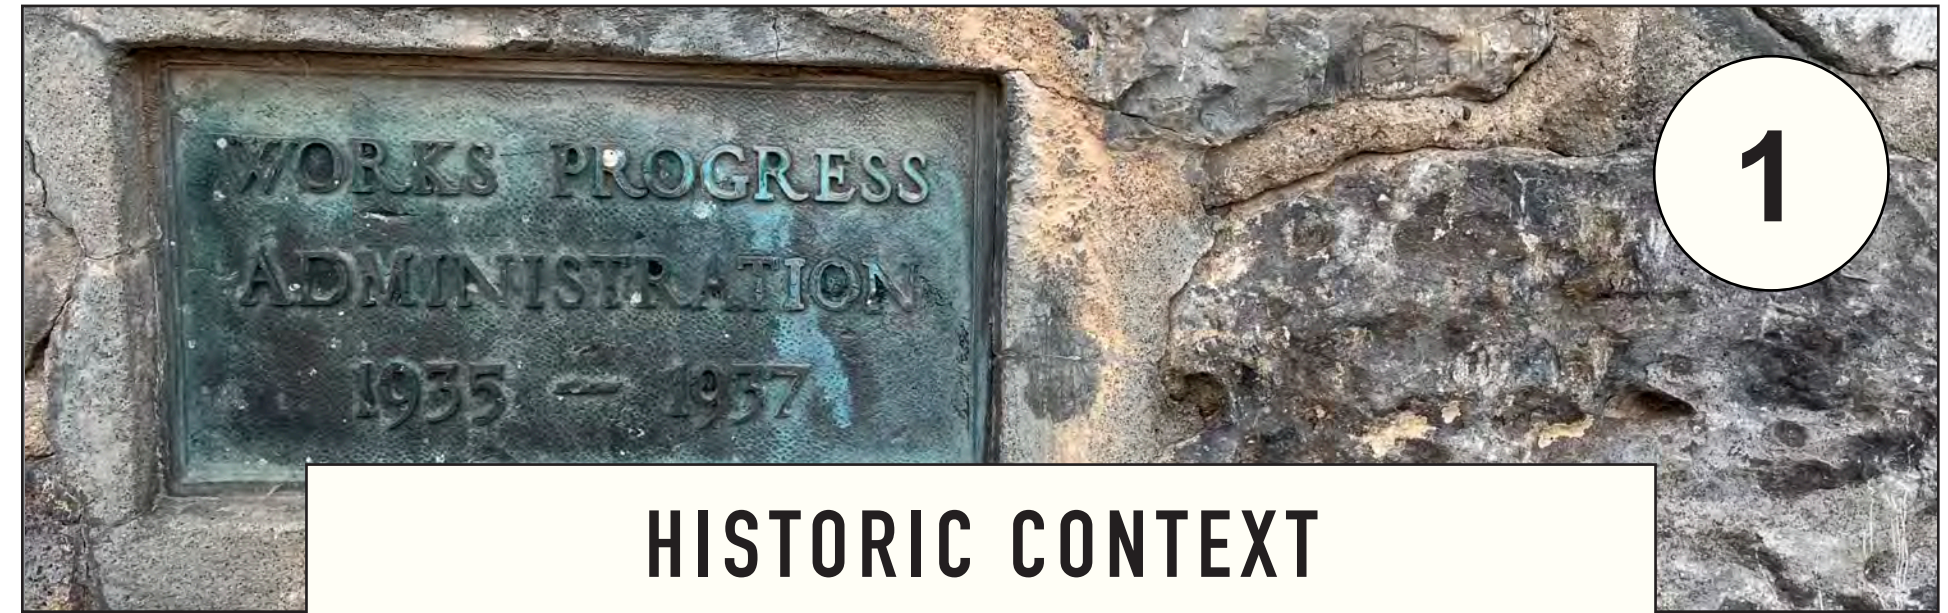
## HISTORIC CONTEXT AND INTEGRITY

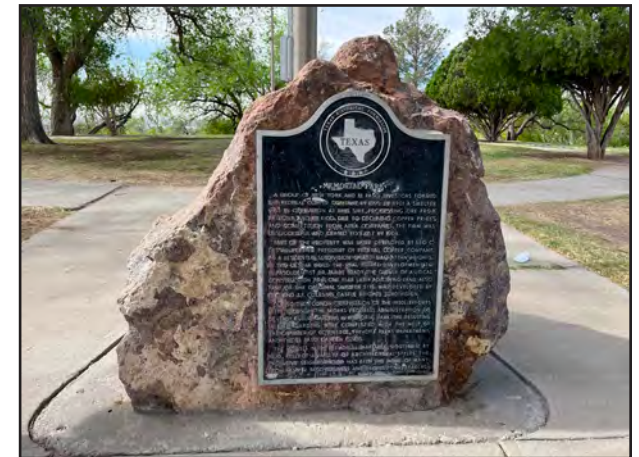
Chapter 1: Historic Context and Integrity provides a history of Memorial Park within the context of El Paso, a timeline of major events relating to the park's development, an explanation of historic evaluation methodology, recommended areas and periods of significance, character-defining features of the park, and a discussion of historic integrity. Integrity for this chapter was assessed based on seven criteria defined by the National Park Service for evaluating historic resources.

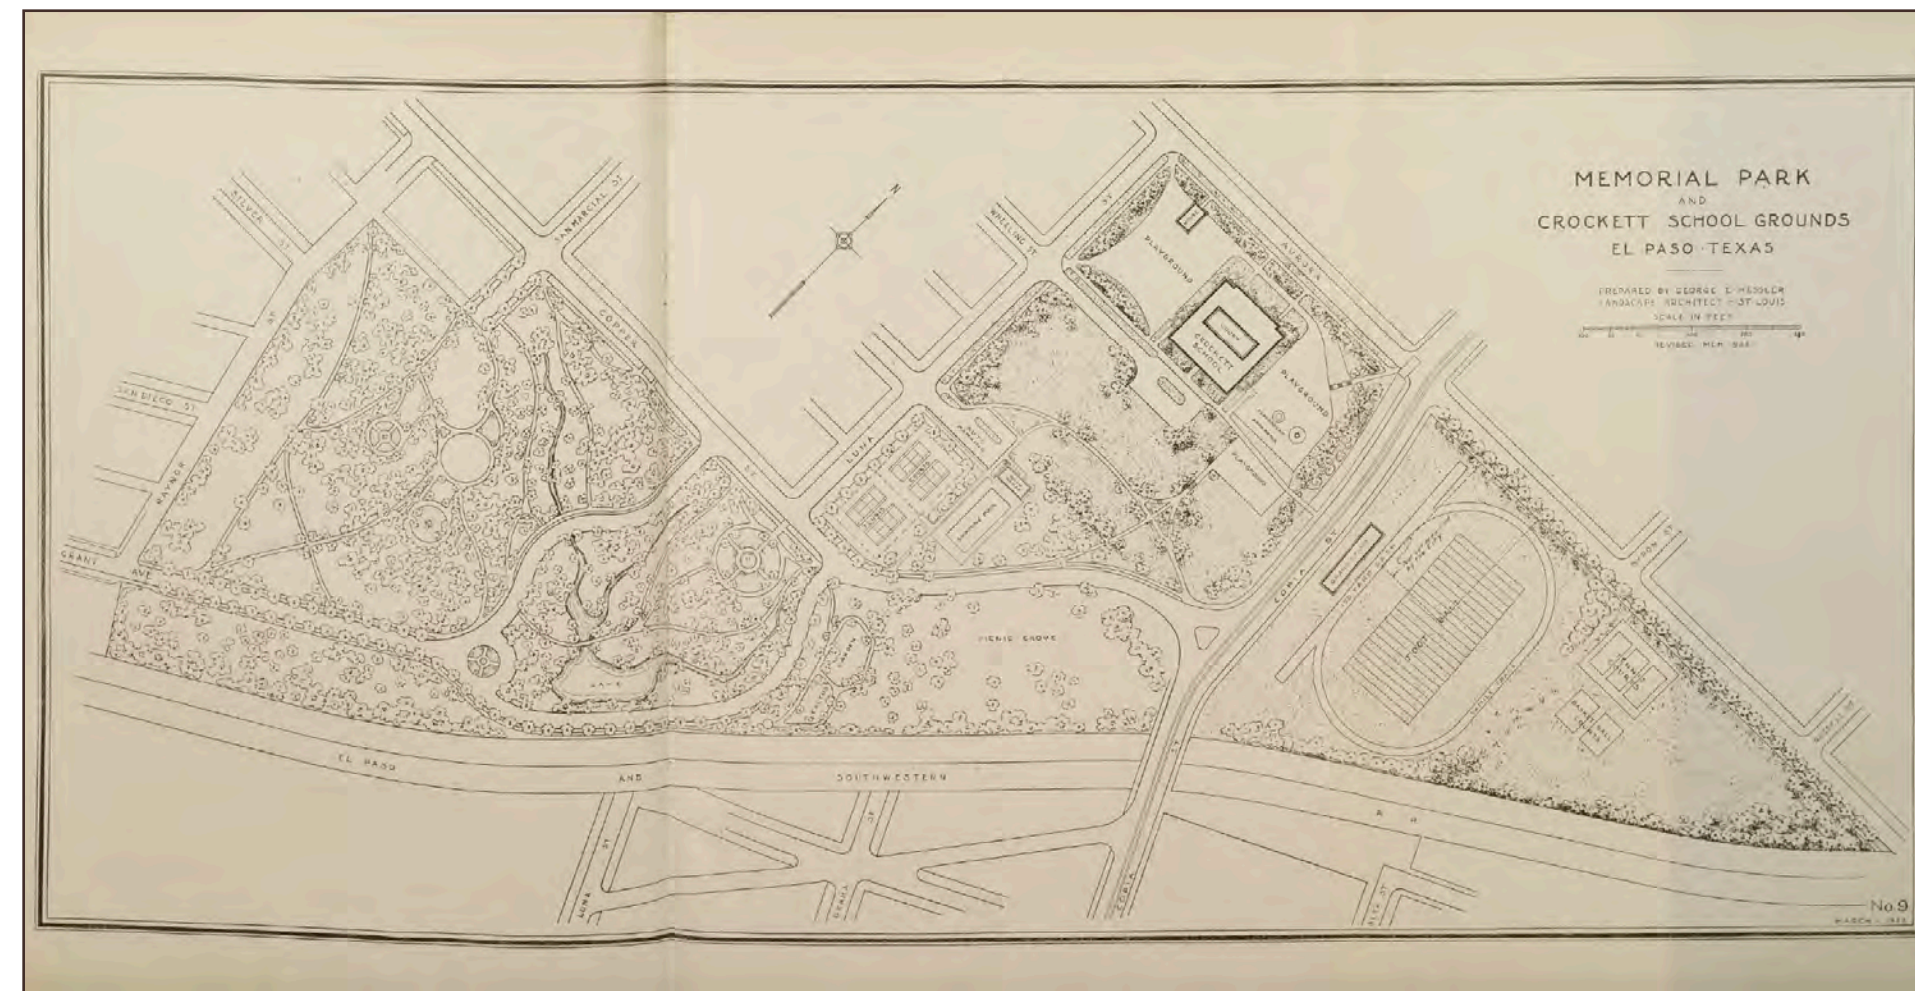
Memorial Park Map from the 1925 City Plan for El Paso Texas. It is likely that some of the features on this plan were realized prior to 1925. For example, the south bridge (HR1) has the date "1922" engraved in the stone, suggesting that it pre-dates City Plan publication.

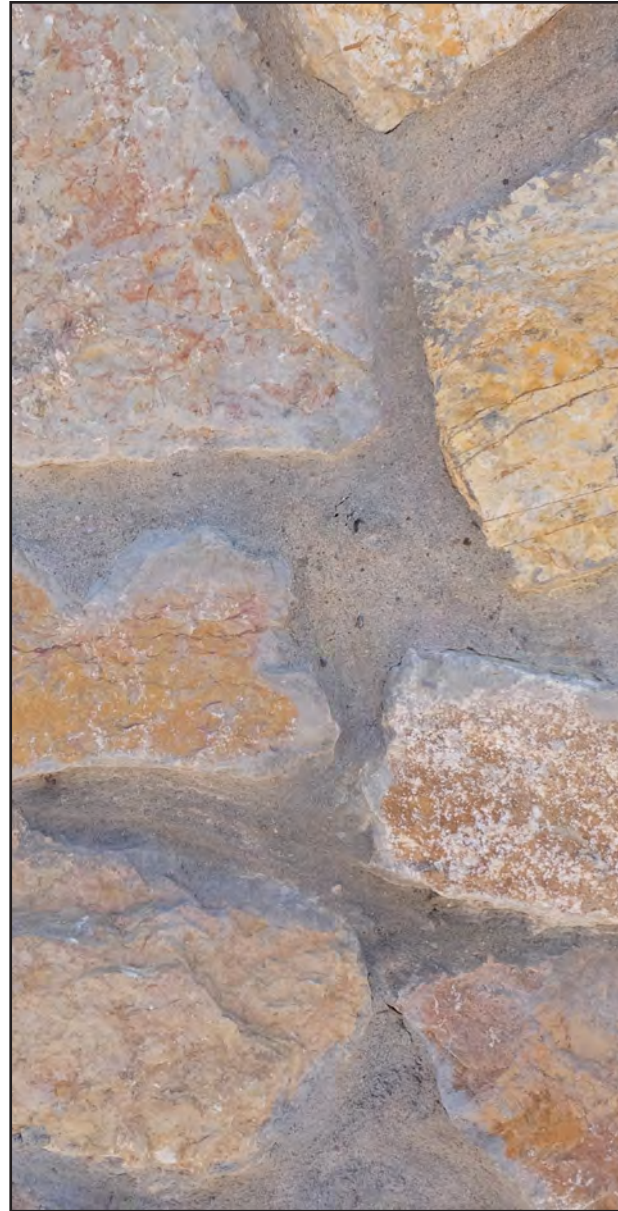
MEMORIAL PARK HISTORY AND DEVELOPMENT

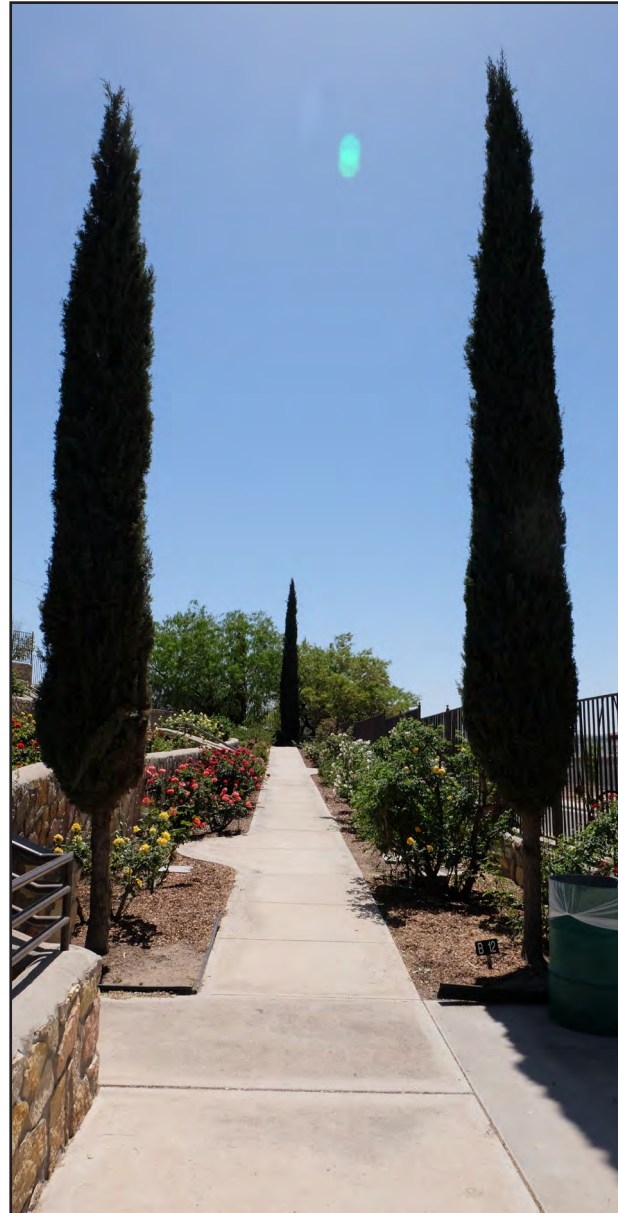
HISTORIC EVALUATION METHODOLOGY

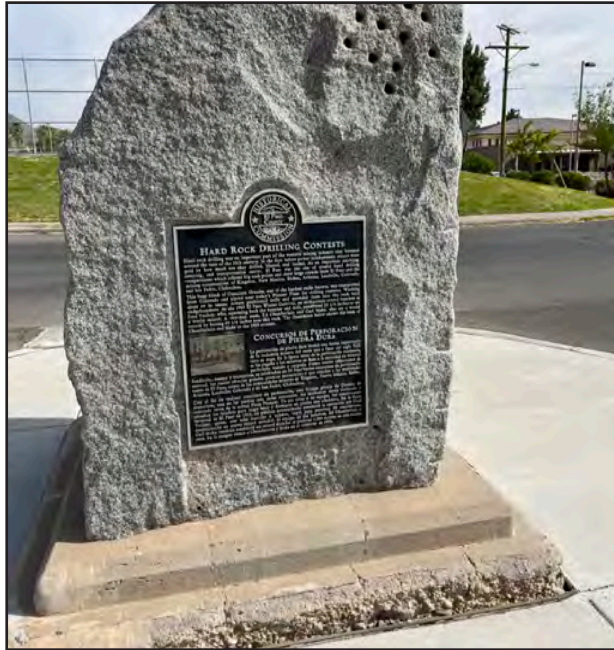
El Paso Historical Commission Marker for the Hard Rock Drilling Contest

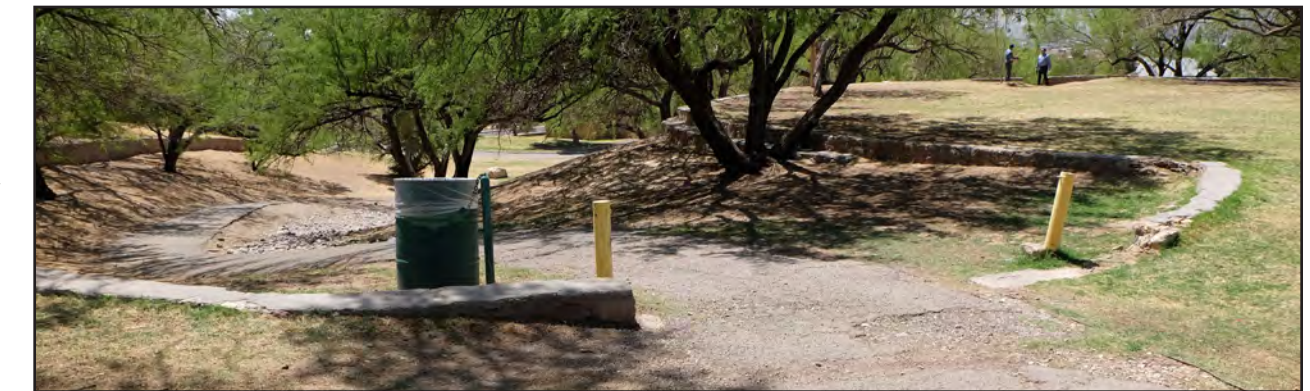
Memorial Park's hilly topography is one of its character-defining features.

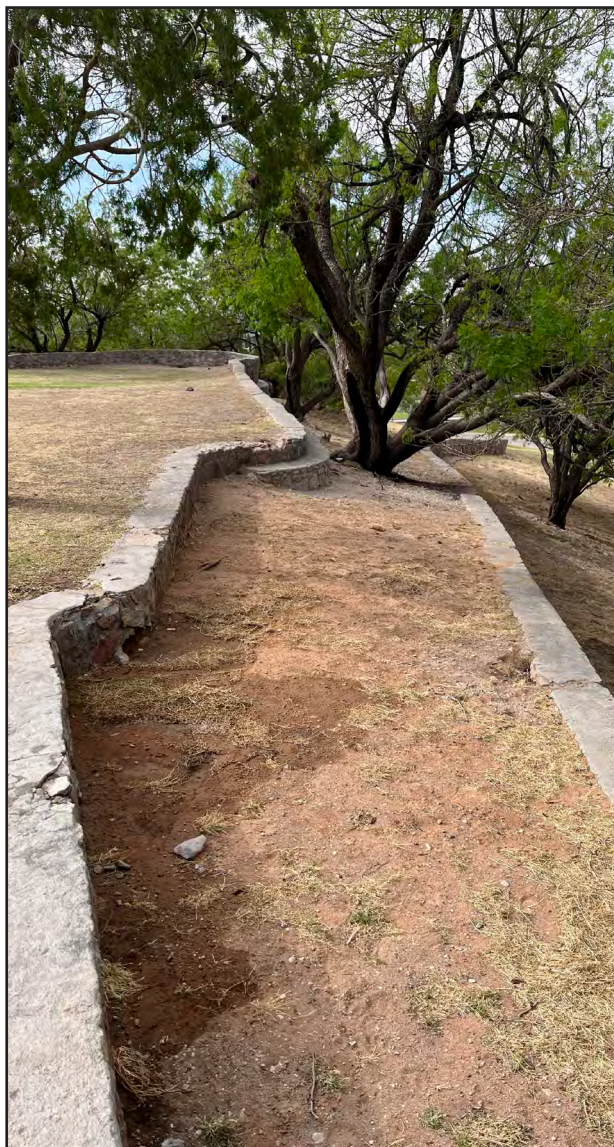
Memorial Park was first established over 100 years ago, and since then has undergone periods of development, deterioration, alteration, expansion, upgrade, and neglect. Some alterations to the park are minimal, and do not impact the overall historic integrity of the park to such a degree that they interfere with the park’s ability to convey its historical significance. These include cracked or missing stones in the masonry, cracked mortar, and the use of incompatible Portland cement mortar. Some alterations, including demolition of the Hilltop Garden and lover’s benches, were done during the park’s period of significance, and thus are part of the park’s history. Later, mid-century additions to the park, including the 1950s Garden Center and Rose Garden, have achieved historical significance in their own right, and contribute to the park’s overall historic significance.

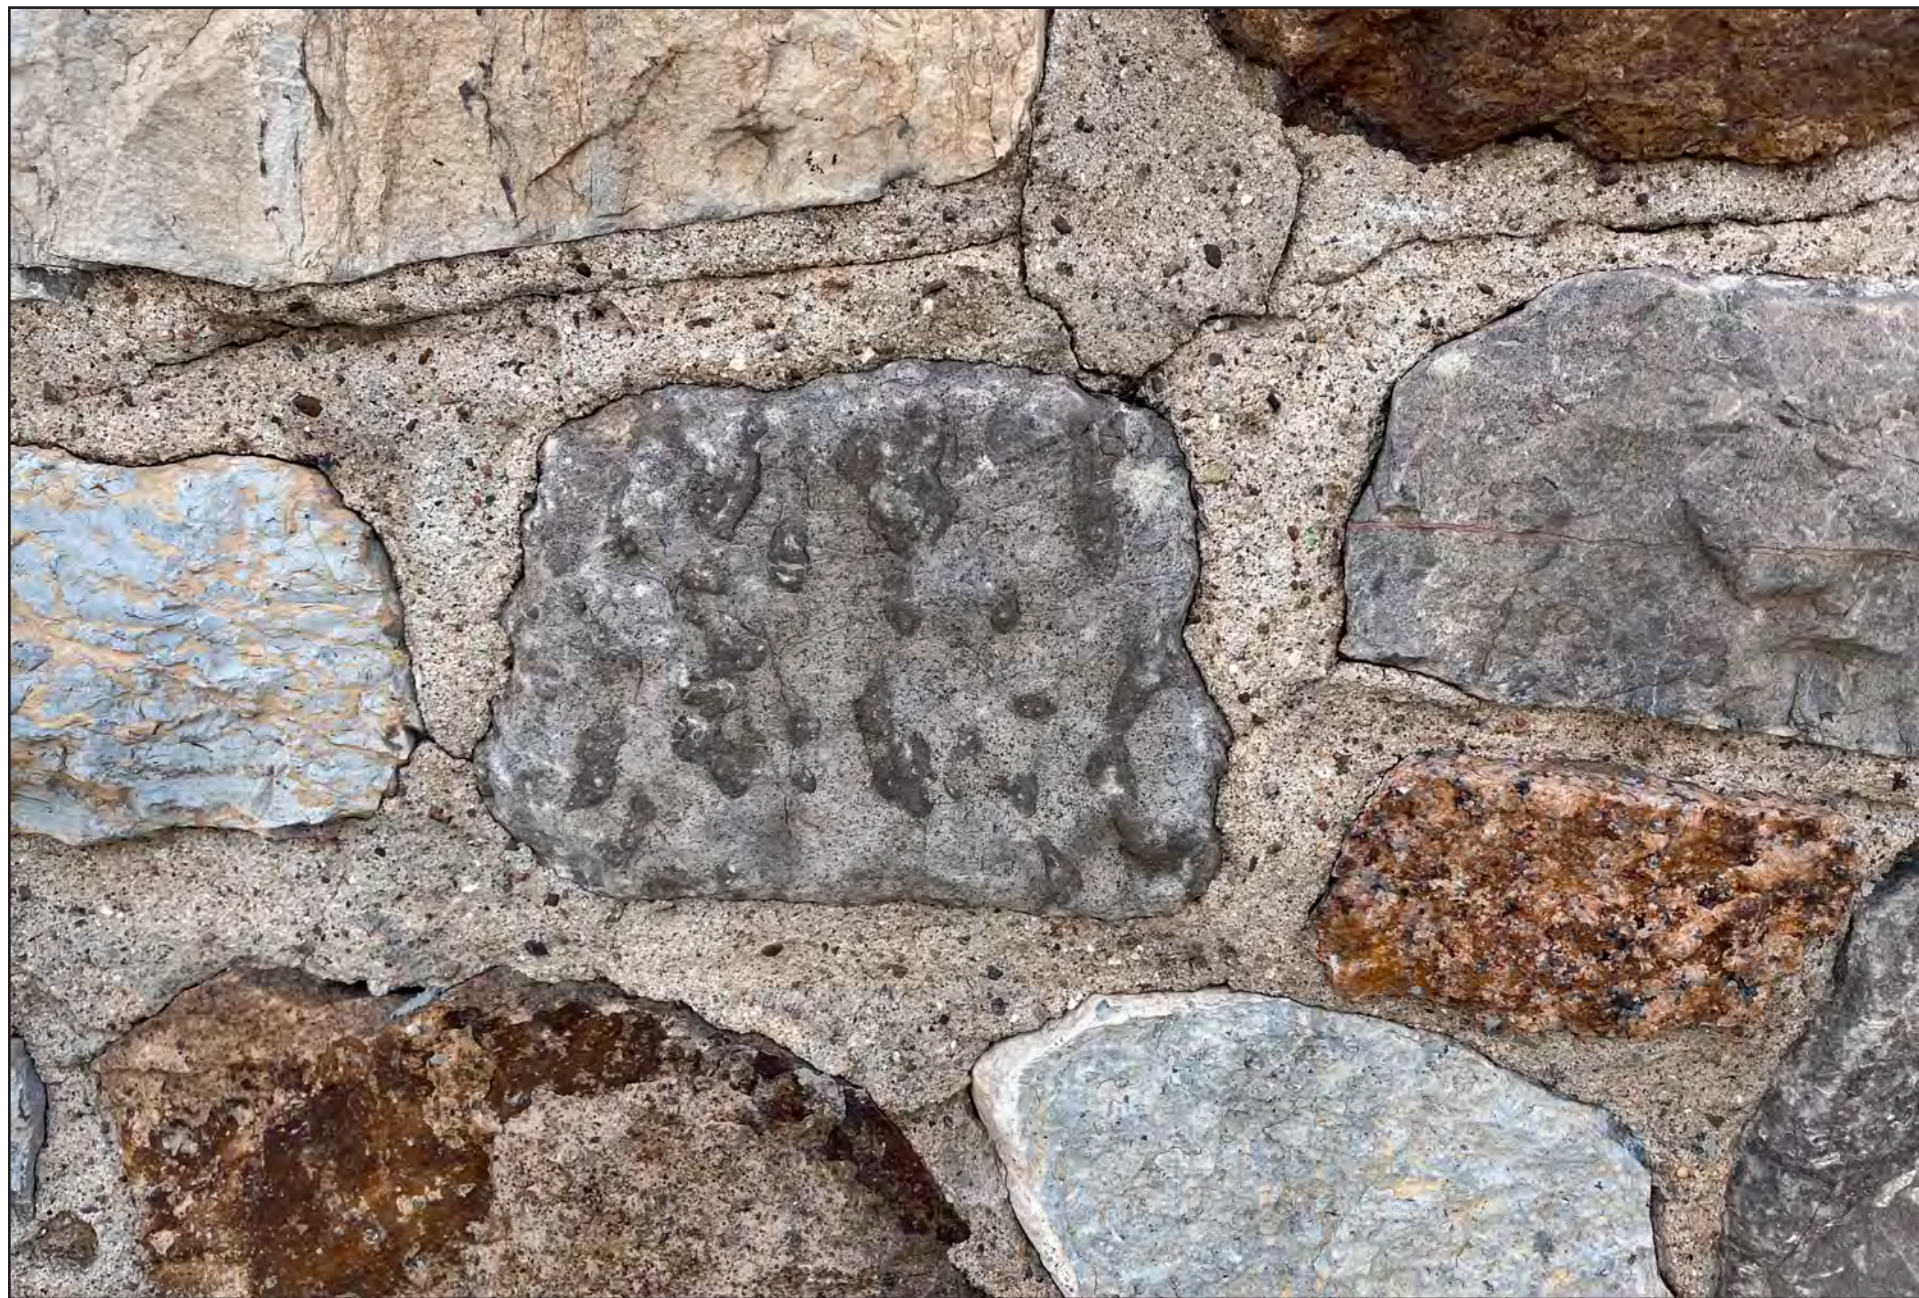
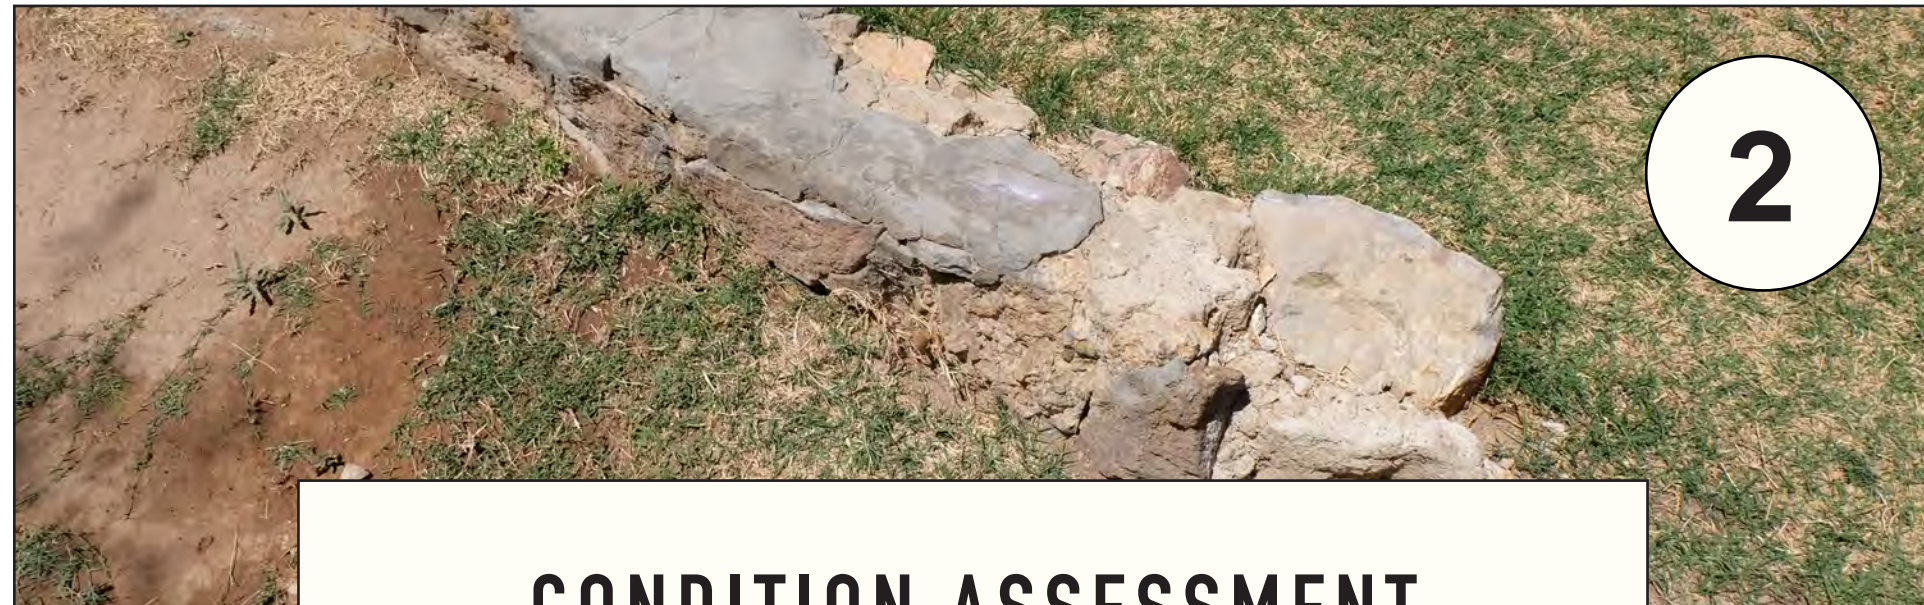
## CONDITION ASSESSMENT

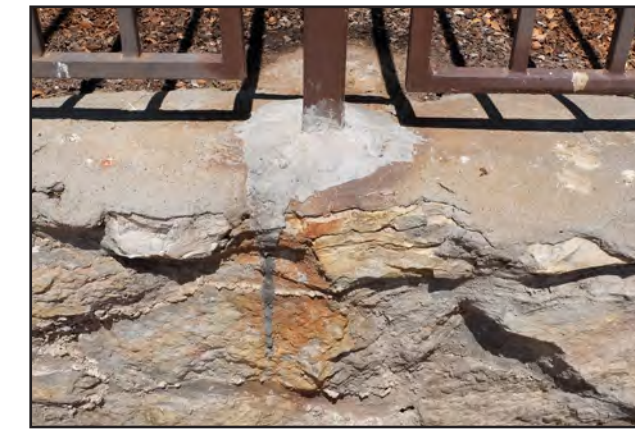
*Incompatible repair patch, corrosion, and staining at the Rose Garden.*

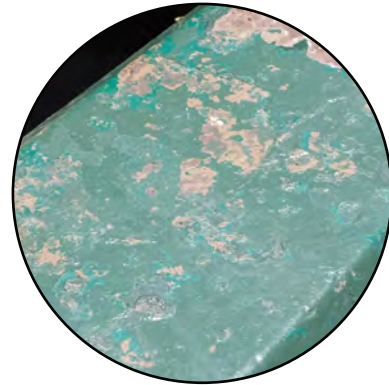
Native stone, limestone, and granite were used through the masonry structures in the park. The masonry structures appear to date from the early 1920s, the WPA-era, midcentury, and more recent times. The masonry materials are irregularly shaped and vary in color, texture, and size.

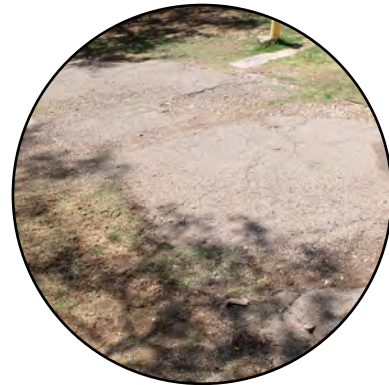
Exterior paint finishes are applied to most buildings throughout the park. It is both an aesthetic and protective layer over the substrate. In general, it is not recommended to apply paint to masonry walls that were historically unpainted. Non-historic paint coatings were noted on the brick exterior walls of the garden center (HR15), the 1920s bridge (HR1), on various elements of the hilltop masonry walls (HR3), and the masonry accessory building (HR18). Paint was likely historically used on the picnic tables (HR20) and exterior elements of the concession building (HR17) and garden center (HR15).

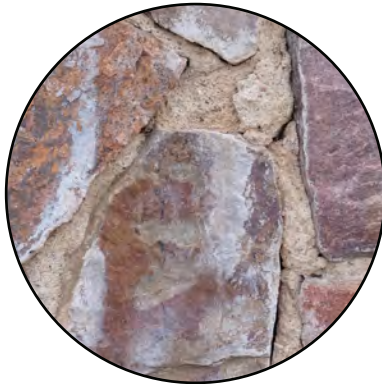
The garden center (HR15) has brick exterior walls..

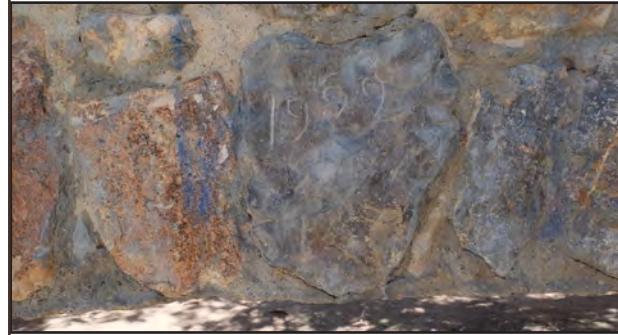
Keystone with "1922" inscription.

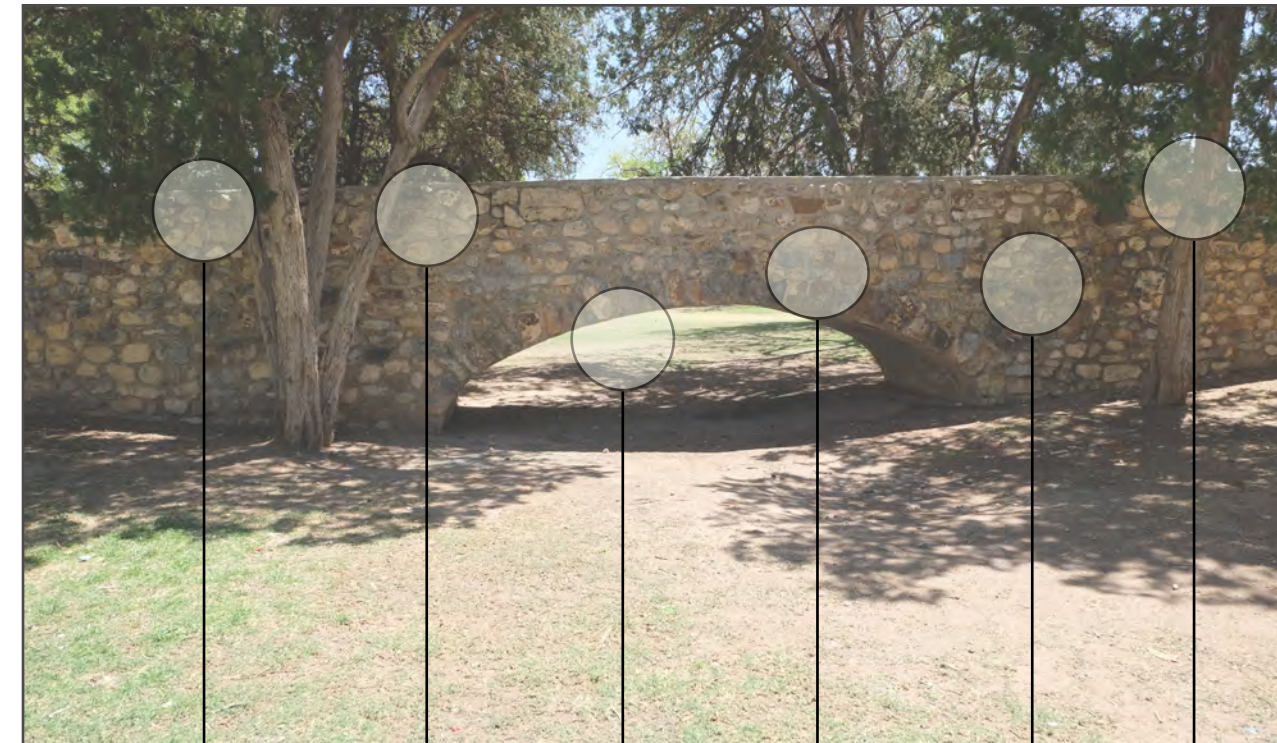
TYPICAL CONDITIONS: 1920S BRIDGE (HR1)

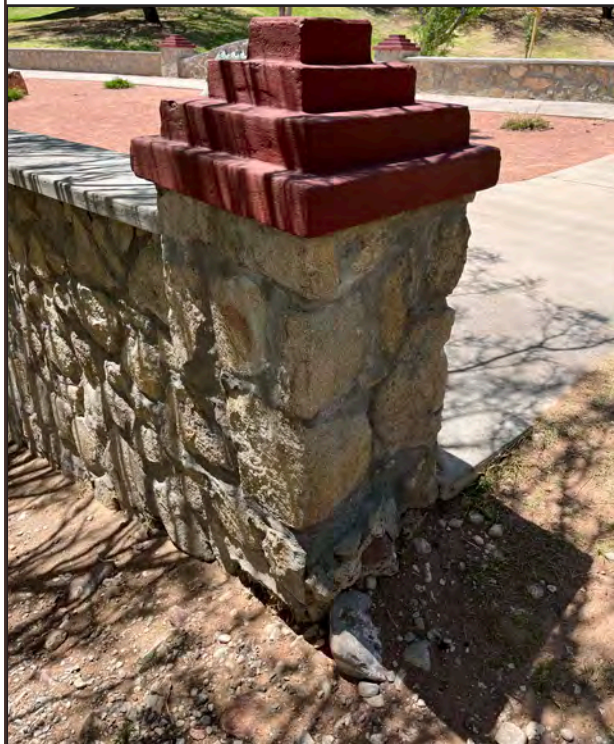
Tiered posts at Estrella Street Bridge

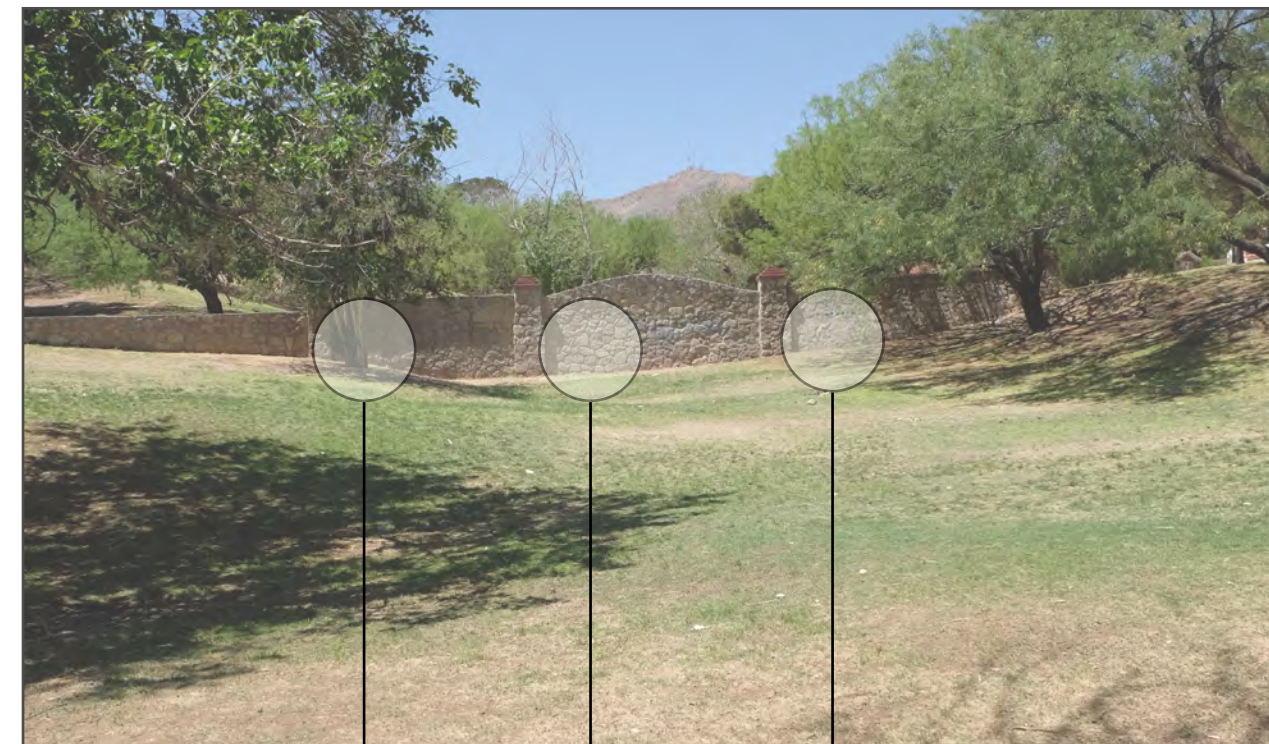
ESTRELLA STREET BRIDGE (HR2)

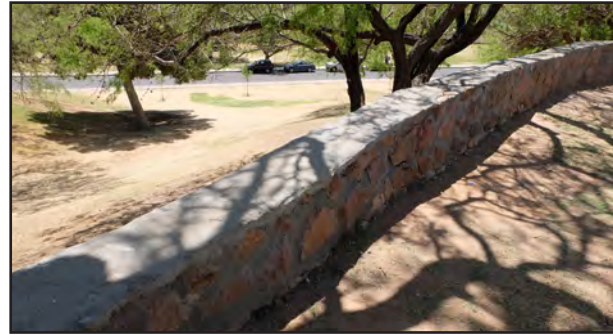
Masonry walls follow the topography of the landscape.

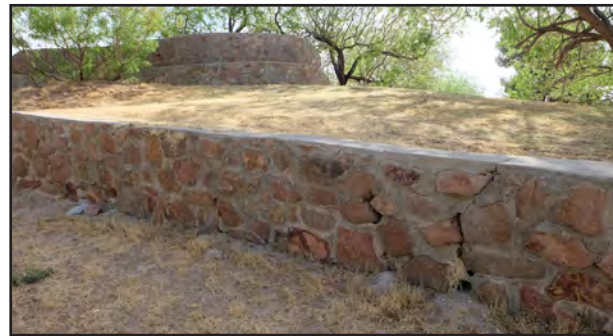
Step cracks from differential settlement
