# Historic Resources of Memorial Park

CITY OF EL PASO

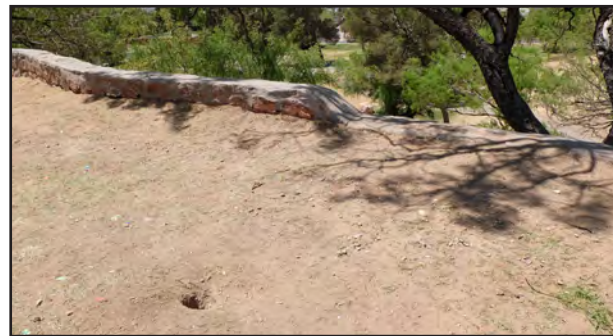
Varying features in the hilltop walls

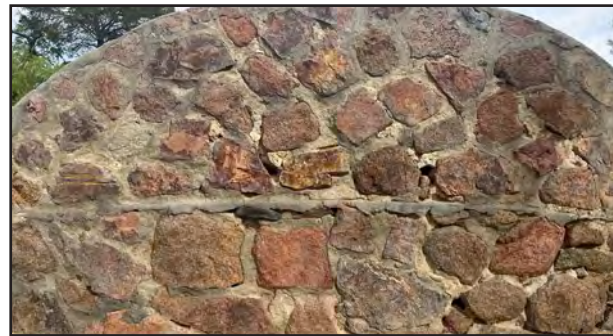
Missing mortar on rear of bench

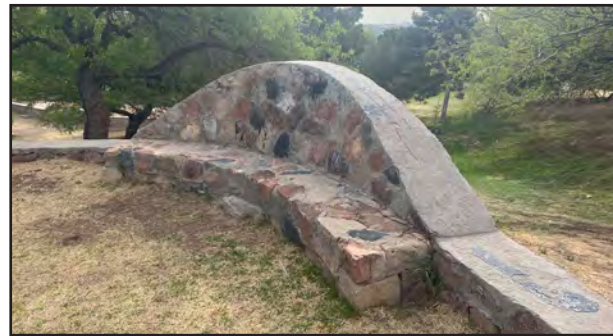
The bench follows the contour of the hilltop walls

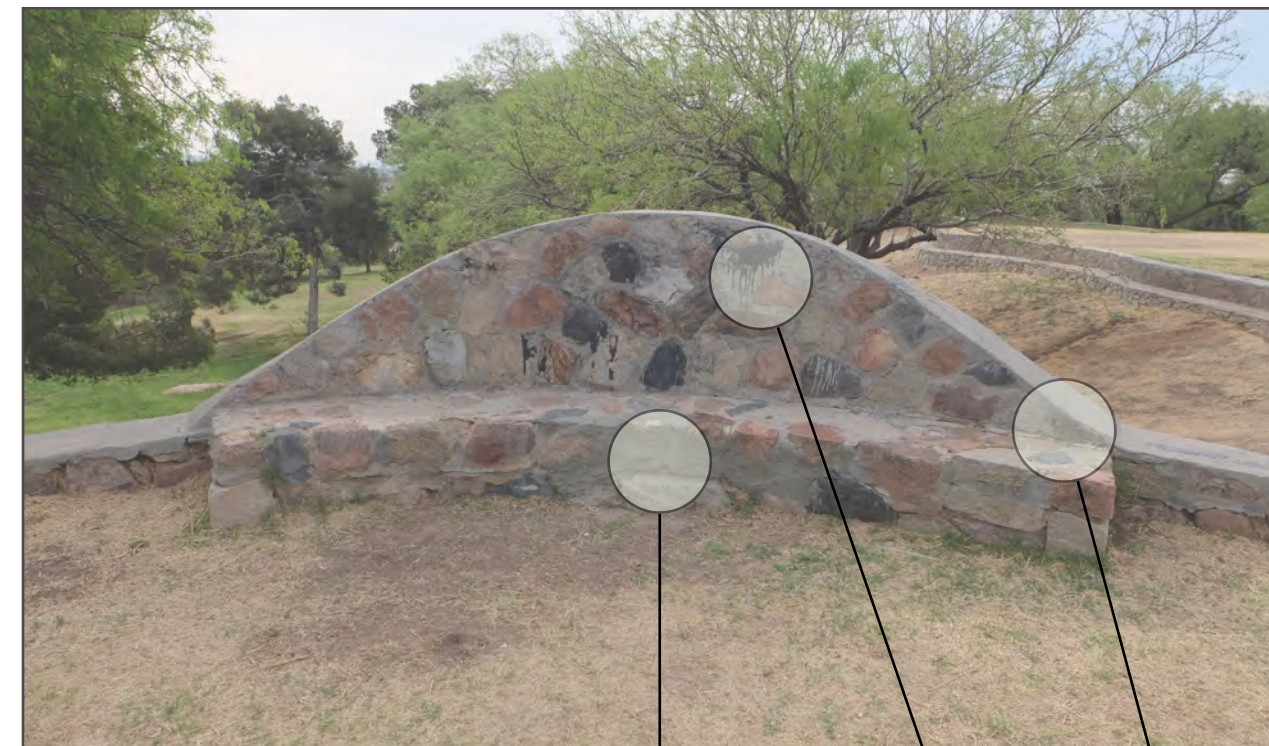
incompatible repair (concrete patch on stone)

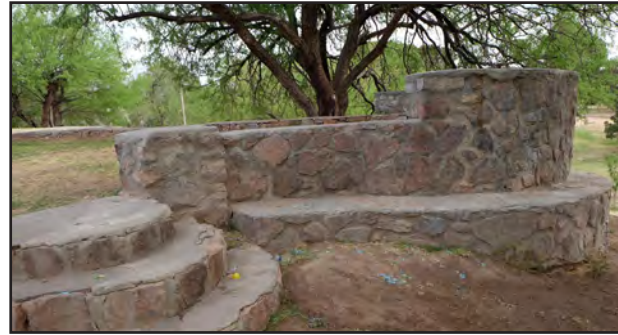
Erosion at rear of bench structure

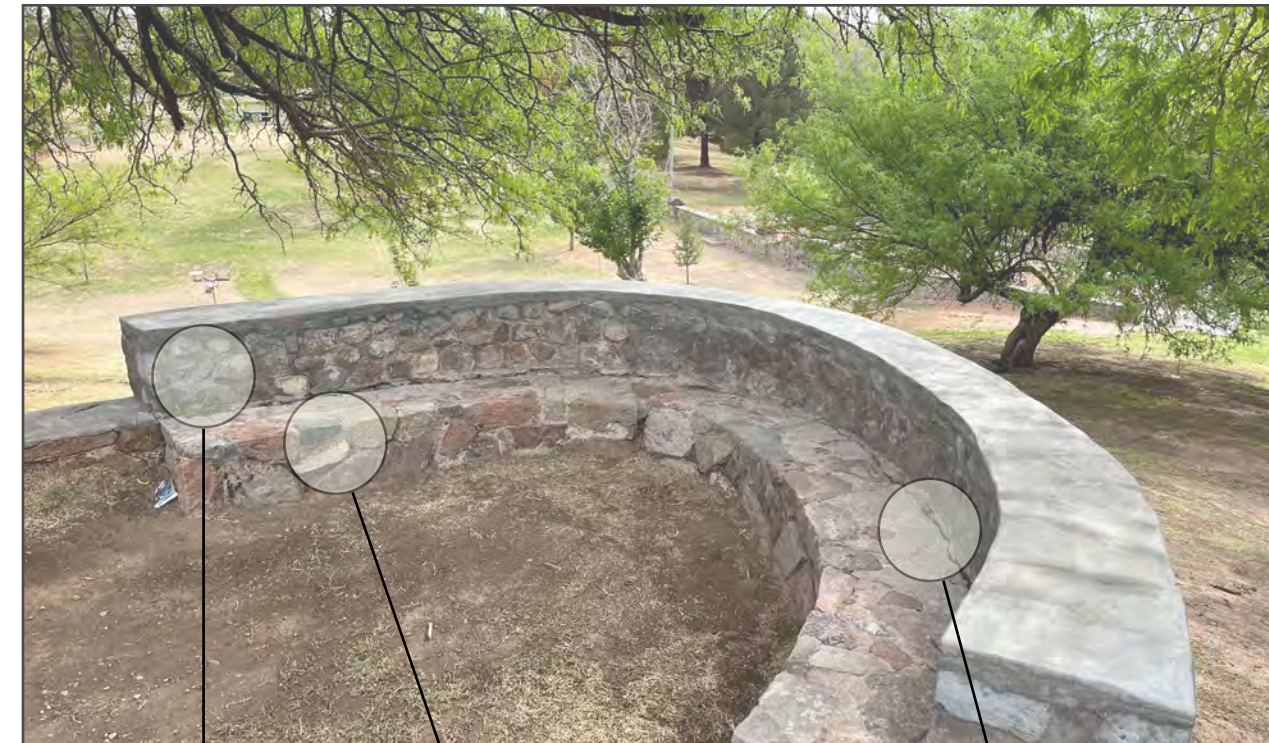
incompatible repair (concrete patch on stone)

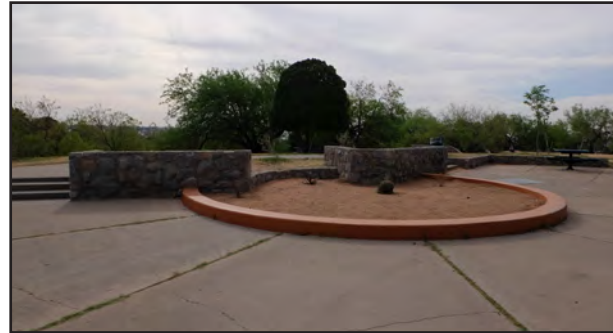
Concrete curbed-garden

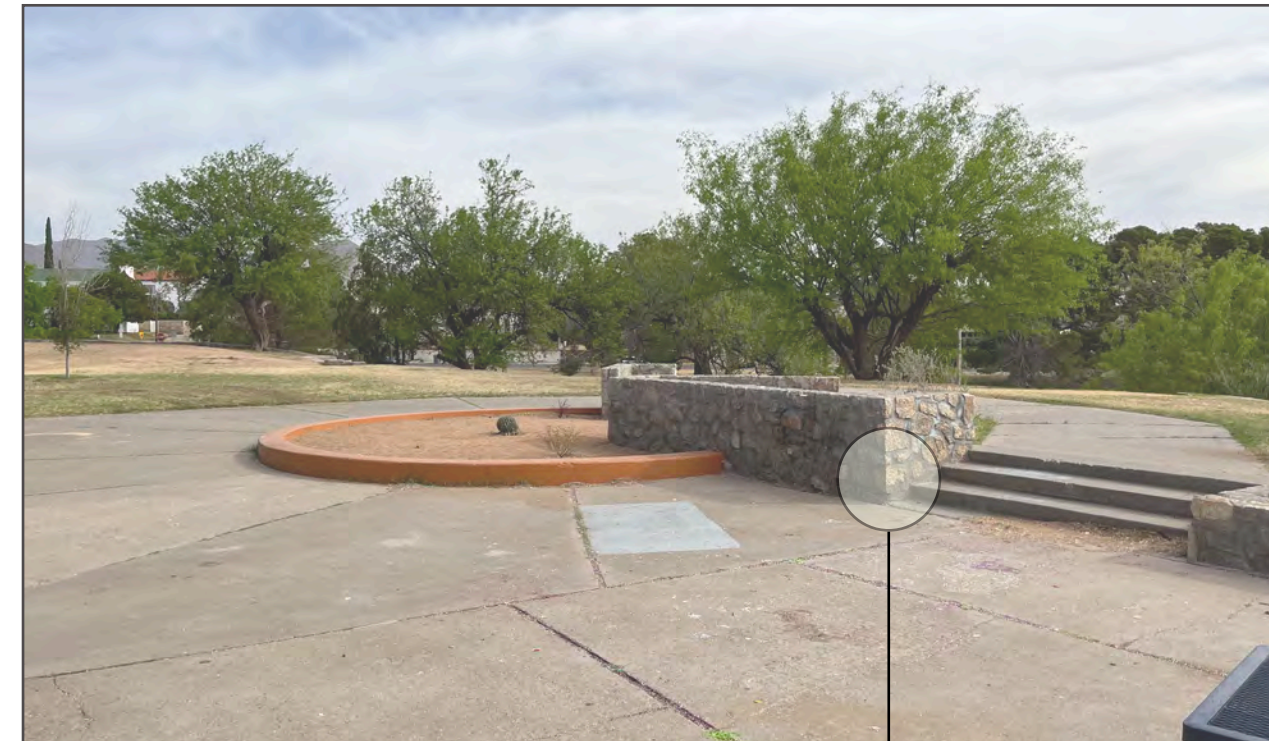
incompatible repair (mortar)

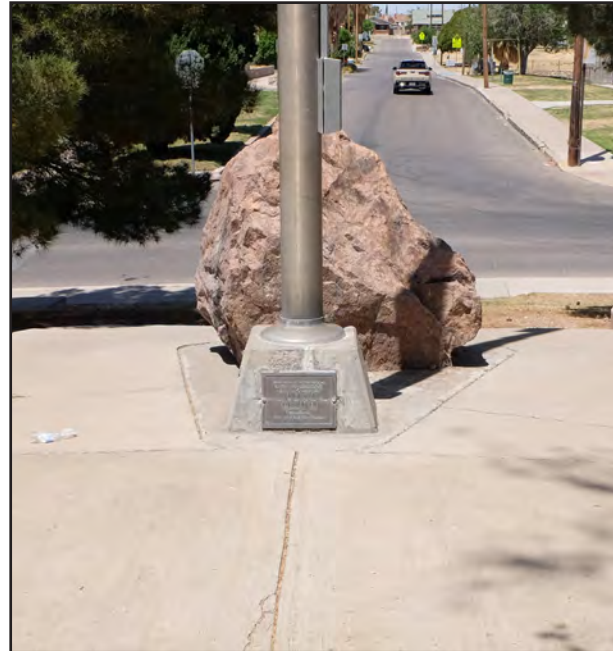
Flagpole with commemorative plaque

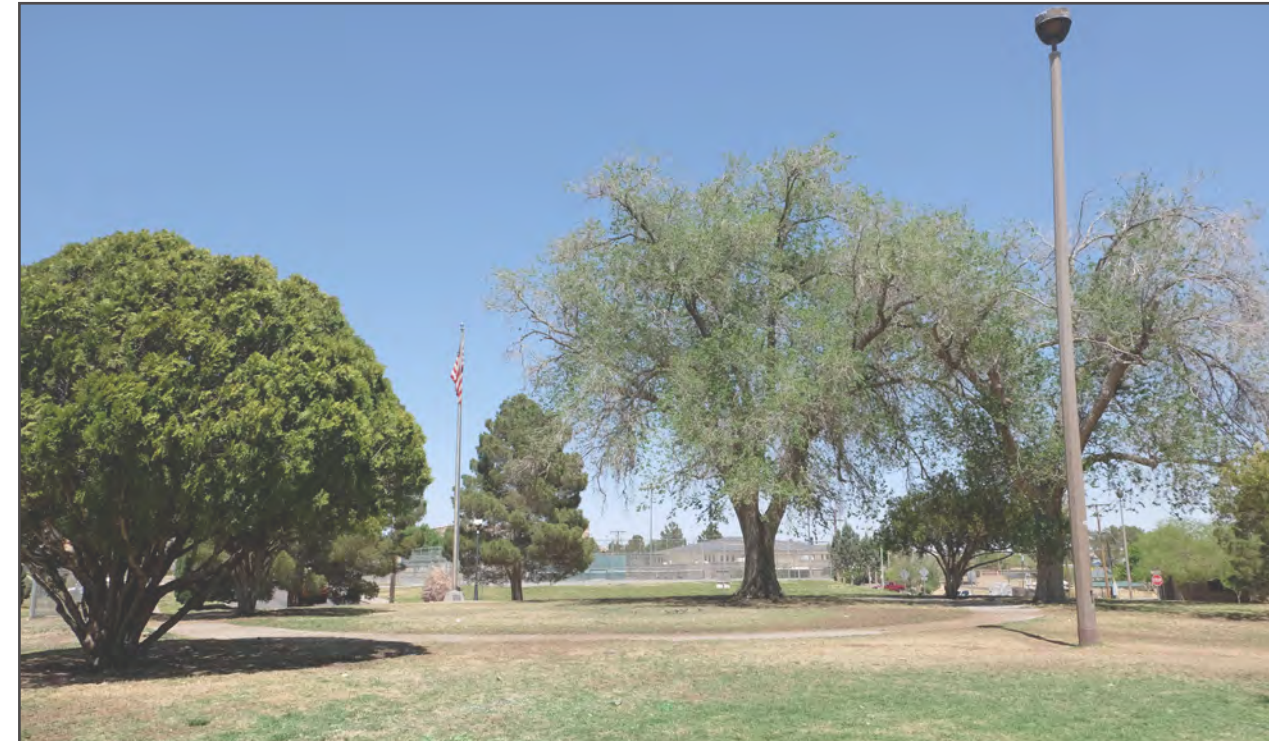
NORTH COPIA STREET WALLS (HR10)

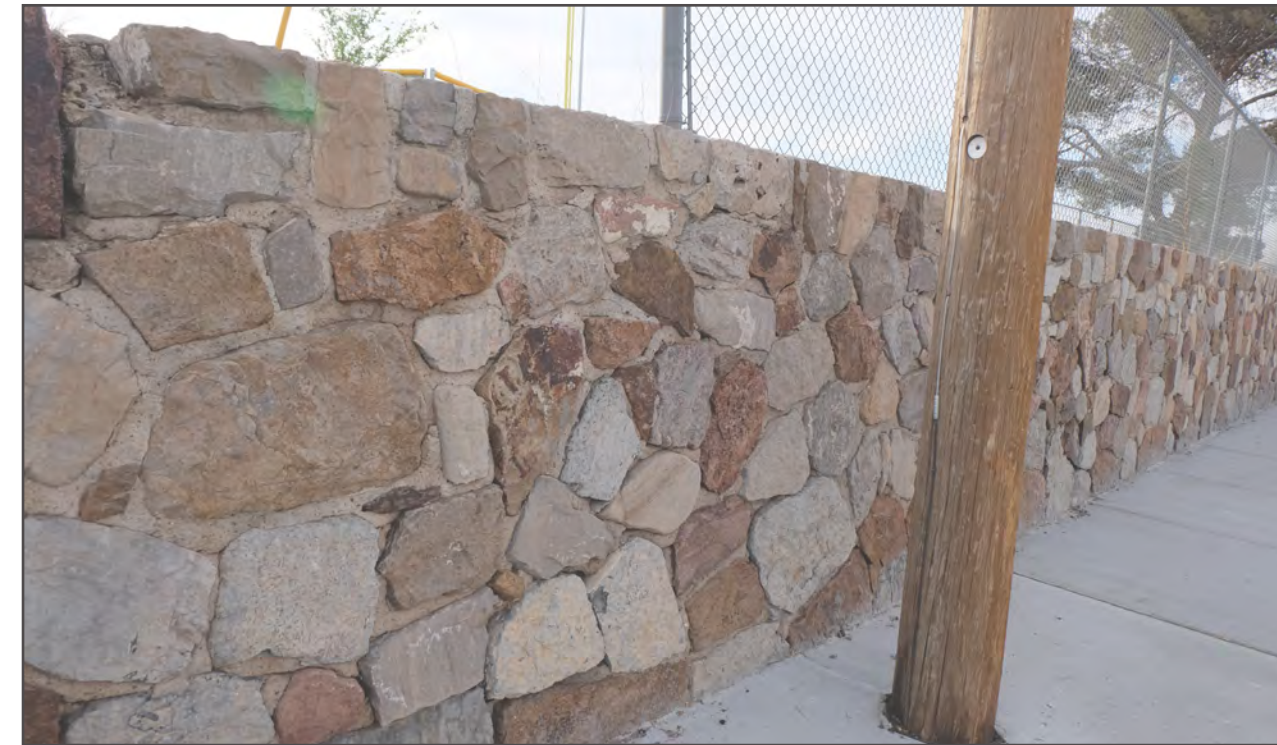
TREATMENT RECOMMENDATIONS

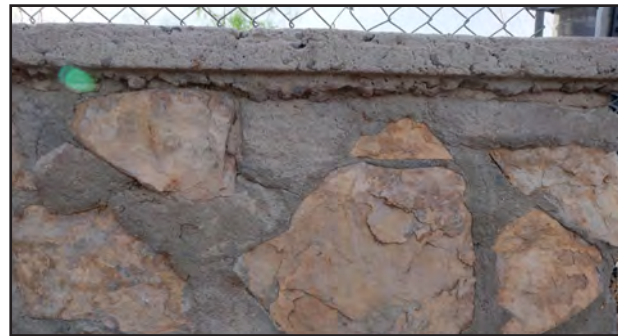
Keystone with "1922" inscription.

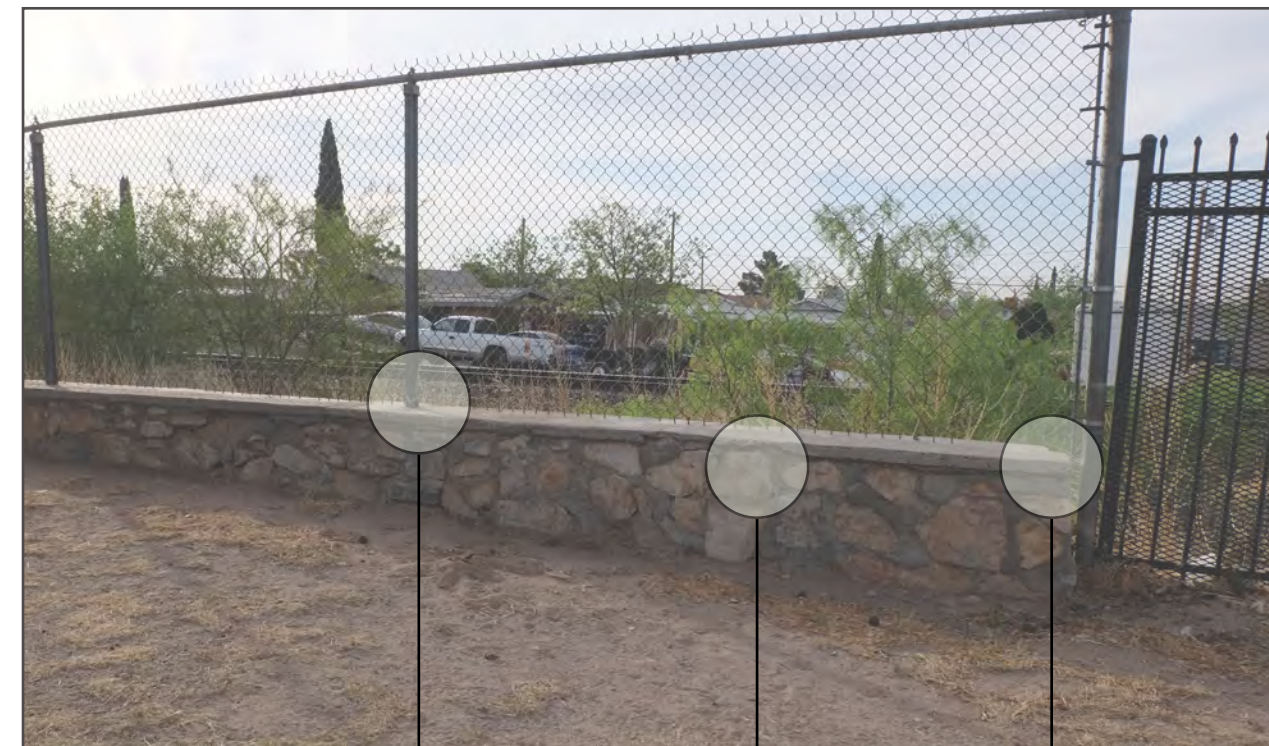
cracks in coping, especially where fence is attached (concrete)

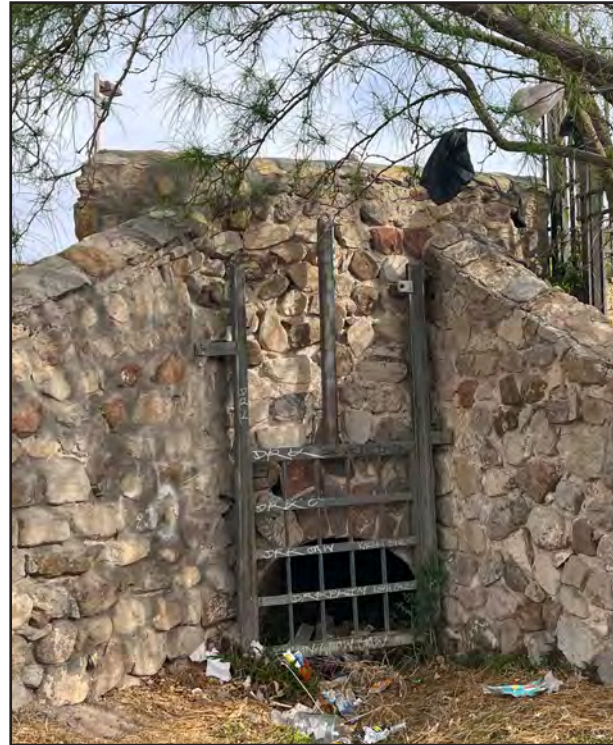
Overall Condition: Fair

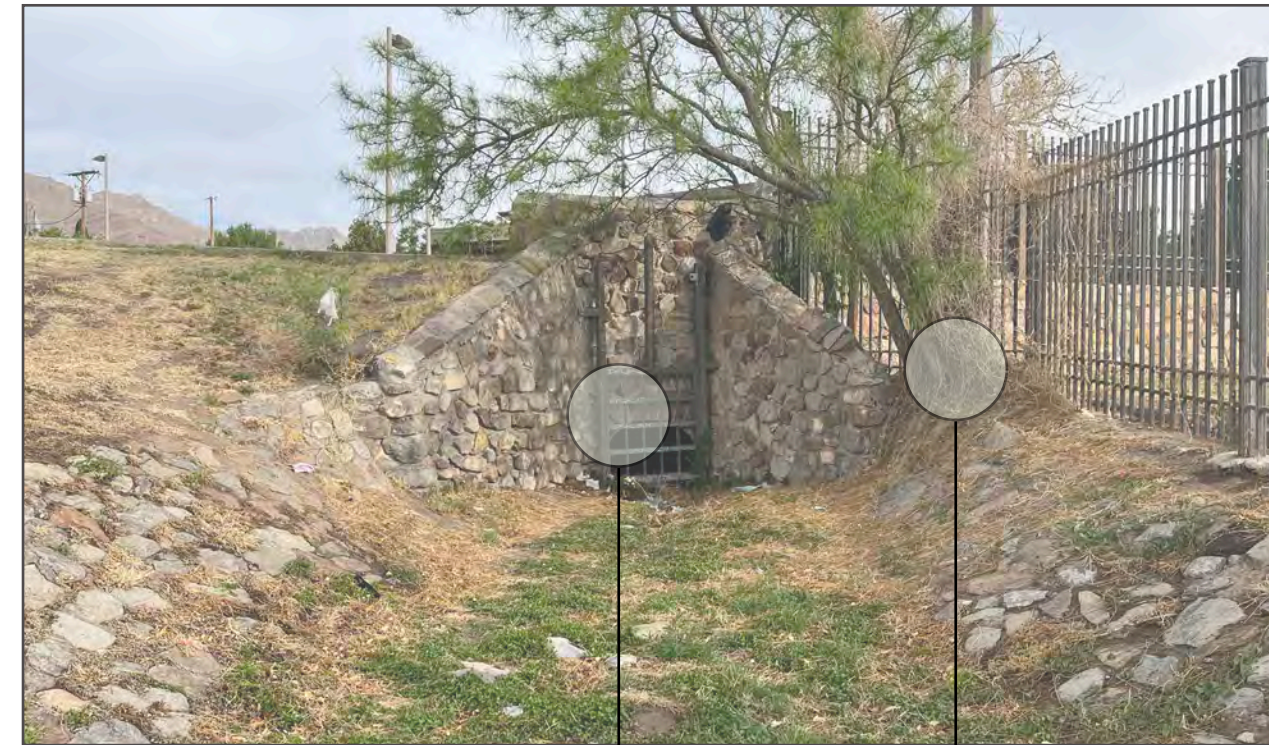
applied graffiti (metal)

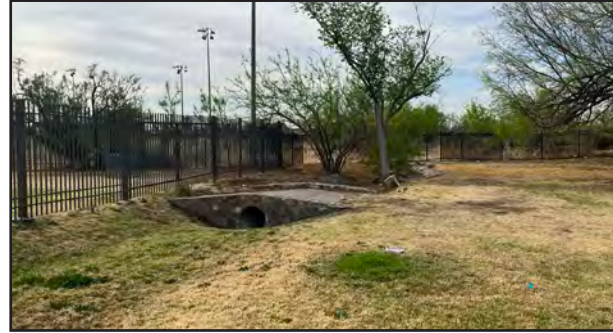
Overall Condition: Fair

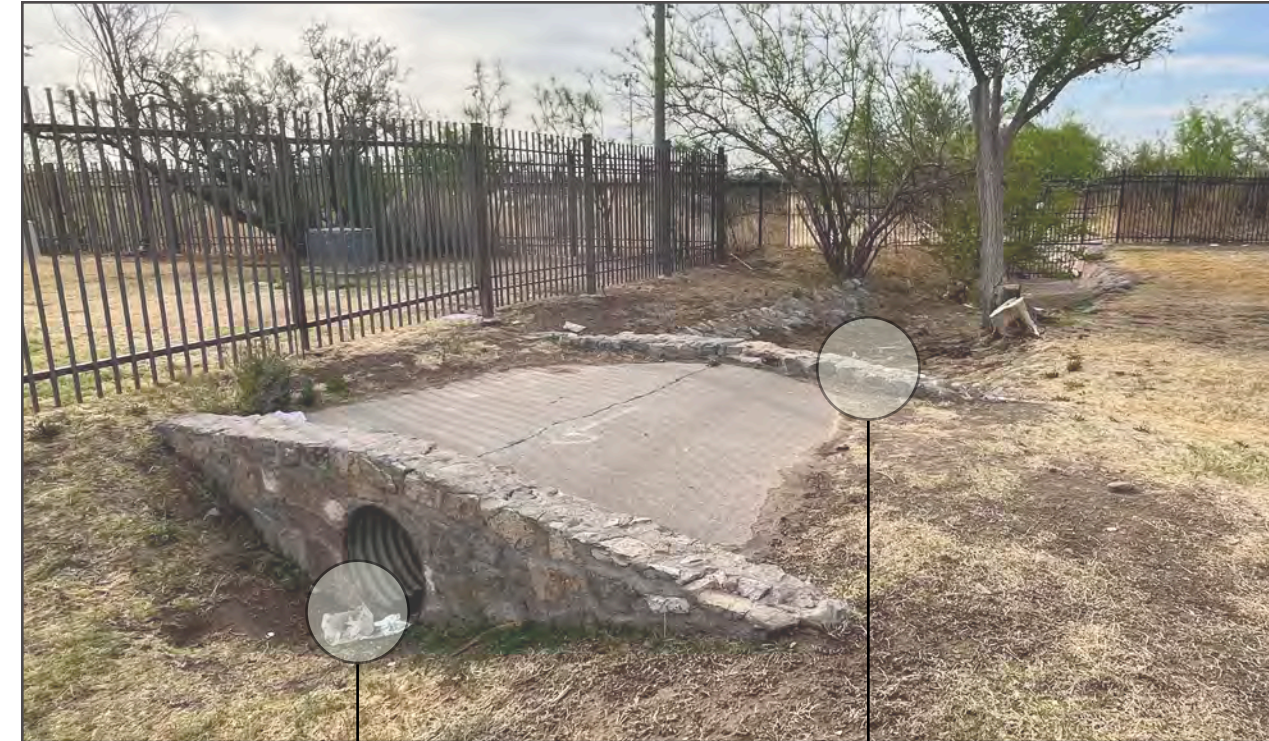
- Vegetation adjacent to historic masonry should be maintained. It can cause conditions of excess moisture, attract insects or vermin, and grow into the masonry walls causing destabilization and damage.

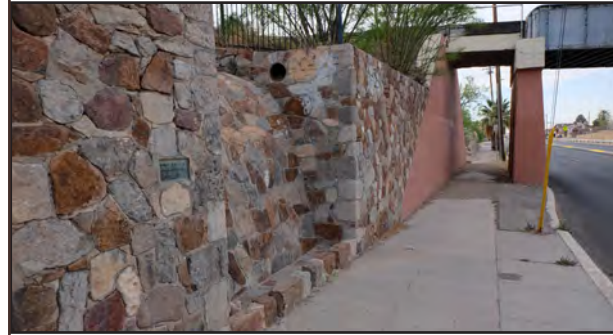
Drainage feature at North Copia Street and the railroad tracks

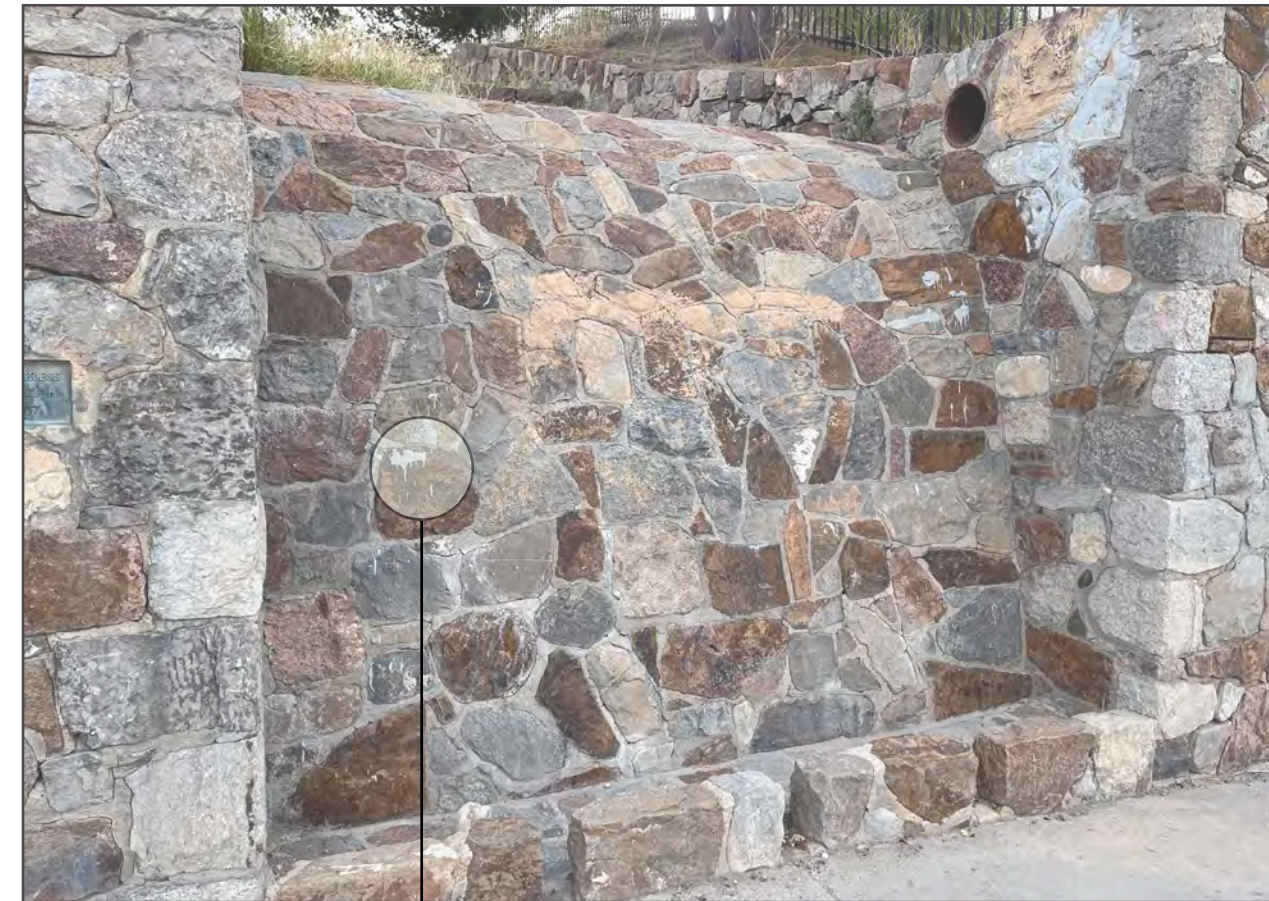
applied paint (masonry)

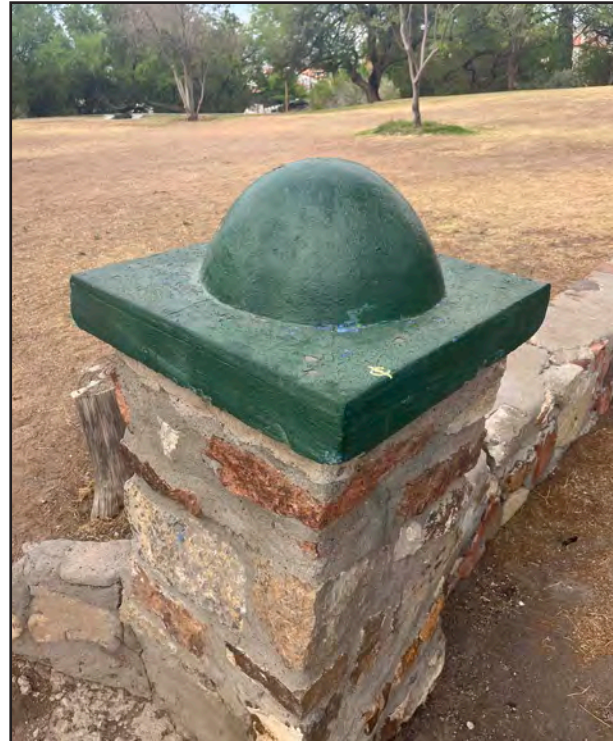
Overall Condition: Fair

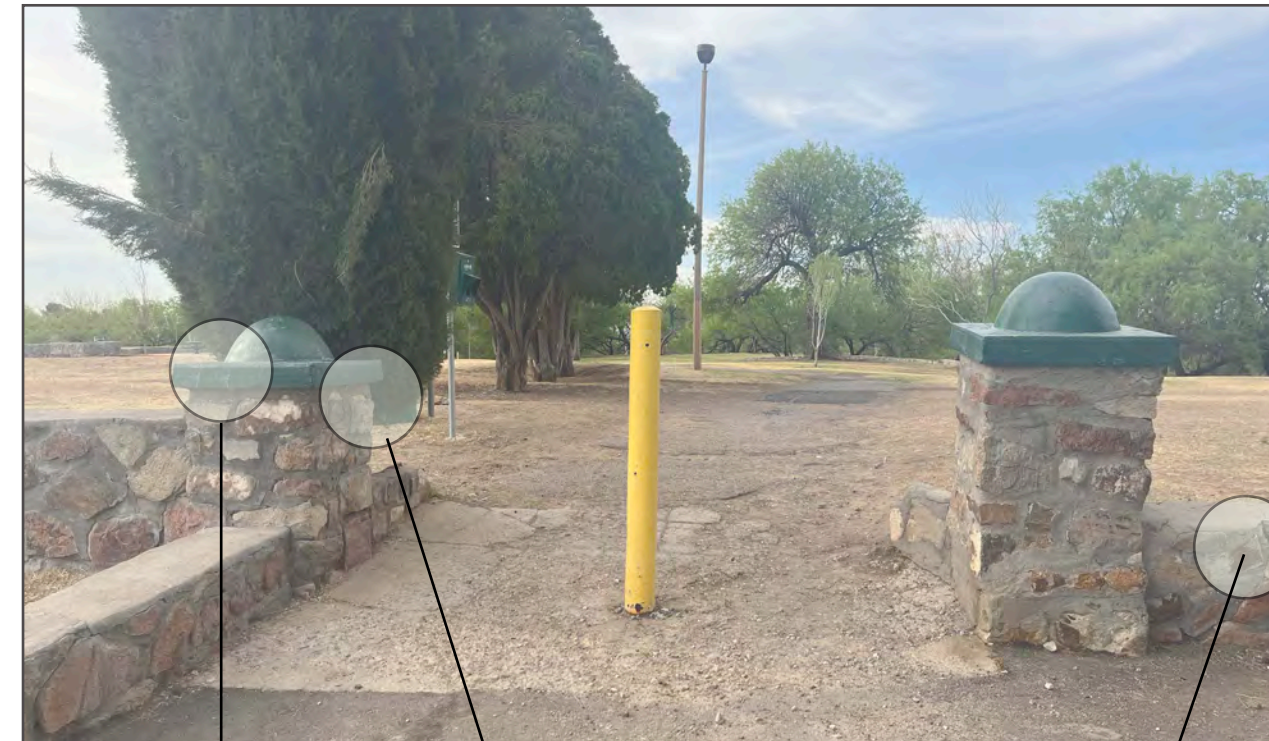
failing paint coating (concrete)

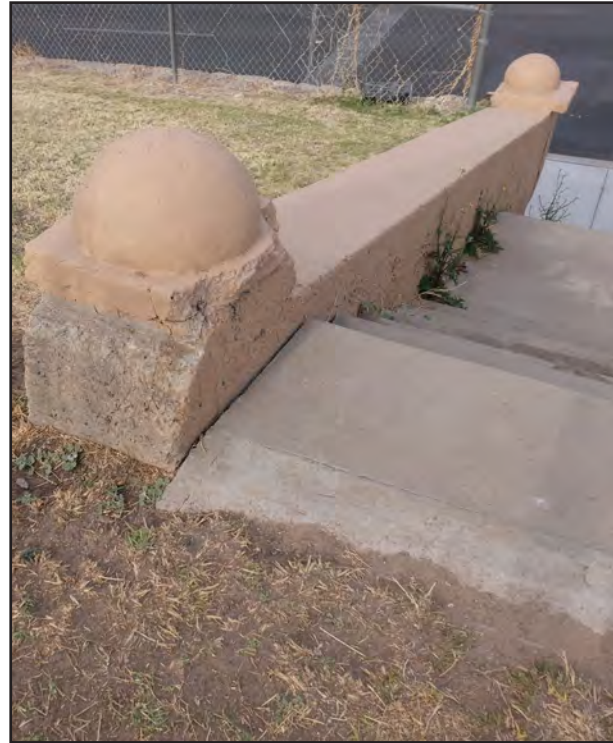
Overall Condition: Poor

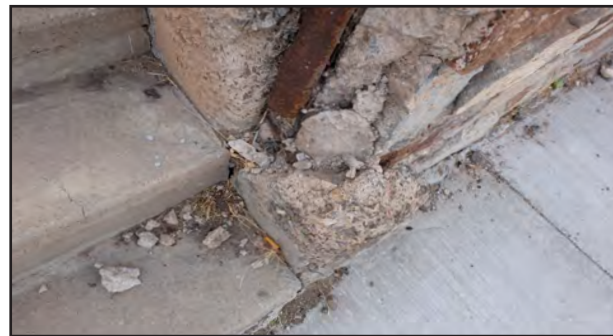
Typical interior structural failure

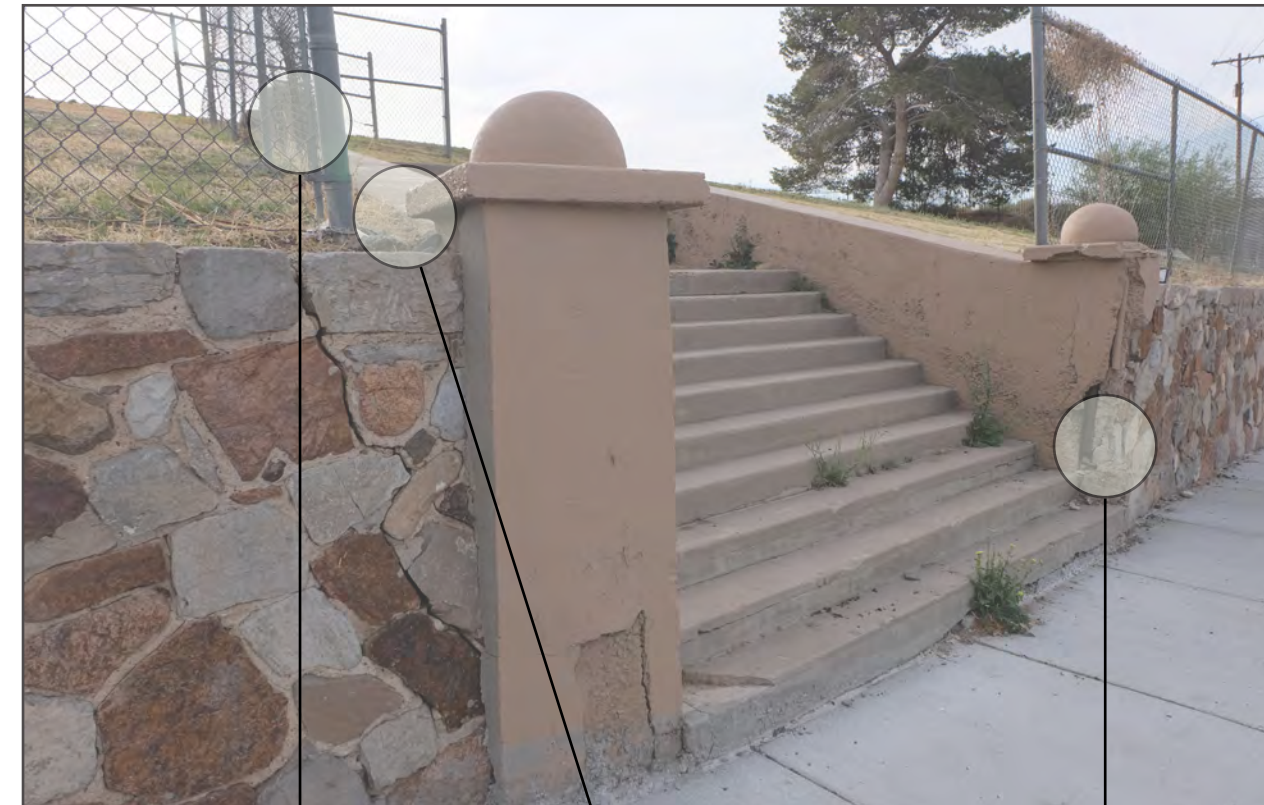
spalling due to corroded rebar

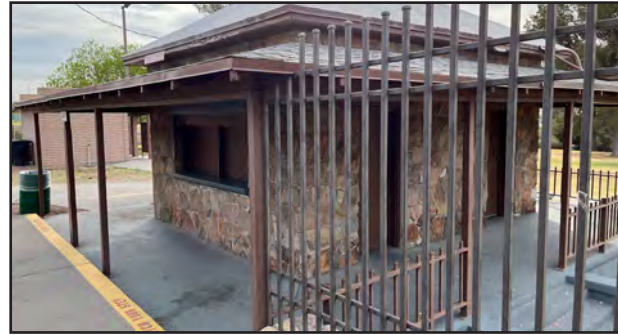
CONCESSION BUILDING (HR17)

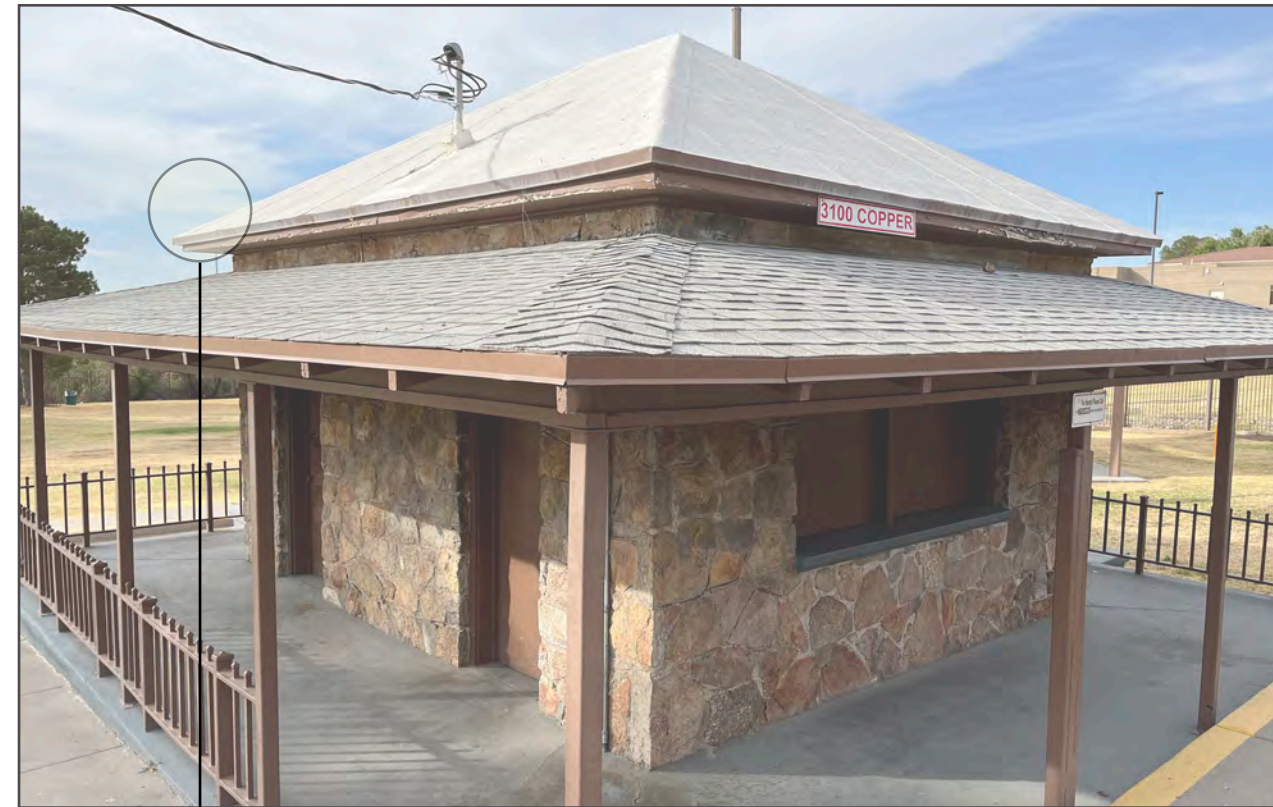
CONCESSION BUILDING (HR17)

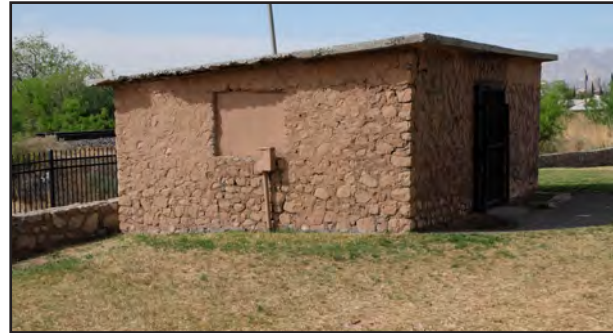
Accessory building exterior with enclosed window

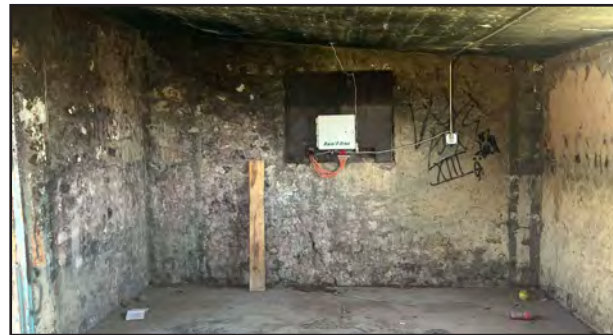
Accessory building interior with applied graffiti and deterioration

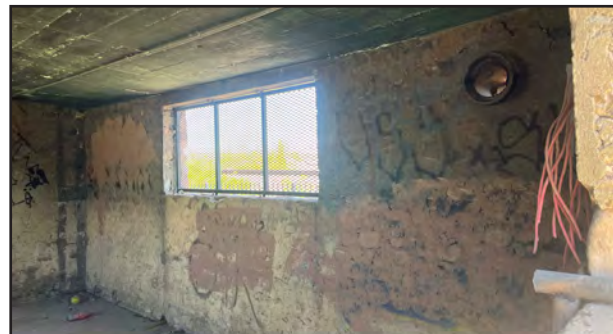
Accessory building interior with applied graffiti and deterioration

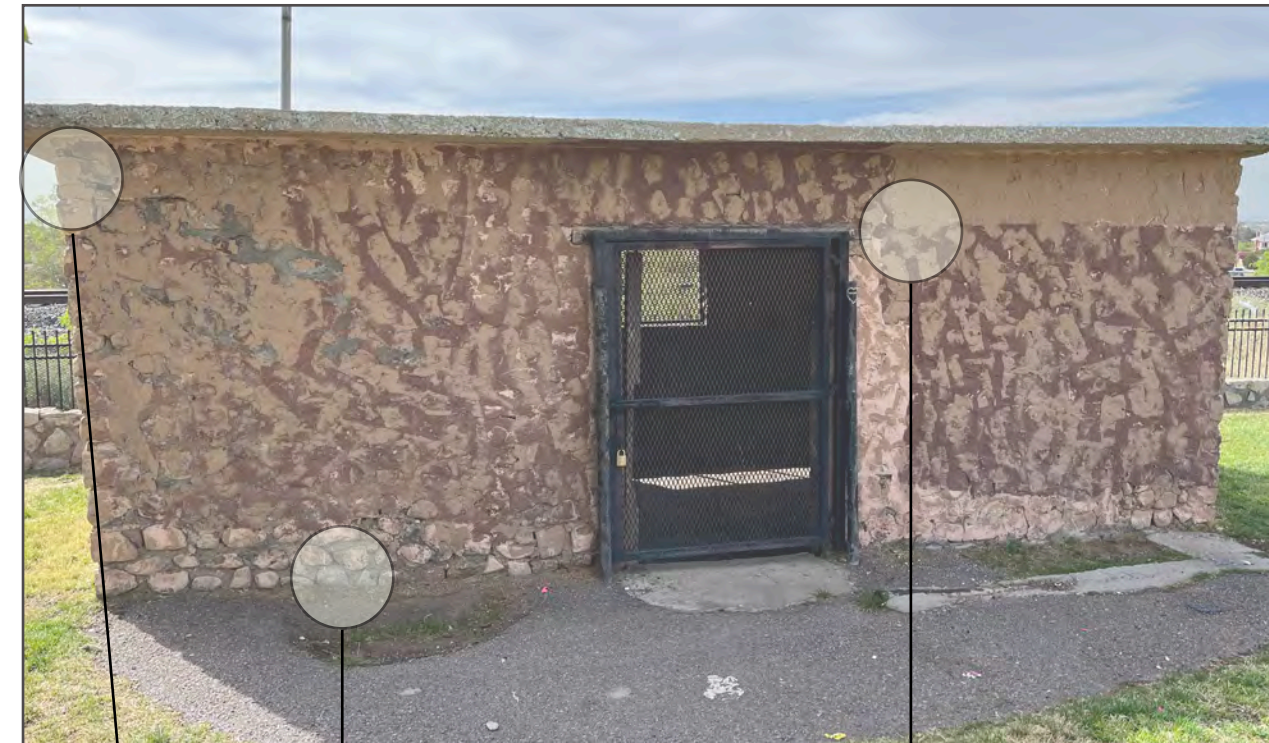
corrosion (structural metal)

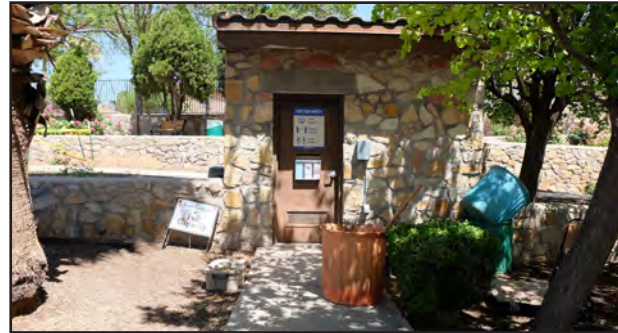
Keystone with "1922" inscription.

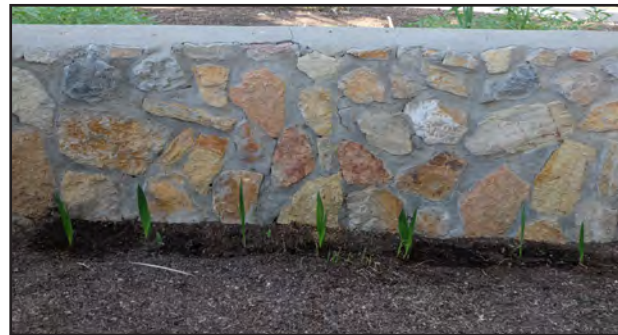
The interior rose garden walls are in good condition with some cracks in the concrete coping.

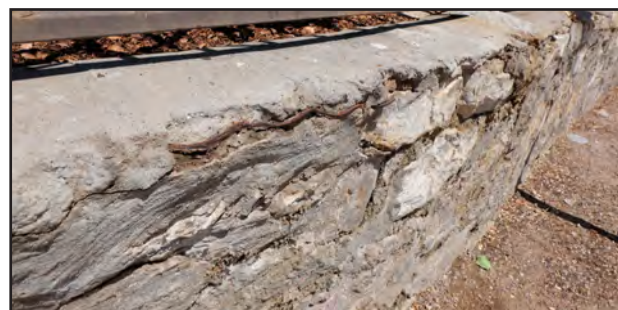
Typical mortar and masonry

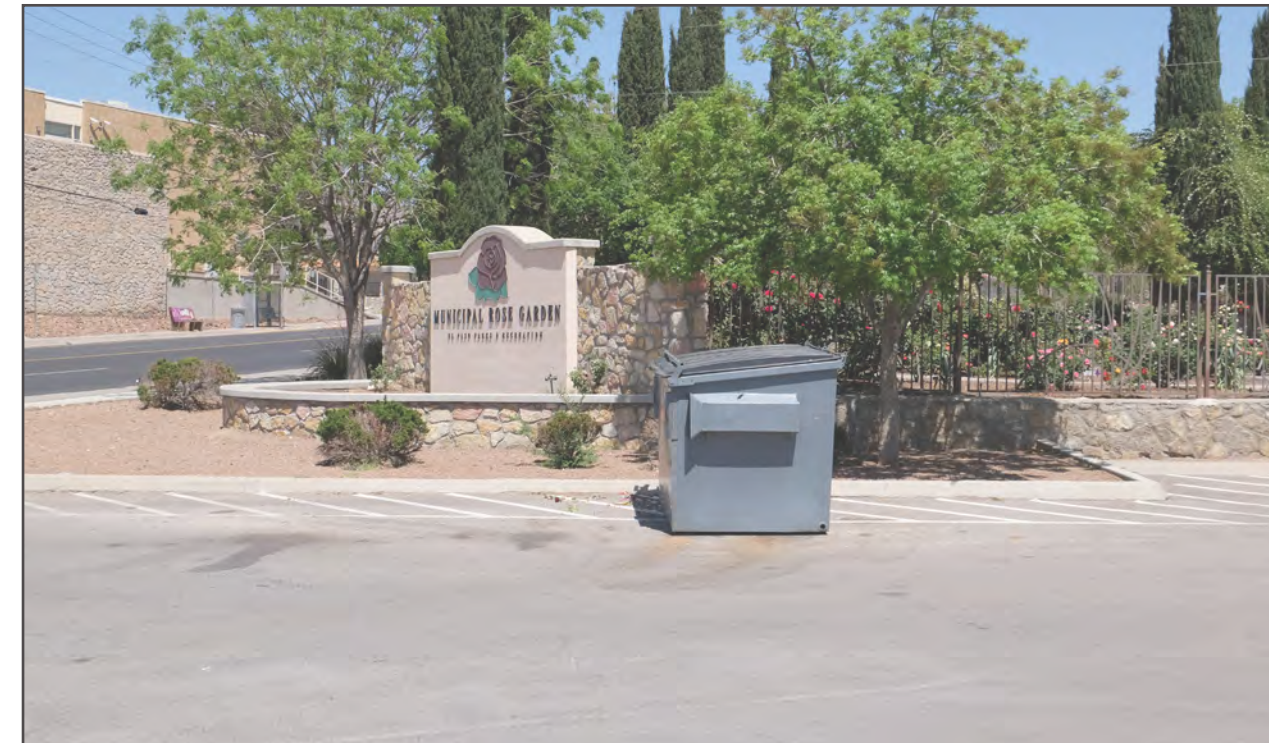
TREATMENT RECOMMENDATIONS

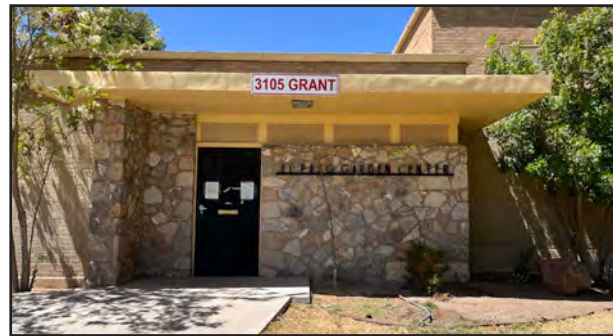
Garden Center entrance

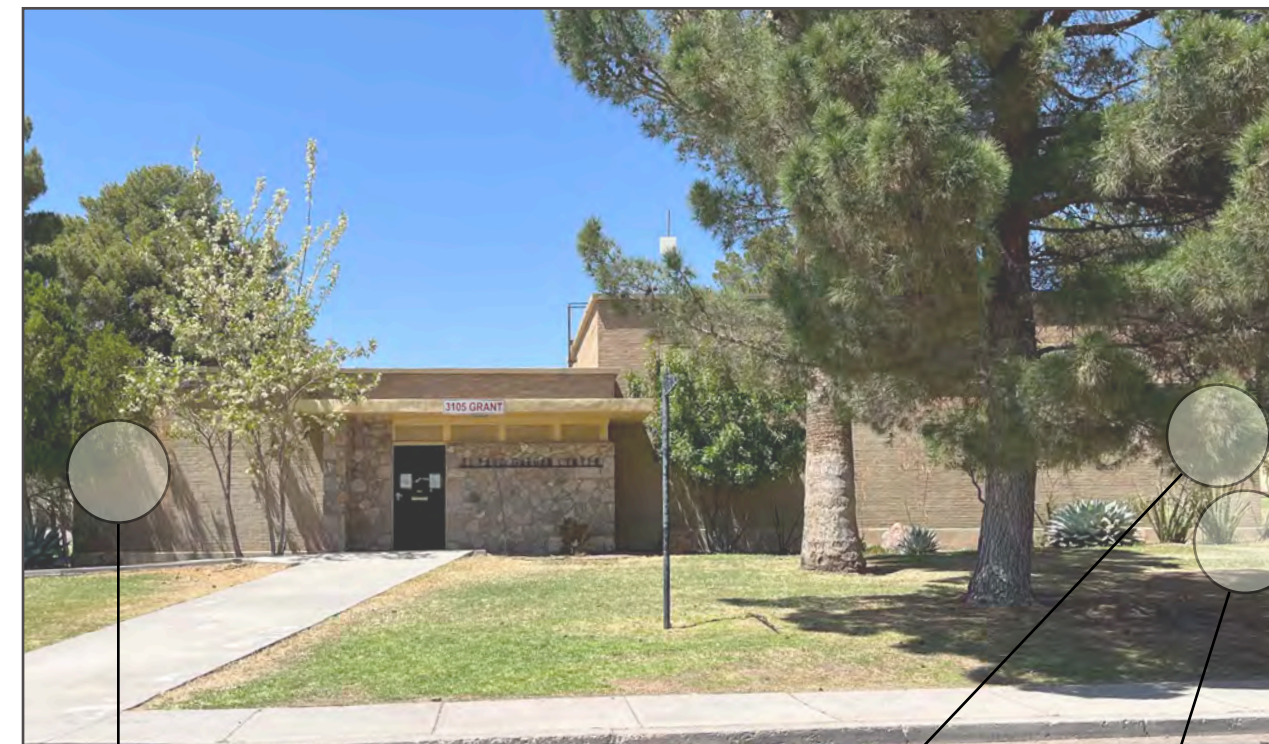
corrosion staining and peeling paint (concrete)

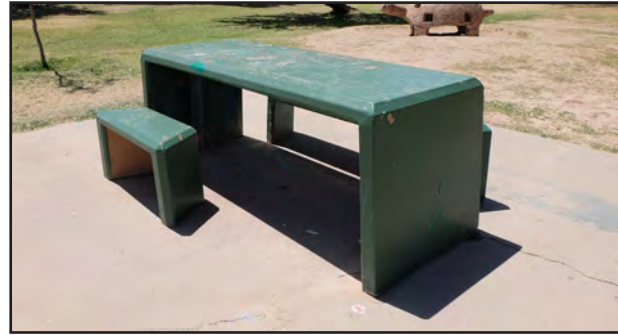
PICNIC TABLES (HR21)

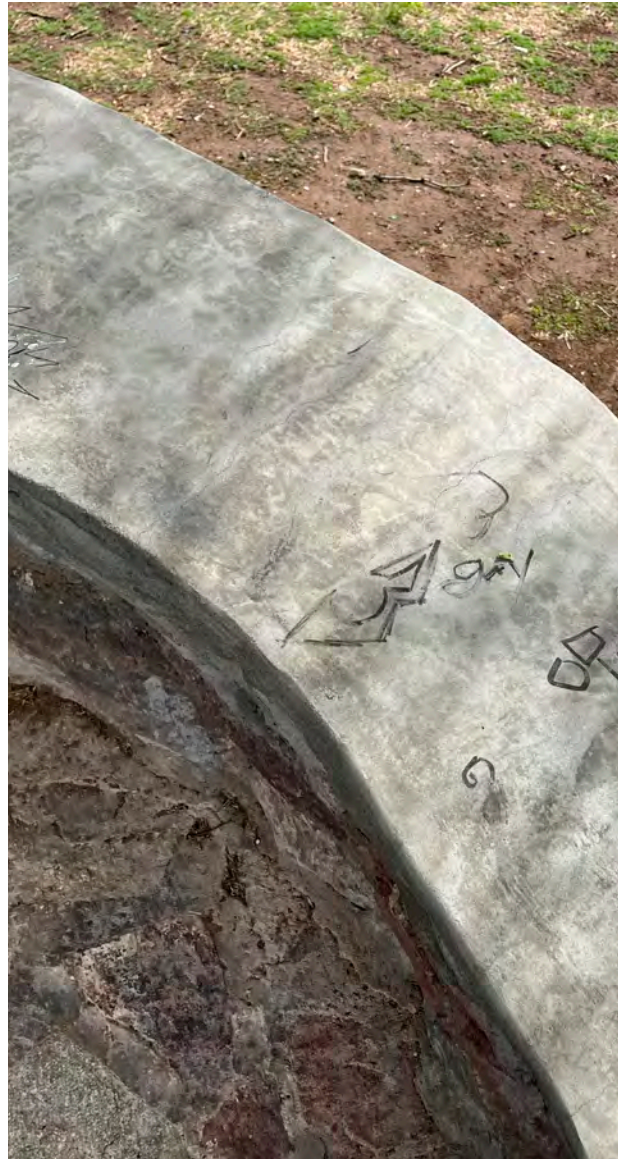
ILLUSTRATED GLOSSARY
